**THE DEVELOPMENT OF A RISK-OF-FAILURE EVALUATION TOOL FOR  
SMALL DAMS IN MZINGWANE CATCHMENT.**

**A thesis submitted in partial fulfilment of the requirements for the Master of  
Science Degree in Integrated Water Resources Management**

**UNIVERSITY OF ZIMBABWE**

**June 2007**

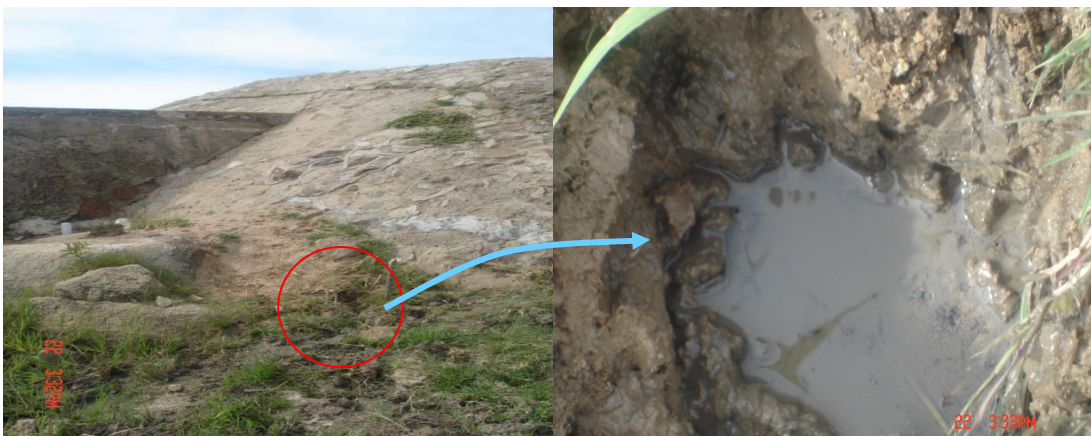
**Picture 1 and 2.** Leakage at Shagwe dam training wall

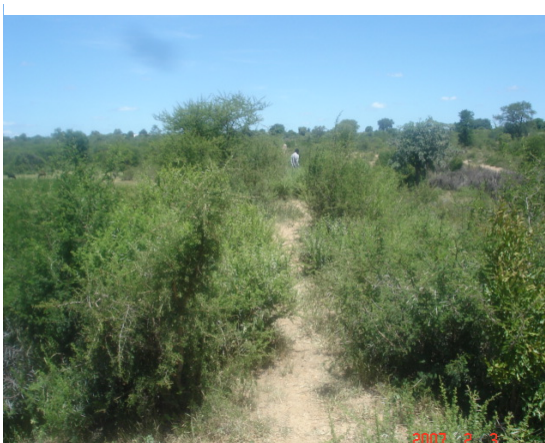
**Picture 3.** Thickets on Zilwane dam wall

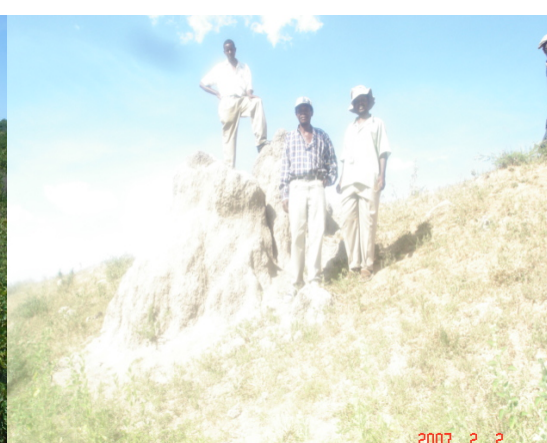
**Picture 4.** Huge termite mound at Sidzibe dam wall

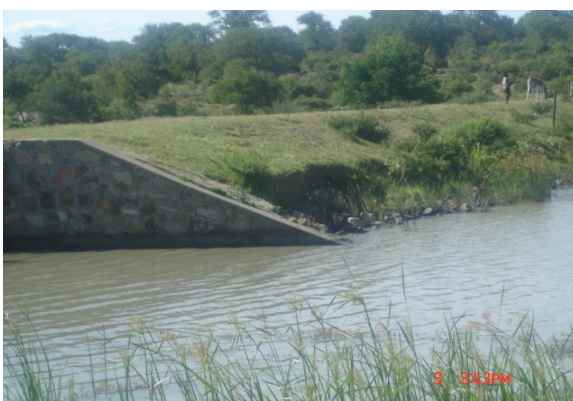
**Picture 5.** Scarping at Hlashtwayo dam

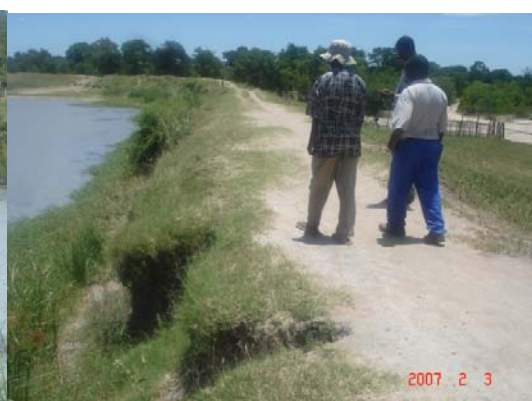
**Picture 6.** Scarping at Embondweni dam

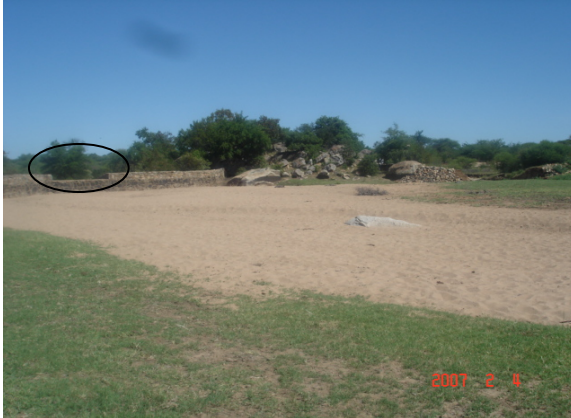
**Picture 7.** Siltation at Chobhukwa dam. The spillway is encircled.

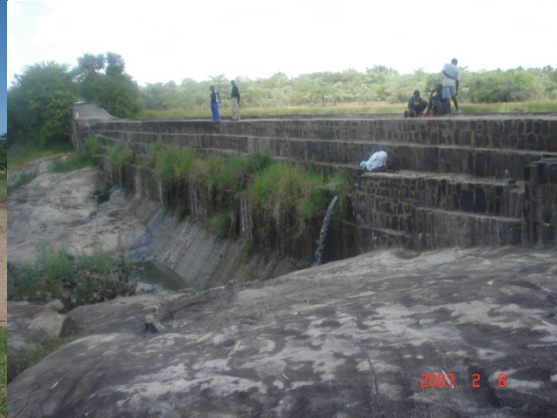
**Picture 8.** Leakage through masonry section of Gumbalo Dam

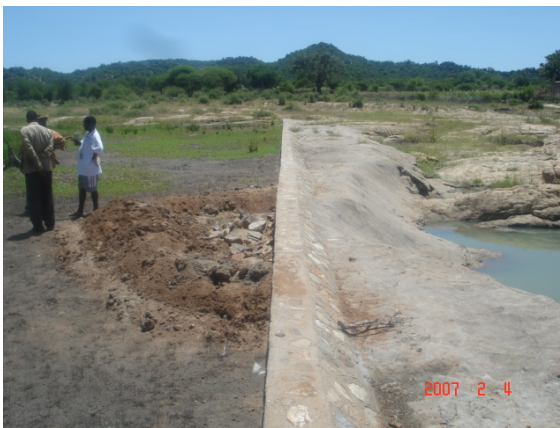
**Picture 9.** A sinkhole through Makoshe dam spillway sill

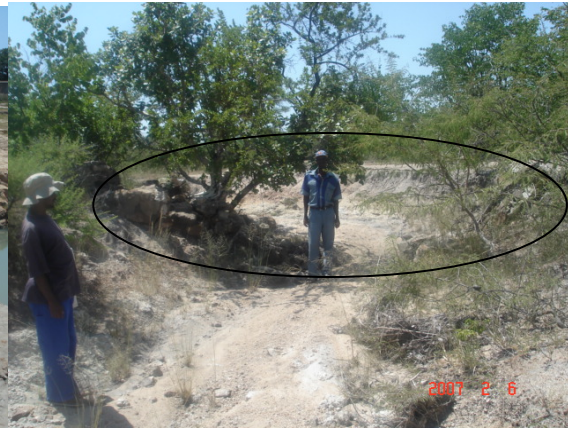
**Picture 10.** Breached Ngwabi dam spillway sill (Area circled)

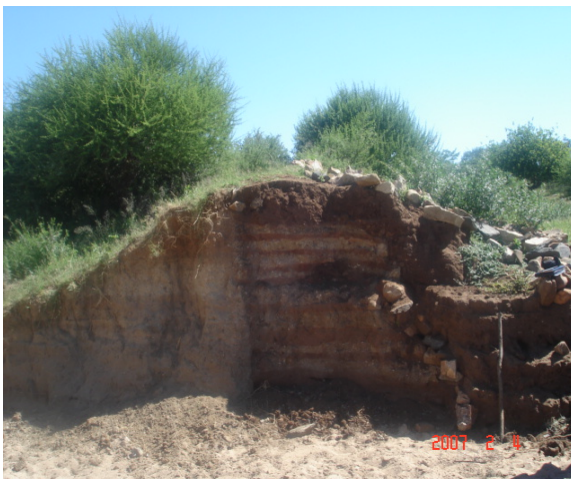
**Picture 11.** Breached Chobukwa dam wall
