Urine diversion dehydration toilets (UDDTs) at a church and nursery school in Nakuru, Kenya

Case study of SuSanA projects

UDD toilet at a church and nursery school, Nakuru, Kenya
SuSanA 2010

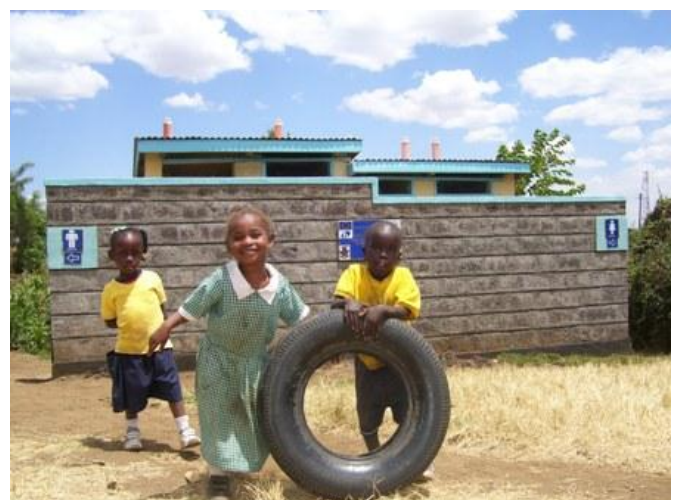
Figure 3 The front view of the UDDT with the men/boys side on the left and the ladies/girls on the right (Source: S. Blume, 2008).

The facility is divided into two sections, the female and the male section. The female side has two units; one single vault UDDT and a double vault UDDT with solar drying cover at the back. The men's section consists of one single vault UDDT and a urinal cubicle with five waterless urinals in the men's section. Two of the urinal bowls are standard ceramic urinal bowls while the other three are specially designed for children out of 5 litre plastic containers and fitted lower to the floor level (300 mm compared to standard level of 600 mm) to allow ease of use by the boys.

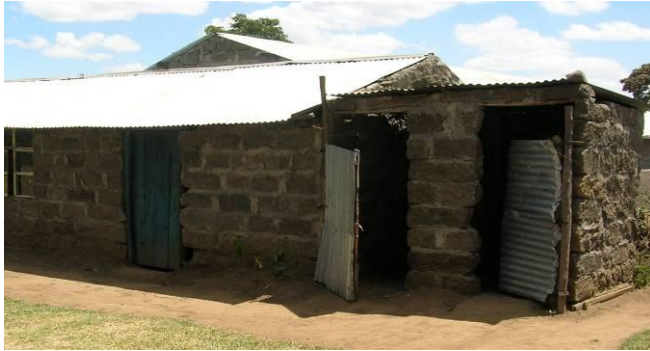
Figure 4 Existing pit latrines

Due to the soil conditions of Nakuru that are mainly volcanic loose soils, ranging from moderate occurrence of surface rock to very shallow soils, there is a high possibility of liquid content in the pit leaking to the underground and transported to the lake along geological fault lines, that may cause contamination to the ground and surface water.

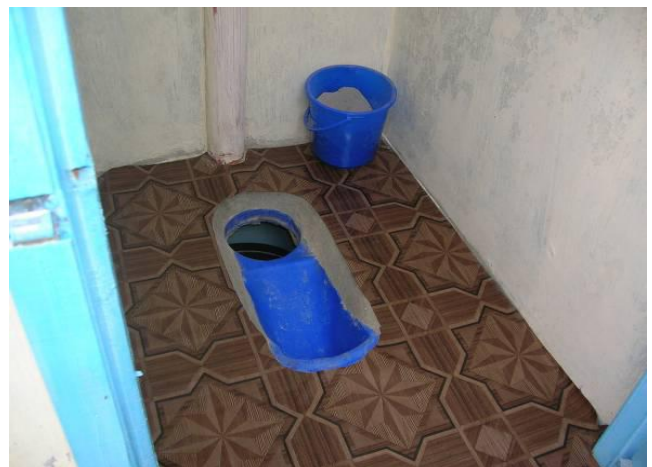
Figure 6 Inside the single vault toilet at the church showing the urine diversion pedestal and a container of ash.

Due to the stigmas on handling faeces, it was agreed that the faeces will be collected in containers for ease of collection, instead of allowing it to drop on the floor of the chamber. The faeces are collected in 50 litre plastic containers placed in the single vault underneath the toilet slab. Smaller containers of 20 to 30 litres were placed in the double vault chambers which are smaller in size. Once the containers are full, they are transferred to the solar drier in the double vault and remain there until they are completely dry and odour free before they are emptied into the garden and applied around banana plants.

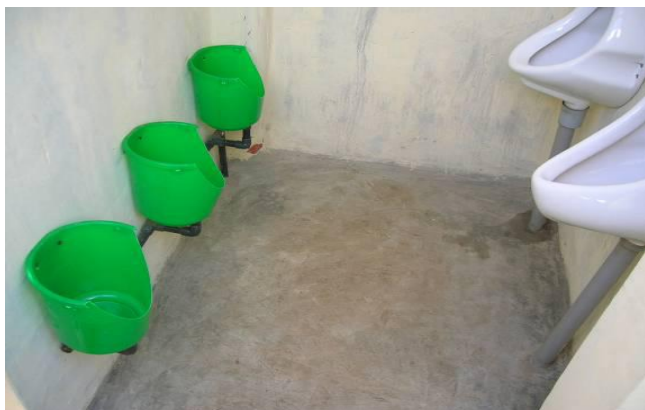
Figure 7 Inside the men's urinal showing the fabricated plastic containers urinal for the kids and standard ceramic urinals.

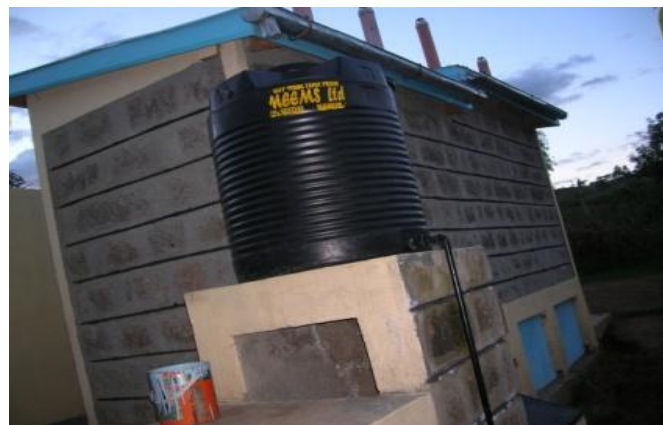
Figure 8 Roof water harvesting system for hand washing at the new UDDT.

Rainwater is harvested from the roof into a 250 litre tank which is connected to ceramic hand washing basins in both the female and the male sections. The greywater from hand washing is drained into a crop field.

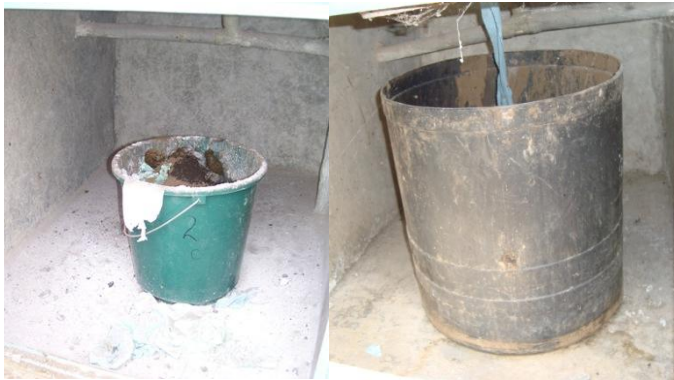
Figure 10 On the right 20 liter container in a single vault (2009). Left: 70 liter container used during the field visit in 2011 (L.Kraft, May 2011)

0.9 x 0.75 meter which can receive 0.6 m³ (600 litres) of faecal matter when 80% full. The use of containers for collection of faeces reduces this capacity to between 150 – 200 litres depending on the number and size of containers used.

It was estimated that 25 kg of faeces were generated per week which totals to 1300 kg per year. The vaults are large enough to hold faecal matter in 50 litre containers for at least six months before withdrawal. This reduces the need to frequently empty the containers and allows pathogen die off for within the six months (WHO, 2006).

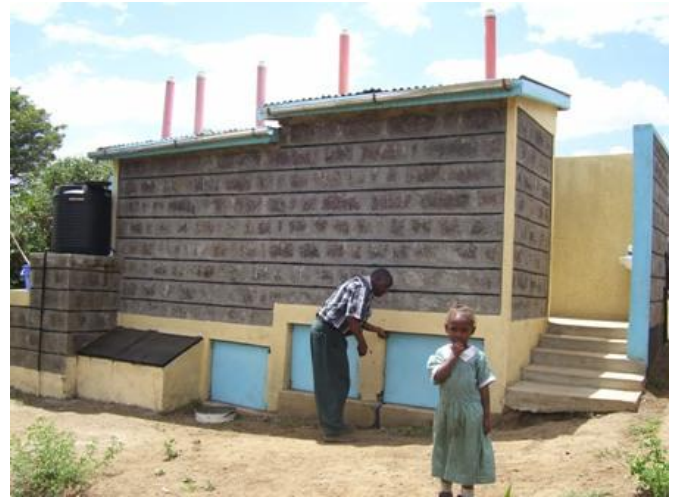
Figure 11 The rear of the UDDT showing the single vaults and the solar drier for the double vault

The vault doors (0.9 m x 0.75 m) made of metal are tightly fixed to avoid flies and painted to avoid rust. The doors on the double vault are fixed at a slope to drain off the water and are painted black for best solar adsorption.

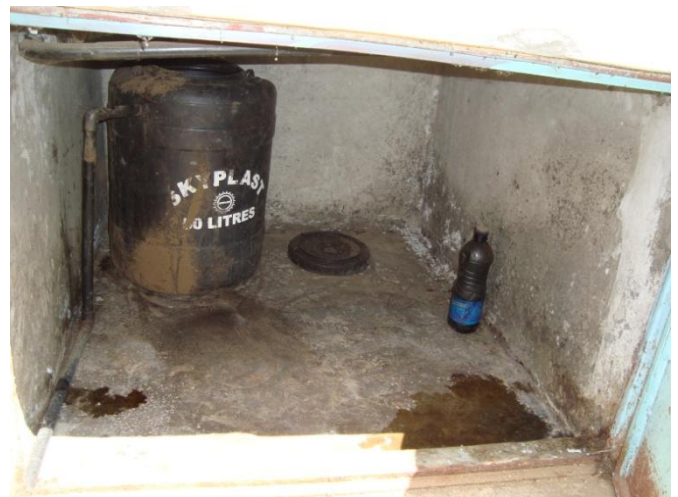
Figure 12 50 liter urine tank with small leakage in pipe (L.Kraft, May 2011)

The superstructure was in good conditions without visible damages. The rainwater harvesting system was in place and connected to the water tank. All collection chambers were well functioning and had containers for faeces inside. The urine tank was well connected and not overflowing but had a small leakage in the connection pipe to the soak pit (Fig.12).

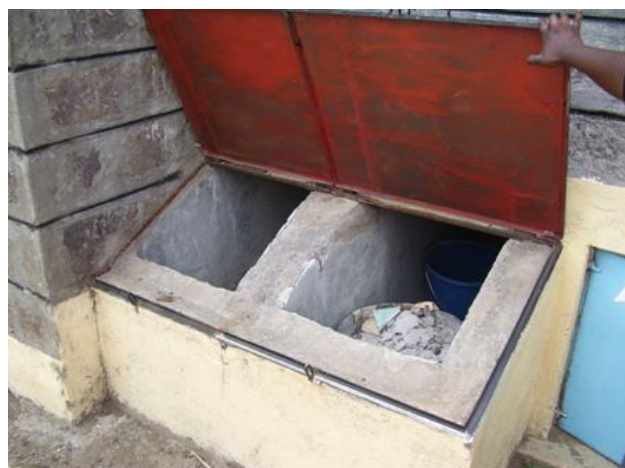
Figure 13 Containers are placed in the solar drier of the double vault compartment (Source: Steffen Blume, 2009)

The containers are cleaned by scrubbing ash or soil inside them and then returned into the vaults as shown in Figure 13.

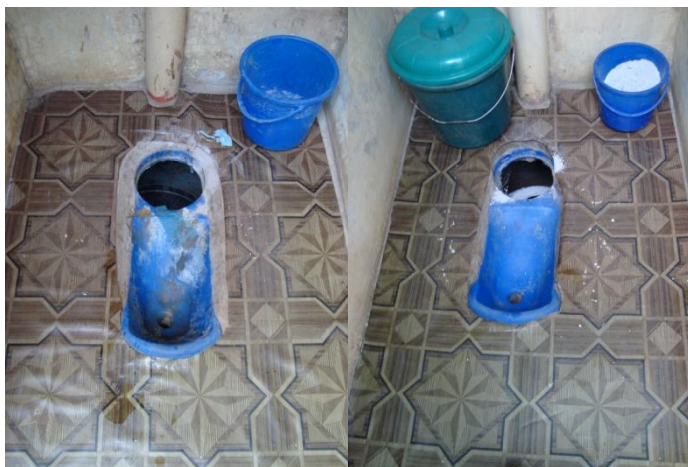
Figure 14 On the left, inside view of toilet used by men with empty ash container, urine on the floor and signs of faecal cross-contamination. Right: Inside view of toilet used by women (Source: L. Kraft, May 2011)

The smell in the toilets was tolerable but the one used by men was not well cleaned. As shown in the picture below (Fig.14) there was urine on the floor and also signs of faecal cross-contamination in the urine section of the toilet pan. The toilet used by women was cleaner and ash was available.

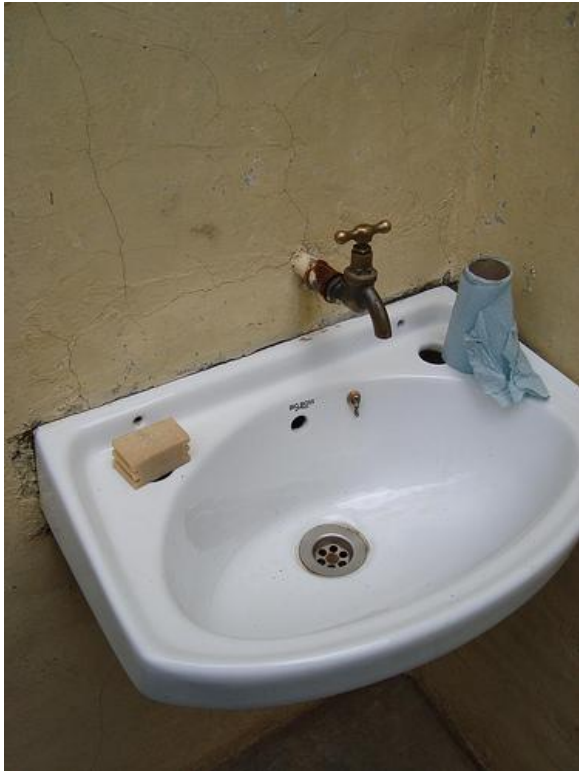
Figure 16 Handwash facility was in good conditions. Toilet paper and soap is provided by the school Source: L. Kraft, May 2011)

The handwash facility was in good conditions but there was no water available as the rainwater harvesting tank cracked. According to the teacher interviewed the children carry water to wash their hands. Toilet paper and soap is provided by the school and was available on both sides (male/female).
