Low-Cost Sanitation Solutions

A report on progress in Post-Earthquake Haiti

Andrew Larsen & Fontes Foundation

FSM 2 Conference

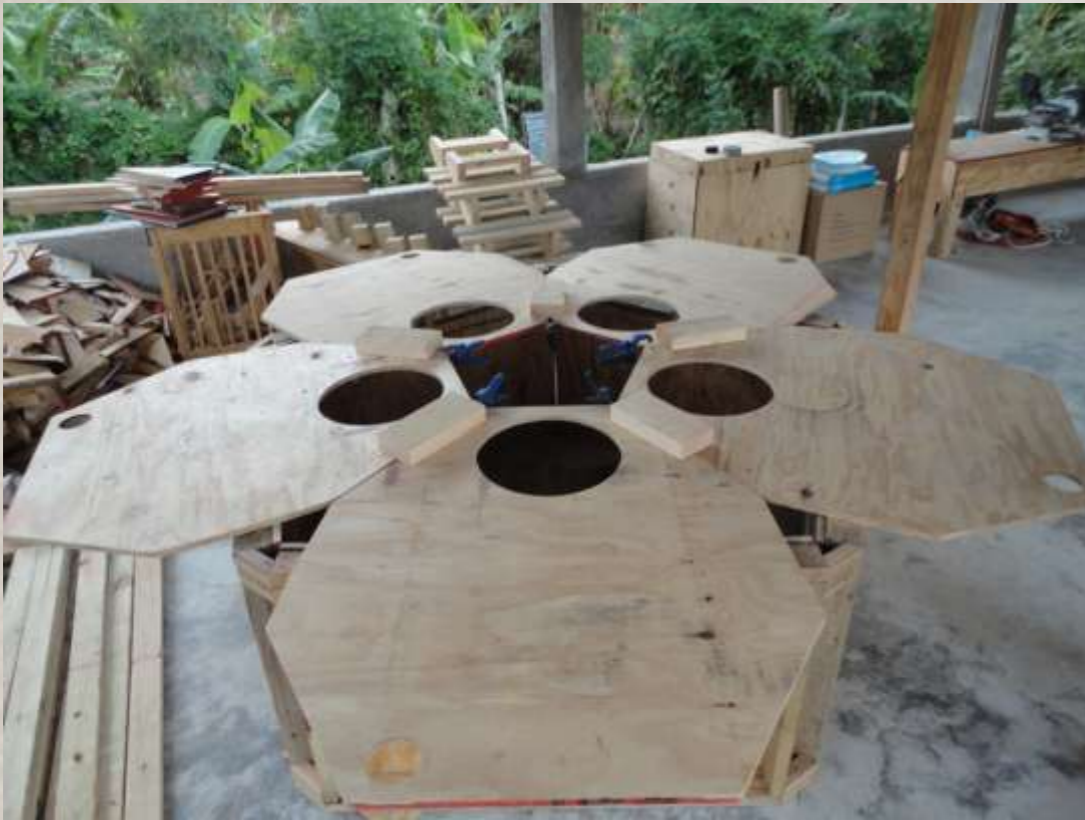
Key Design Features

Reused billboard vinyl: tensioned-fabric building method

Inexpensive structure allows for design innovation

Passive ventilation using large central plenum

Much larger air flow than VIP toilets

Externally stabilized toilet array

Process can be UD or “everything-in-together”

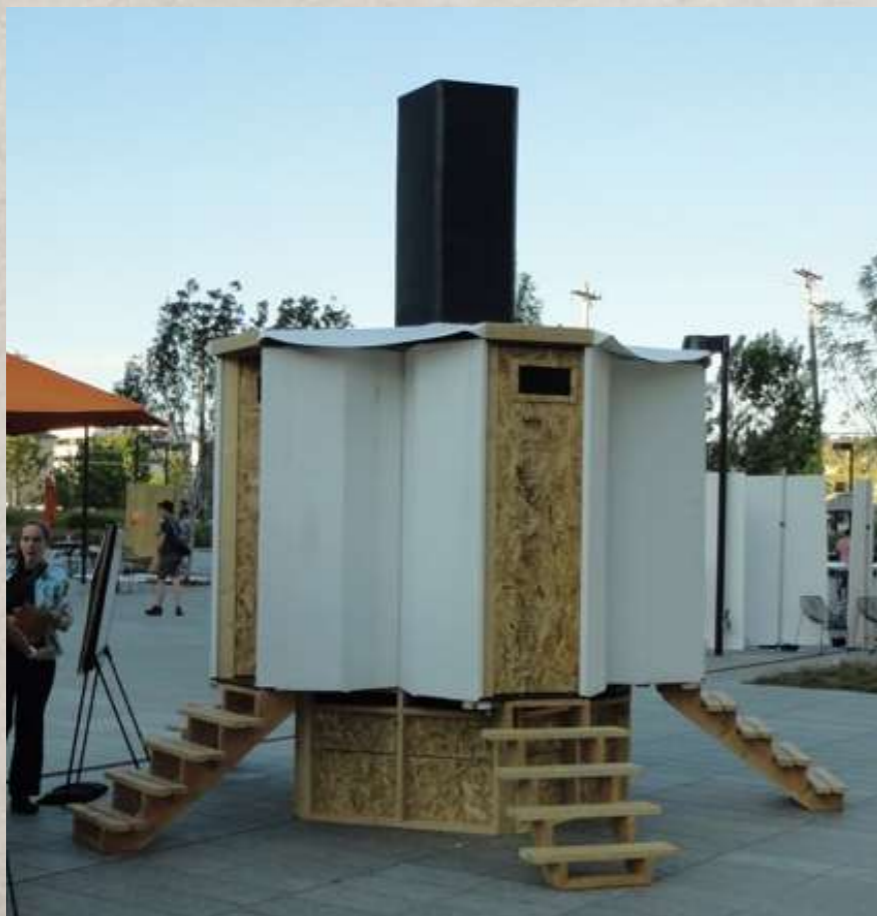
Walls, roof, doors, ballasted supports, and plenum made from tensioned fabric stretched around wood supports. Fabric is UV-resistant and weather-proof.

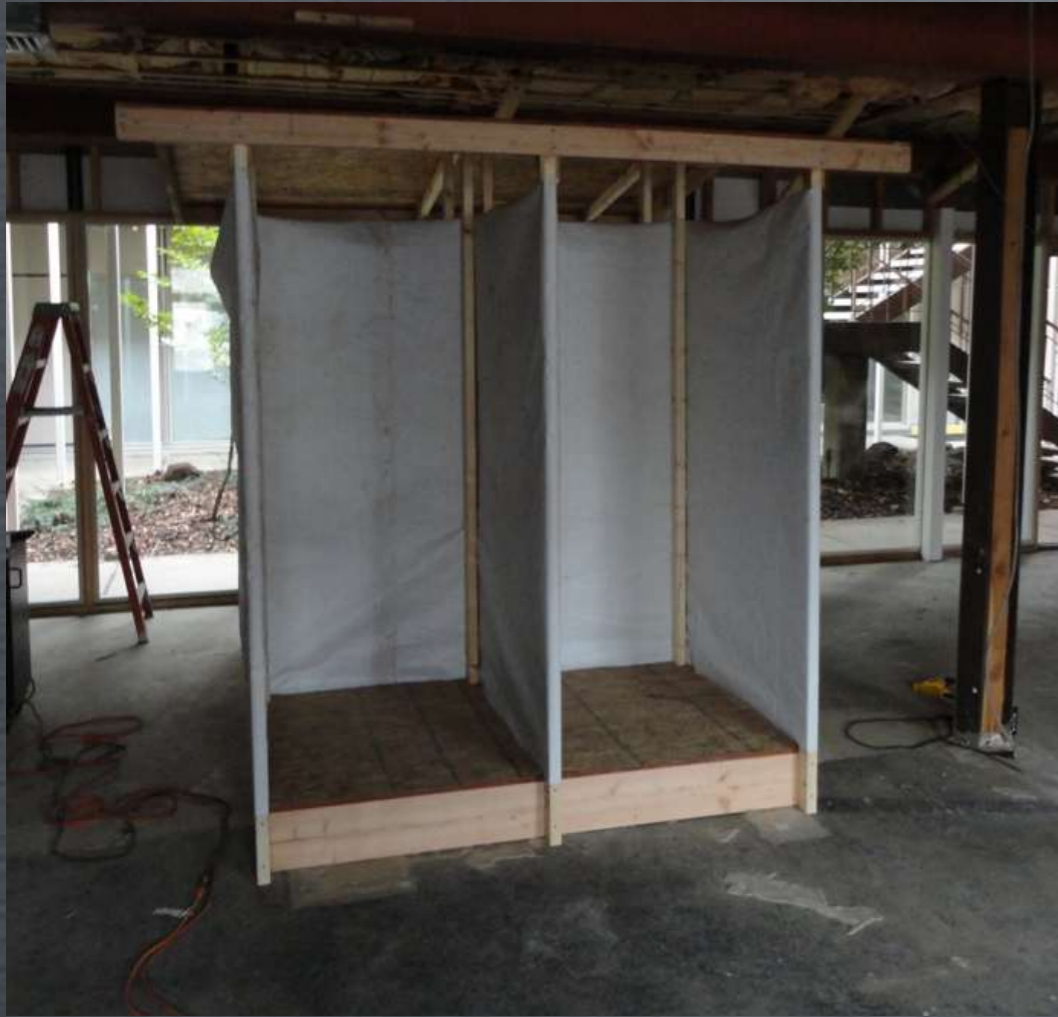
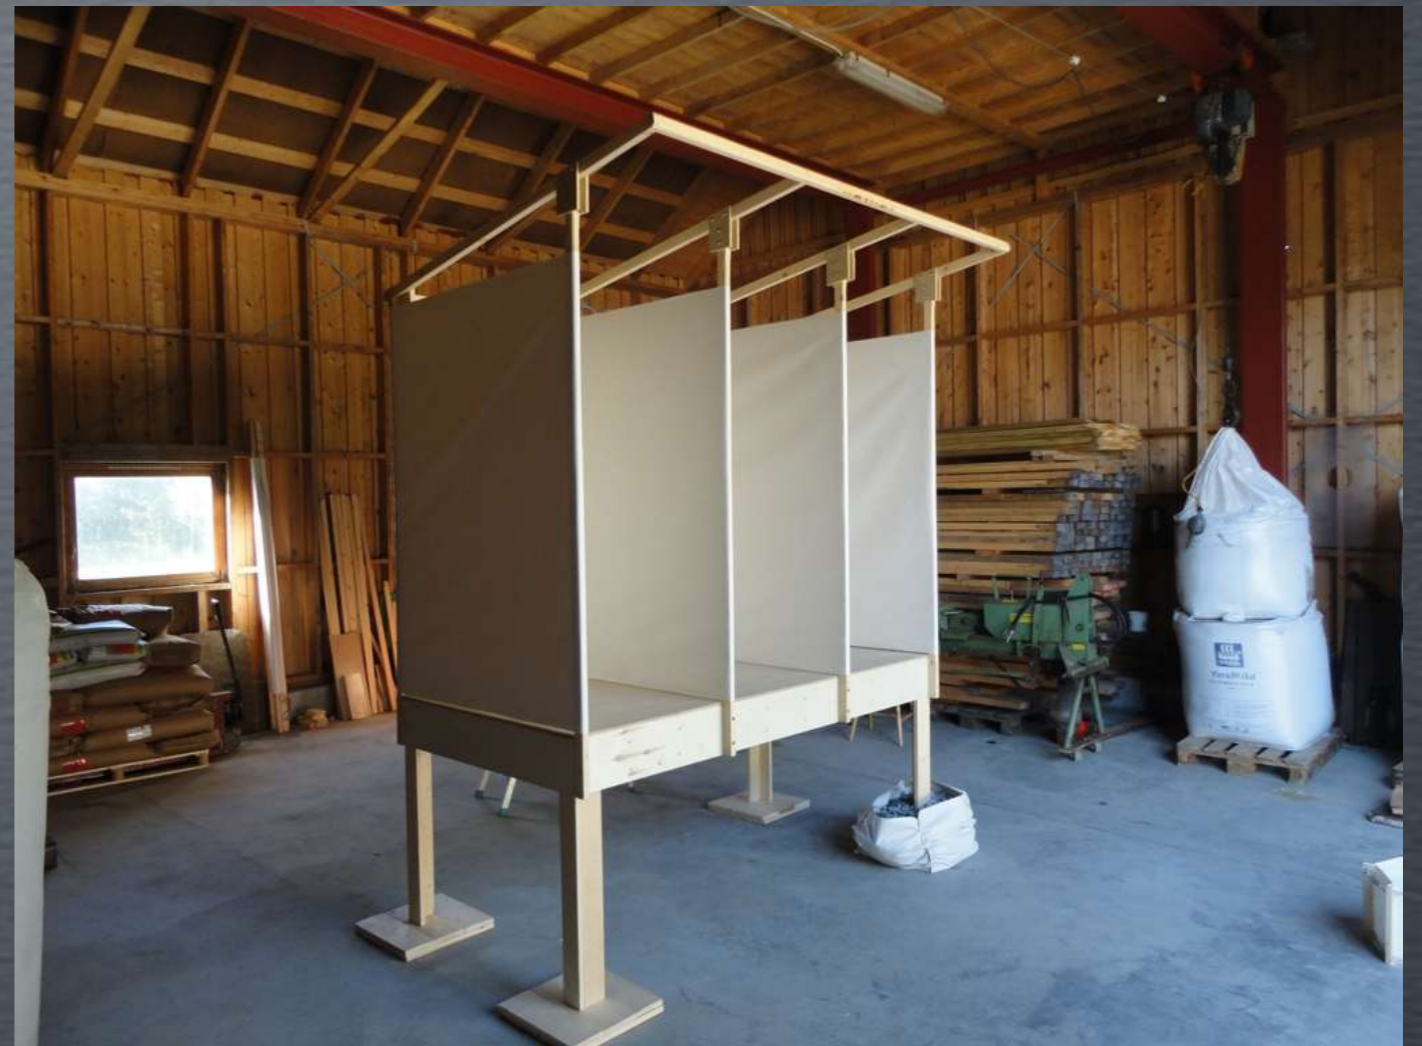
Prototypes in Utah and Norway

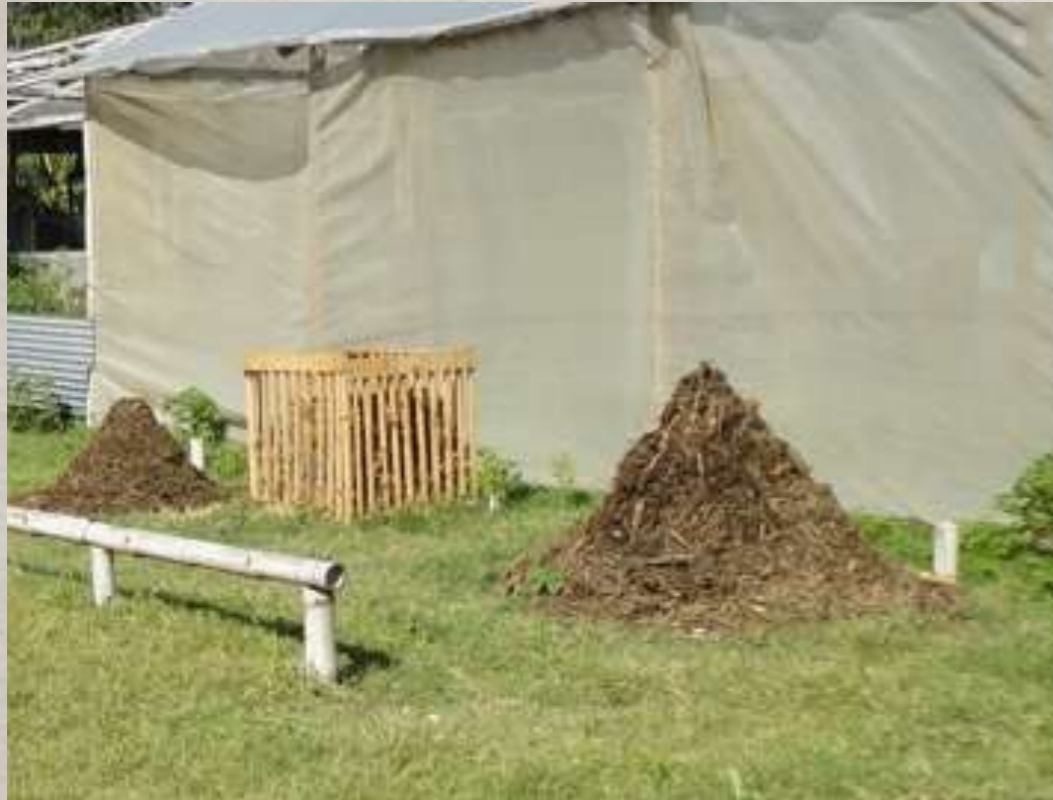
Results So Far

Achieving up to 71 degrees C

Regularly achieving 65 degrees C

We turn when the temperature gets too high

Temperature drops, then climbs back up within two days

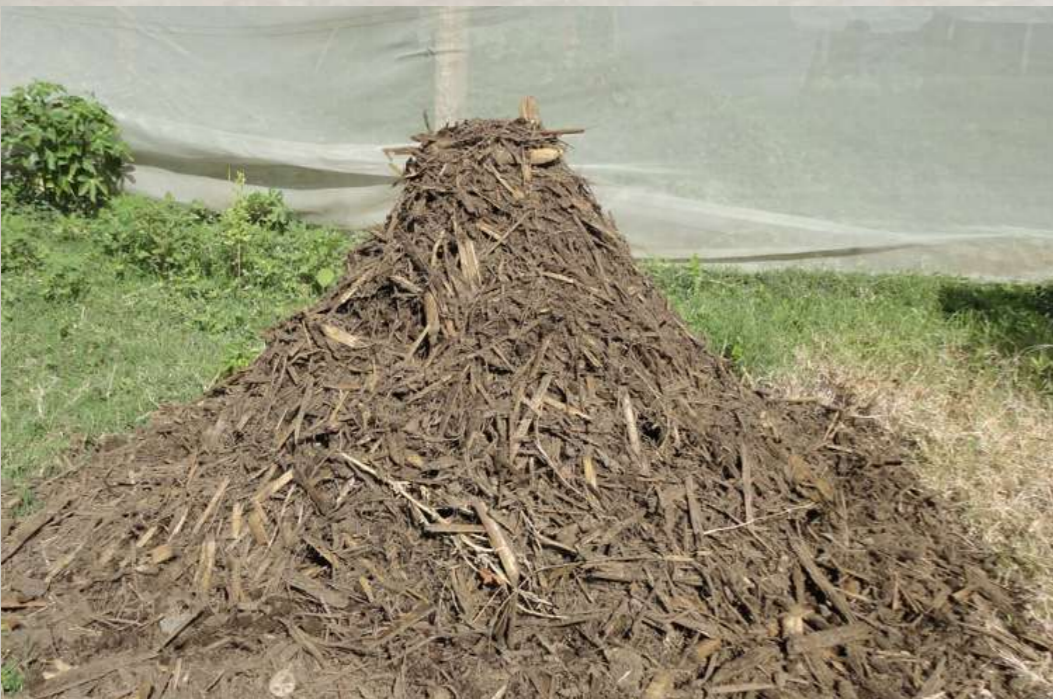
All parts of the pile are exposed to high temperatures after several turns

We can turn every three days

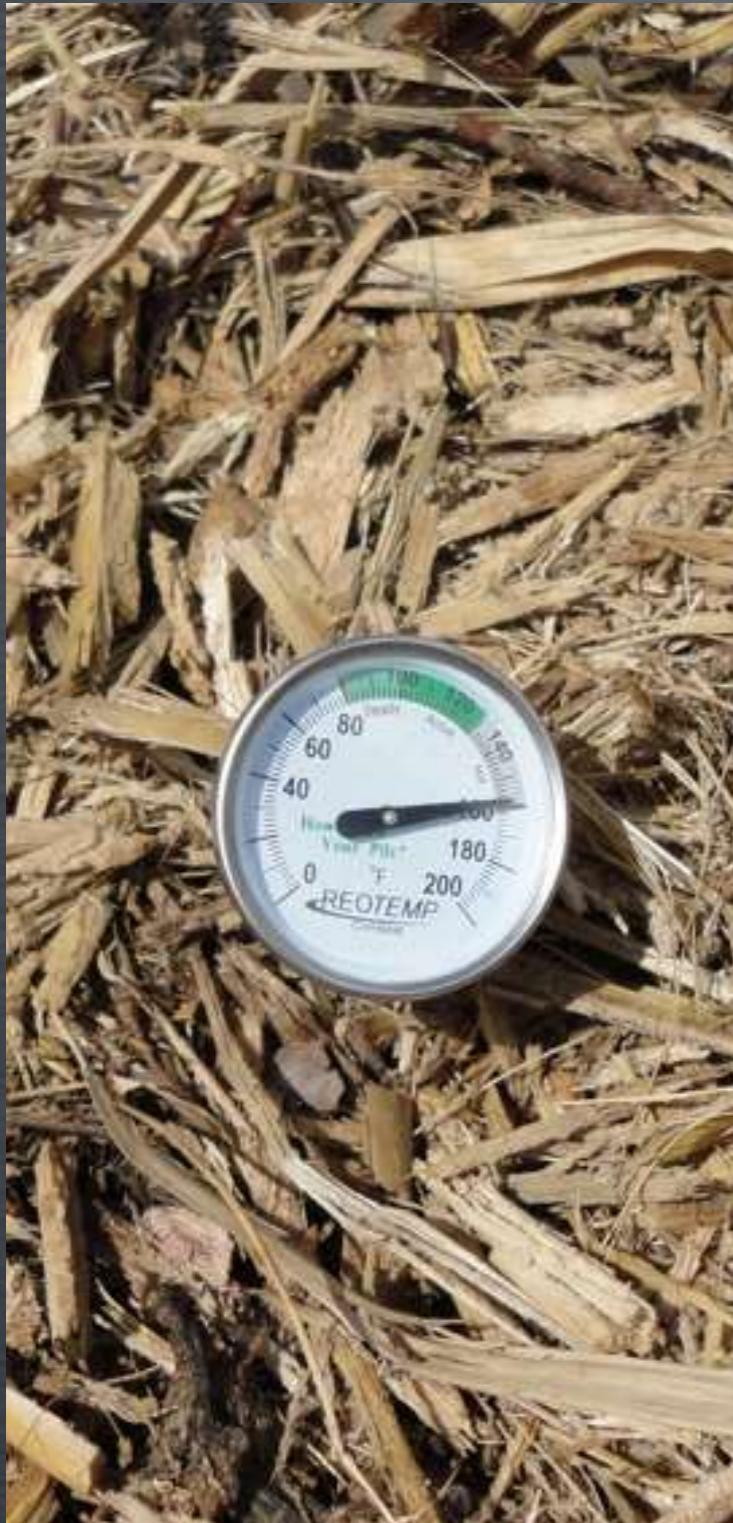
Thermophilic Composting in Haiti

WHO guidelines specify 50 C or greater for one week for composting
Confirmed this with Dr. Jamie Bartram, WHO Toilet materials never exposed to the outside environment
No odors, no flies, no kidding! :)

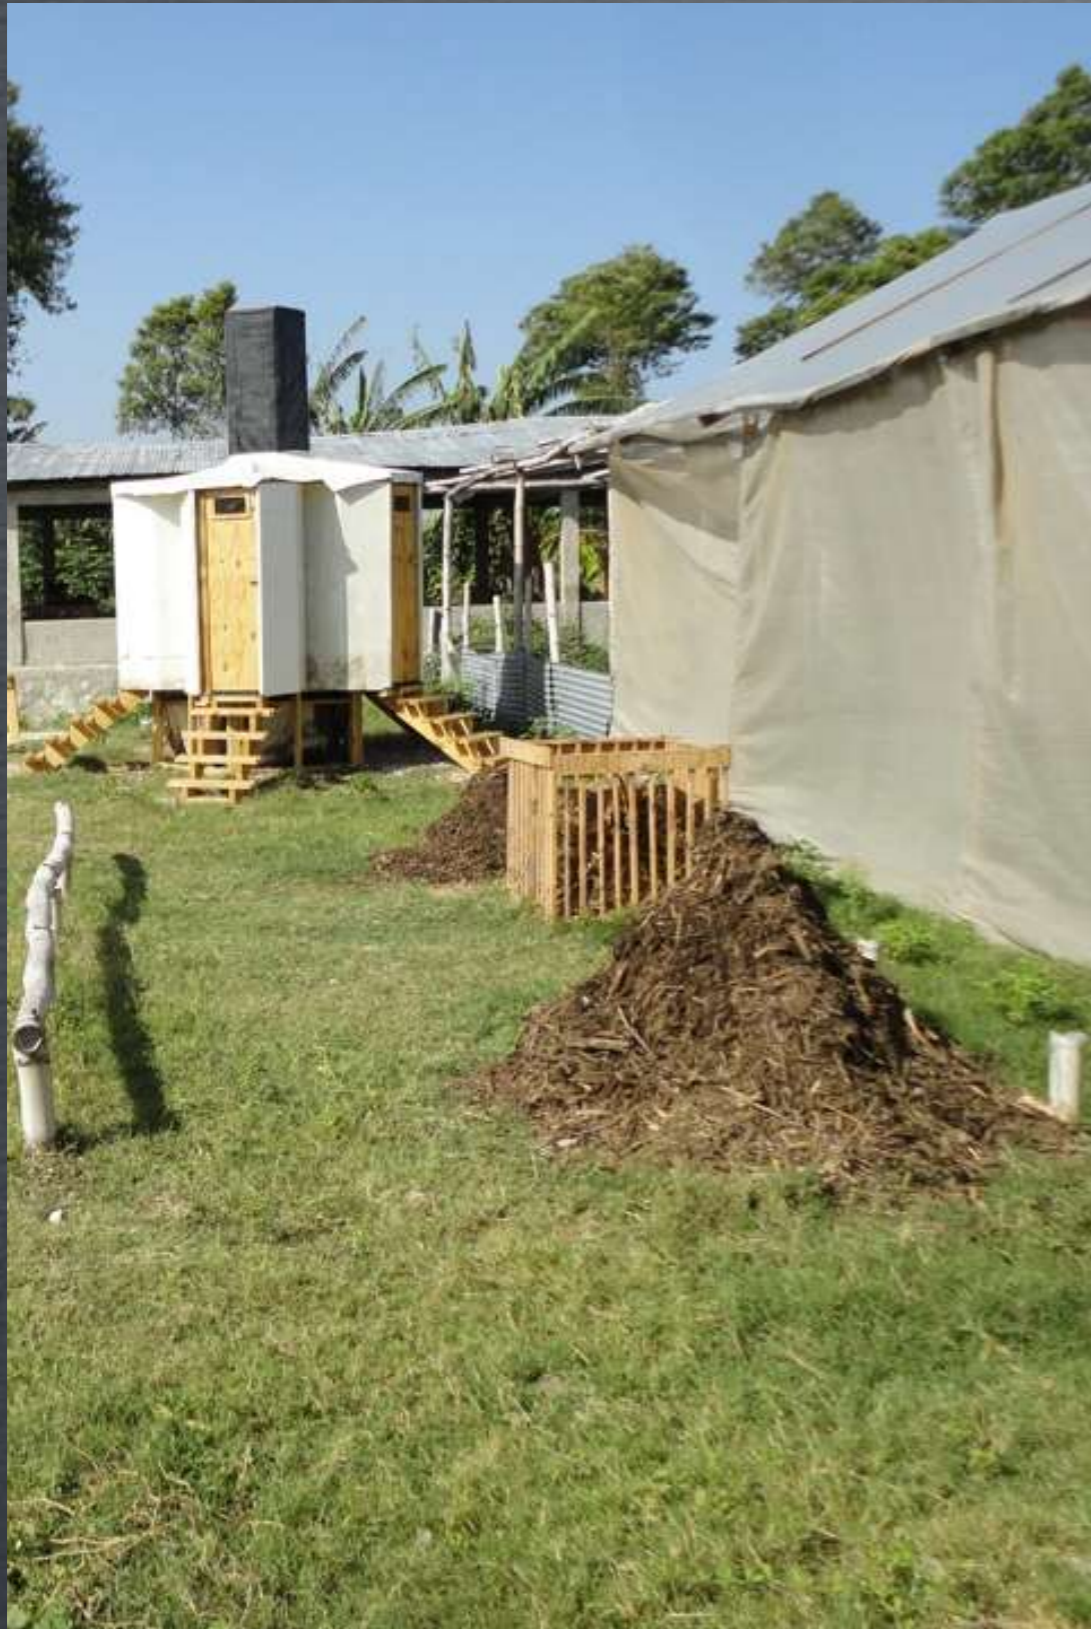
Composting in Peri-urban Port-au-Prince

Compost experiments at
our shop
One pile is sugarcane
bagasse and cow manure
One pile is sugarcane
bagasse and bucket-latrine
contents
Active turning of both piles

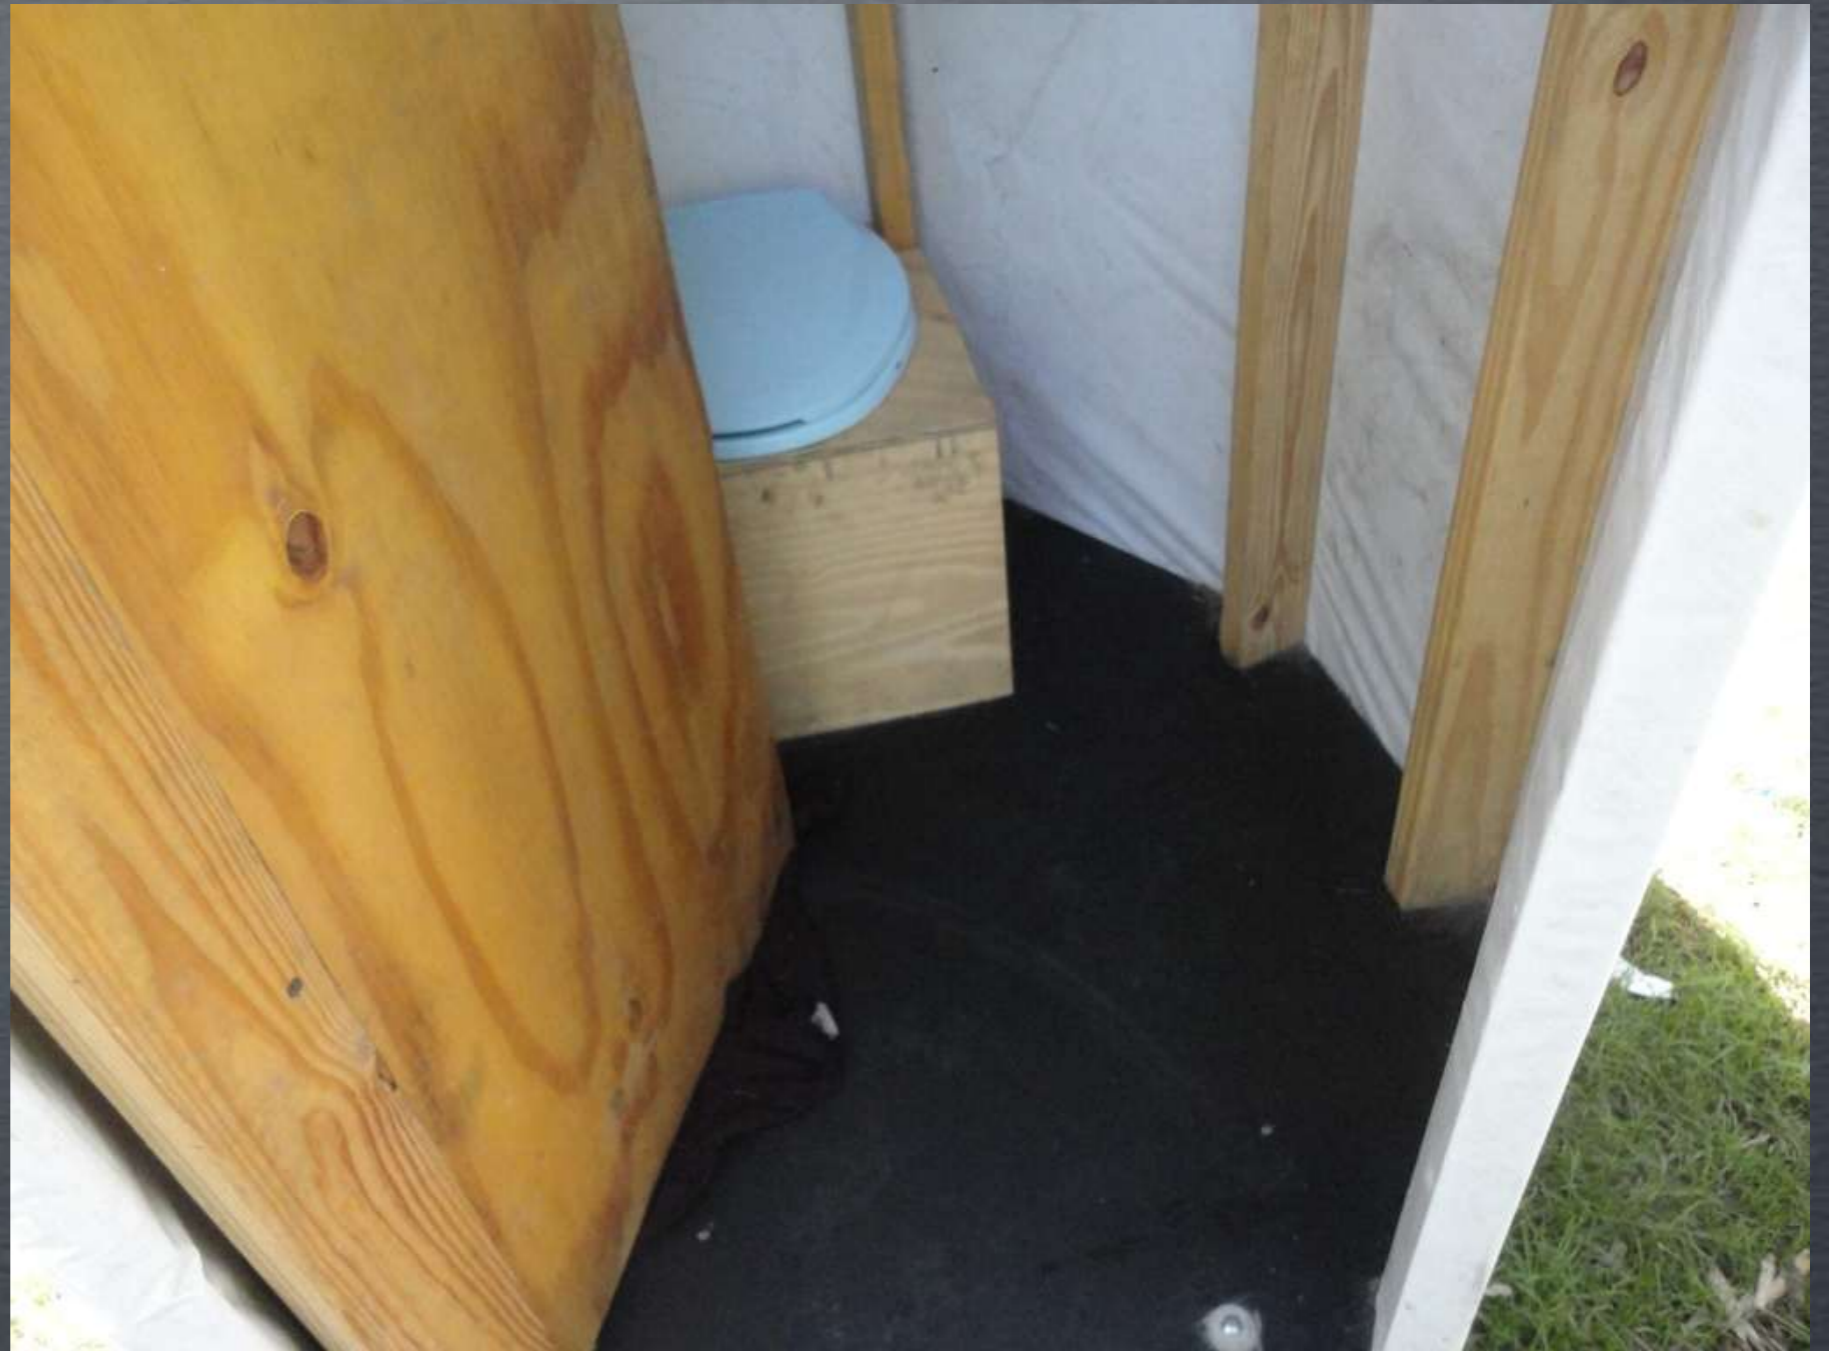
After Tropical Storm Isaac

Toilet blocks
withstood winds
estimated at 50-
60 mph
Plantain and
banana trees
mostly lost
Toilets had been
well-maintained
throughout
Toilets stayed
dry through the
storm

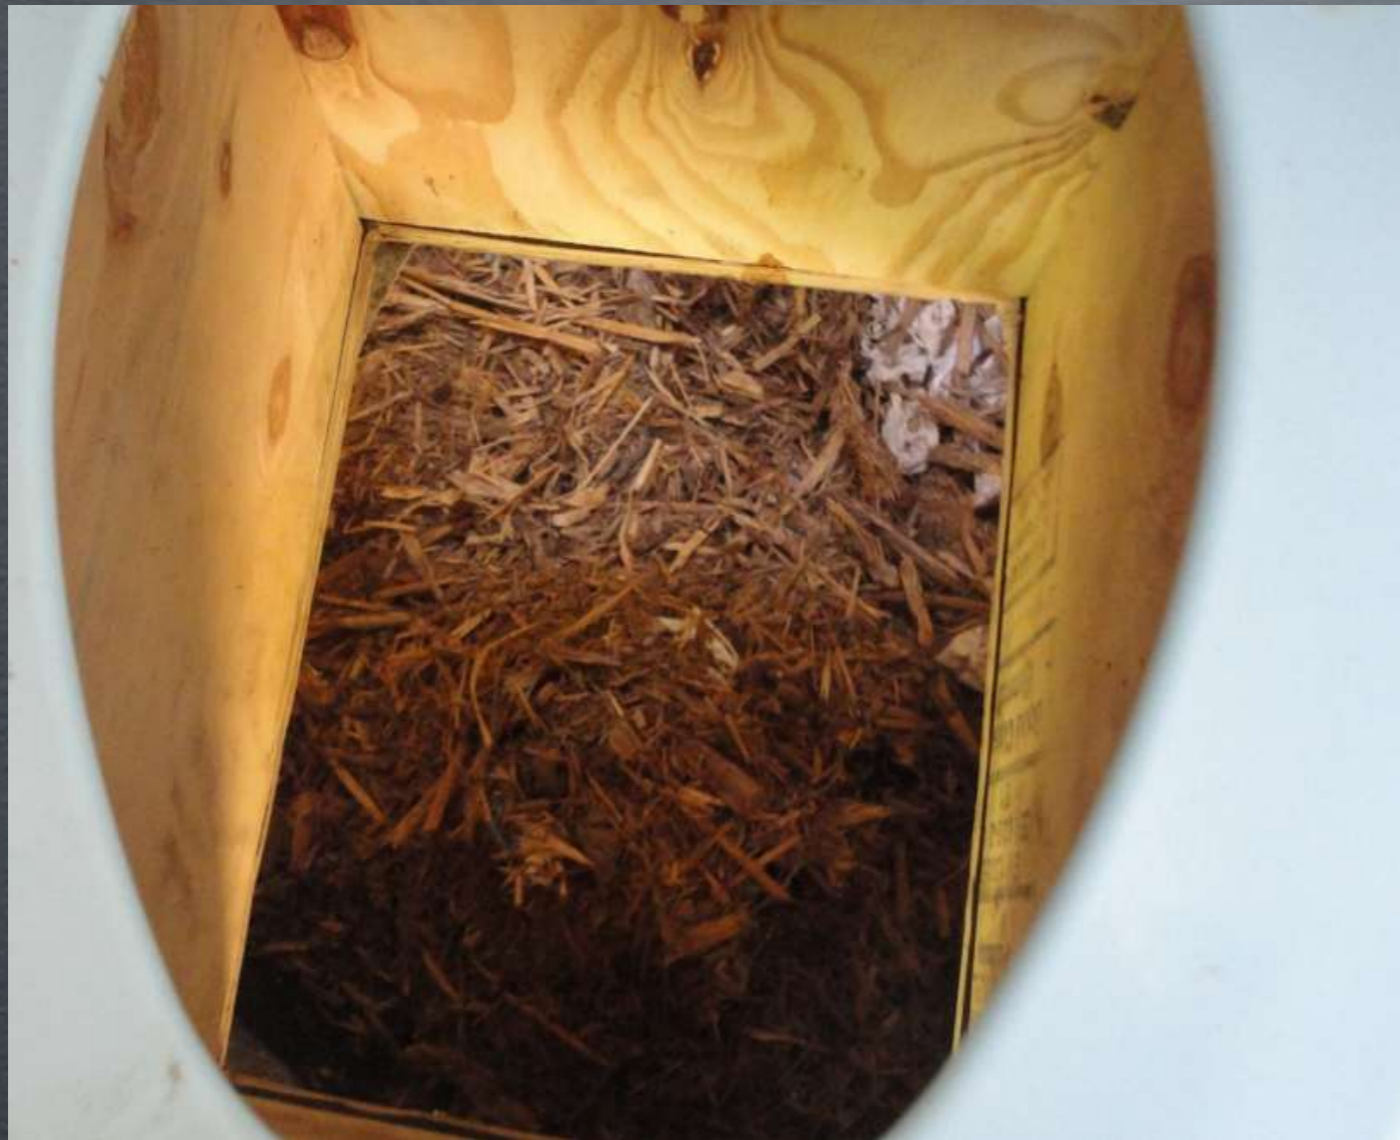
After Tropical Storm Isaac

Users add bagasse
Families maintain the
toilet cubicle
Paid workers maintain
the toilet system and
compost
Families are happy to
pay 100 HTG (\$2.50
USD) per month

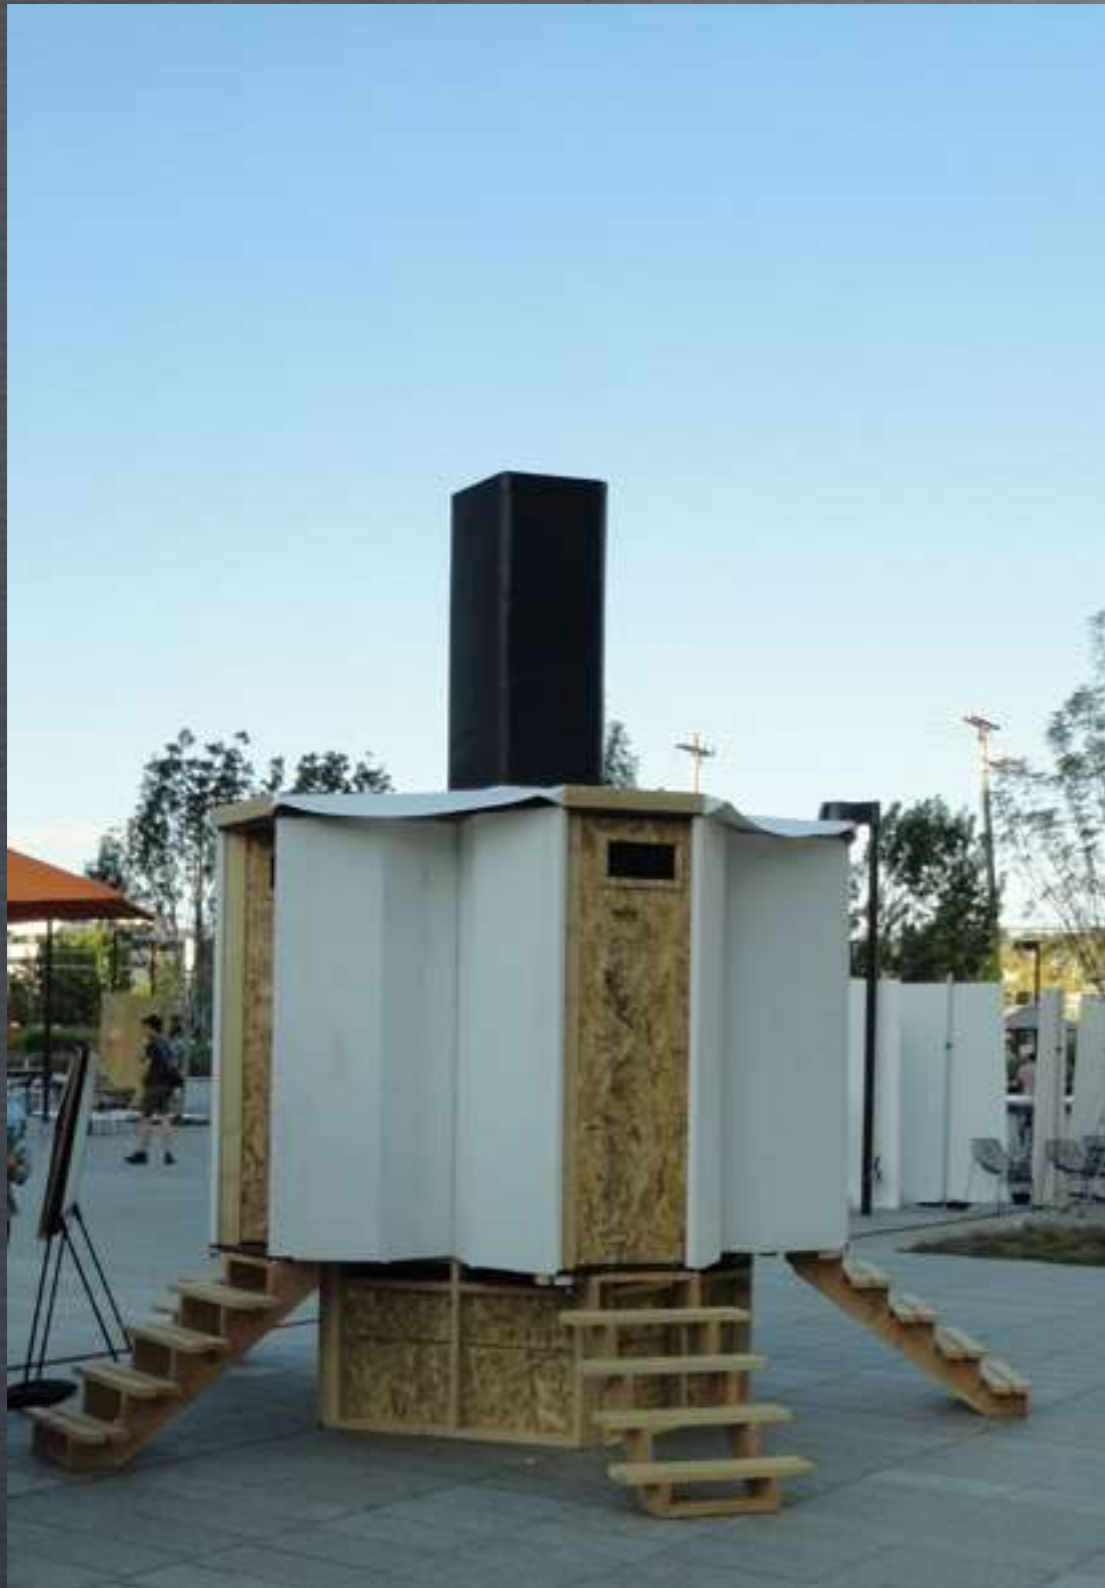
Current Design--Ways Forward

Trying to reduce the amount of lumber
Fabric costs about \$140 USD including shipping
Fabric as a floor covering works better than expected

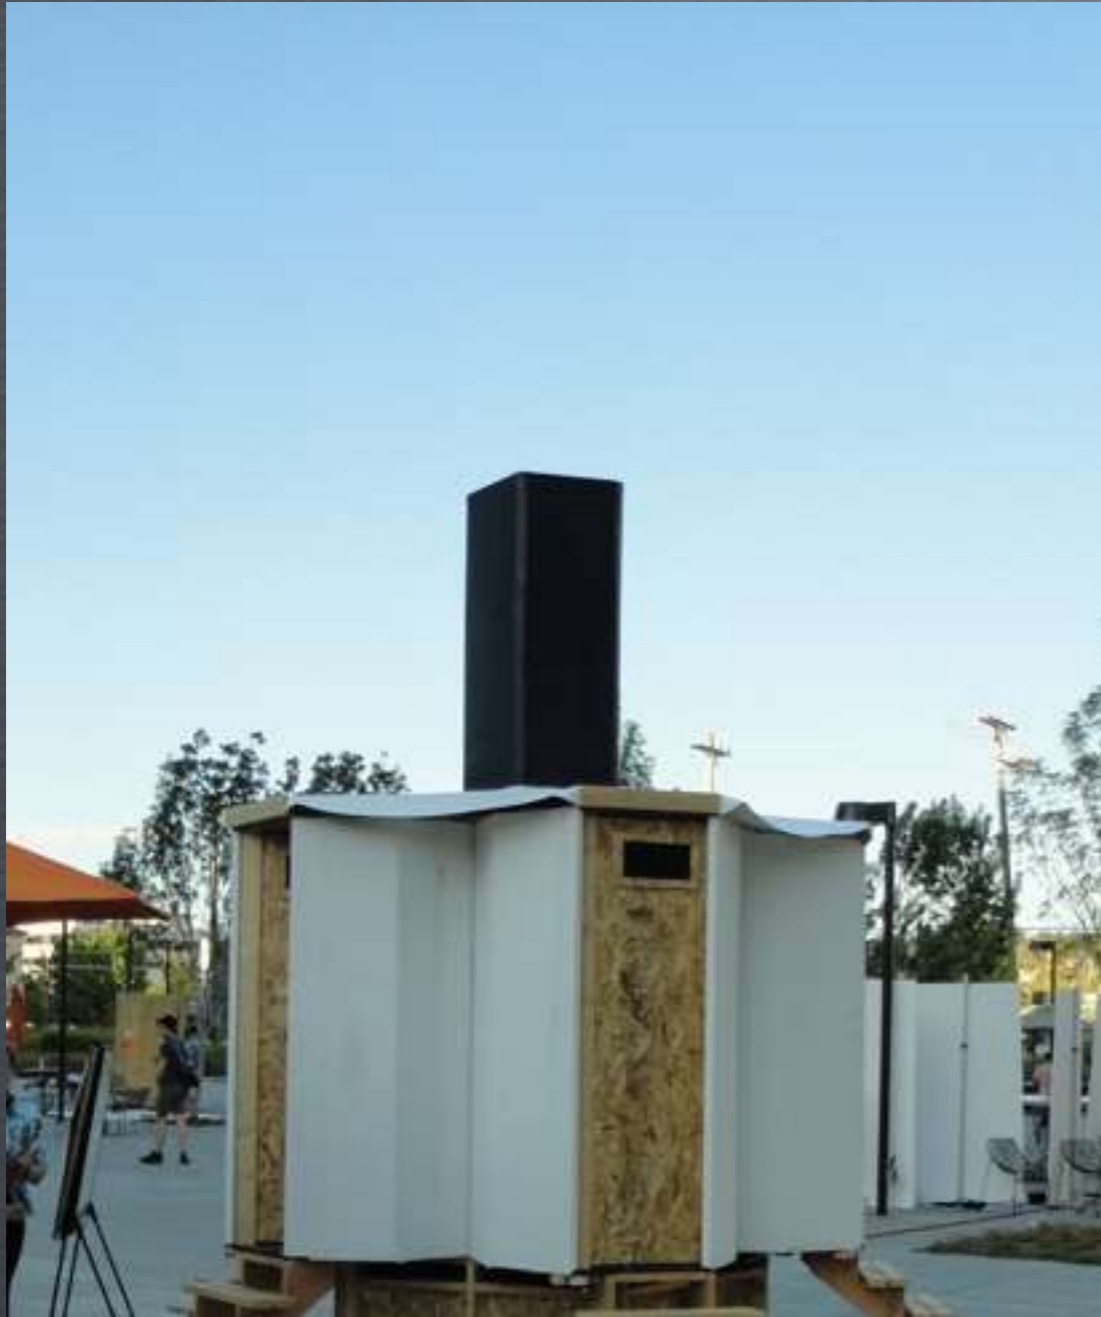
Current Design--Ways Forward

Small pit for the support structure
Pit is lined the same way as the support bin--
billboard fabric bag
Lower lumber costs
No need for stairs or handrail

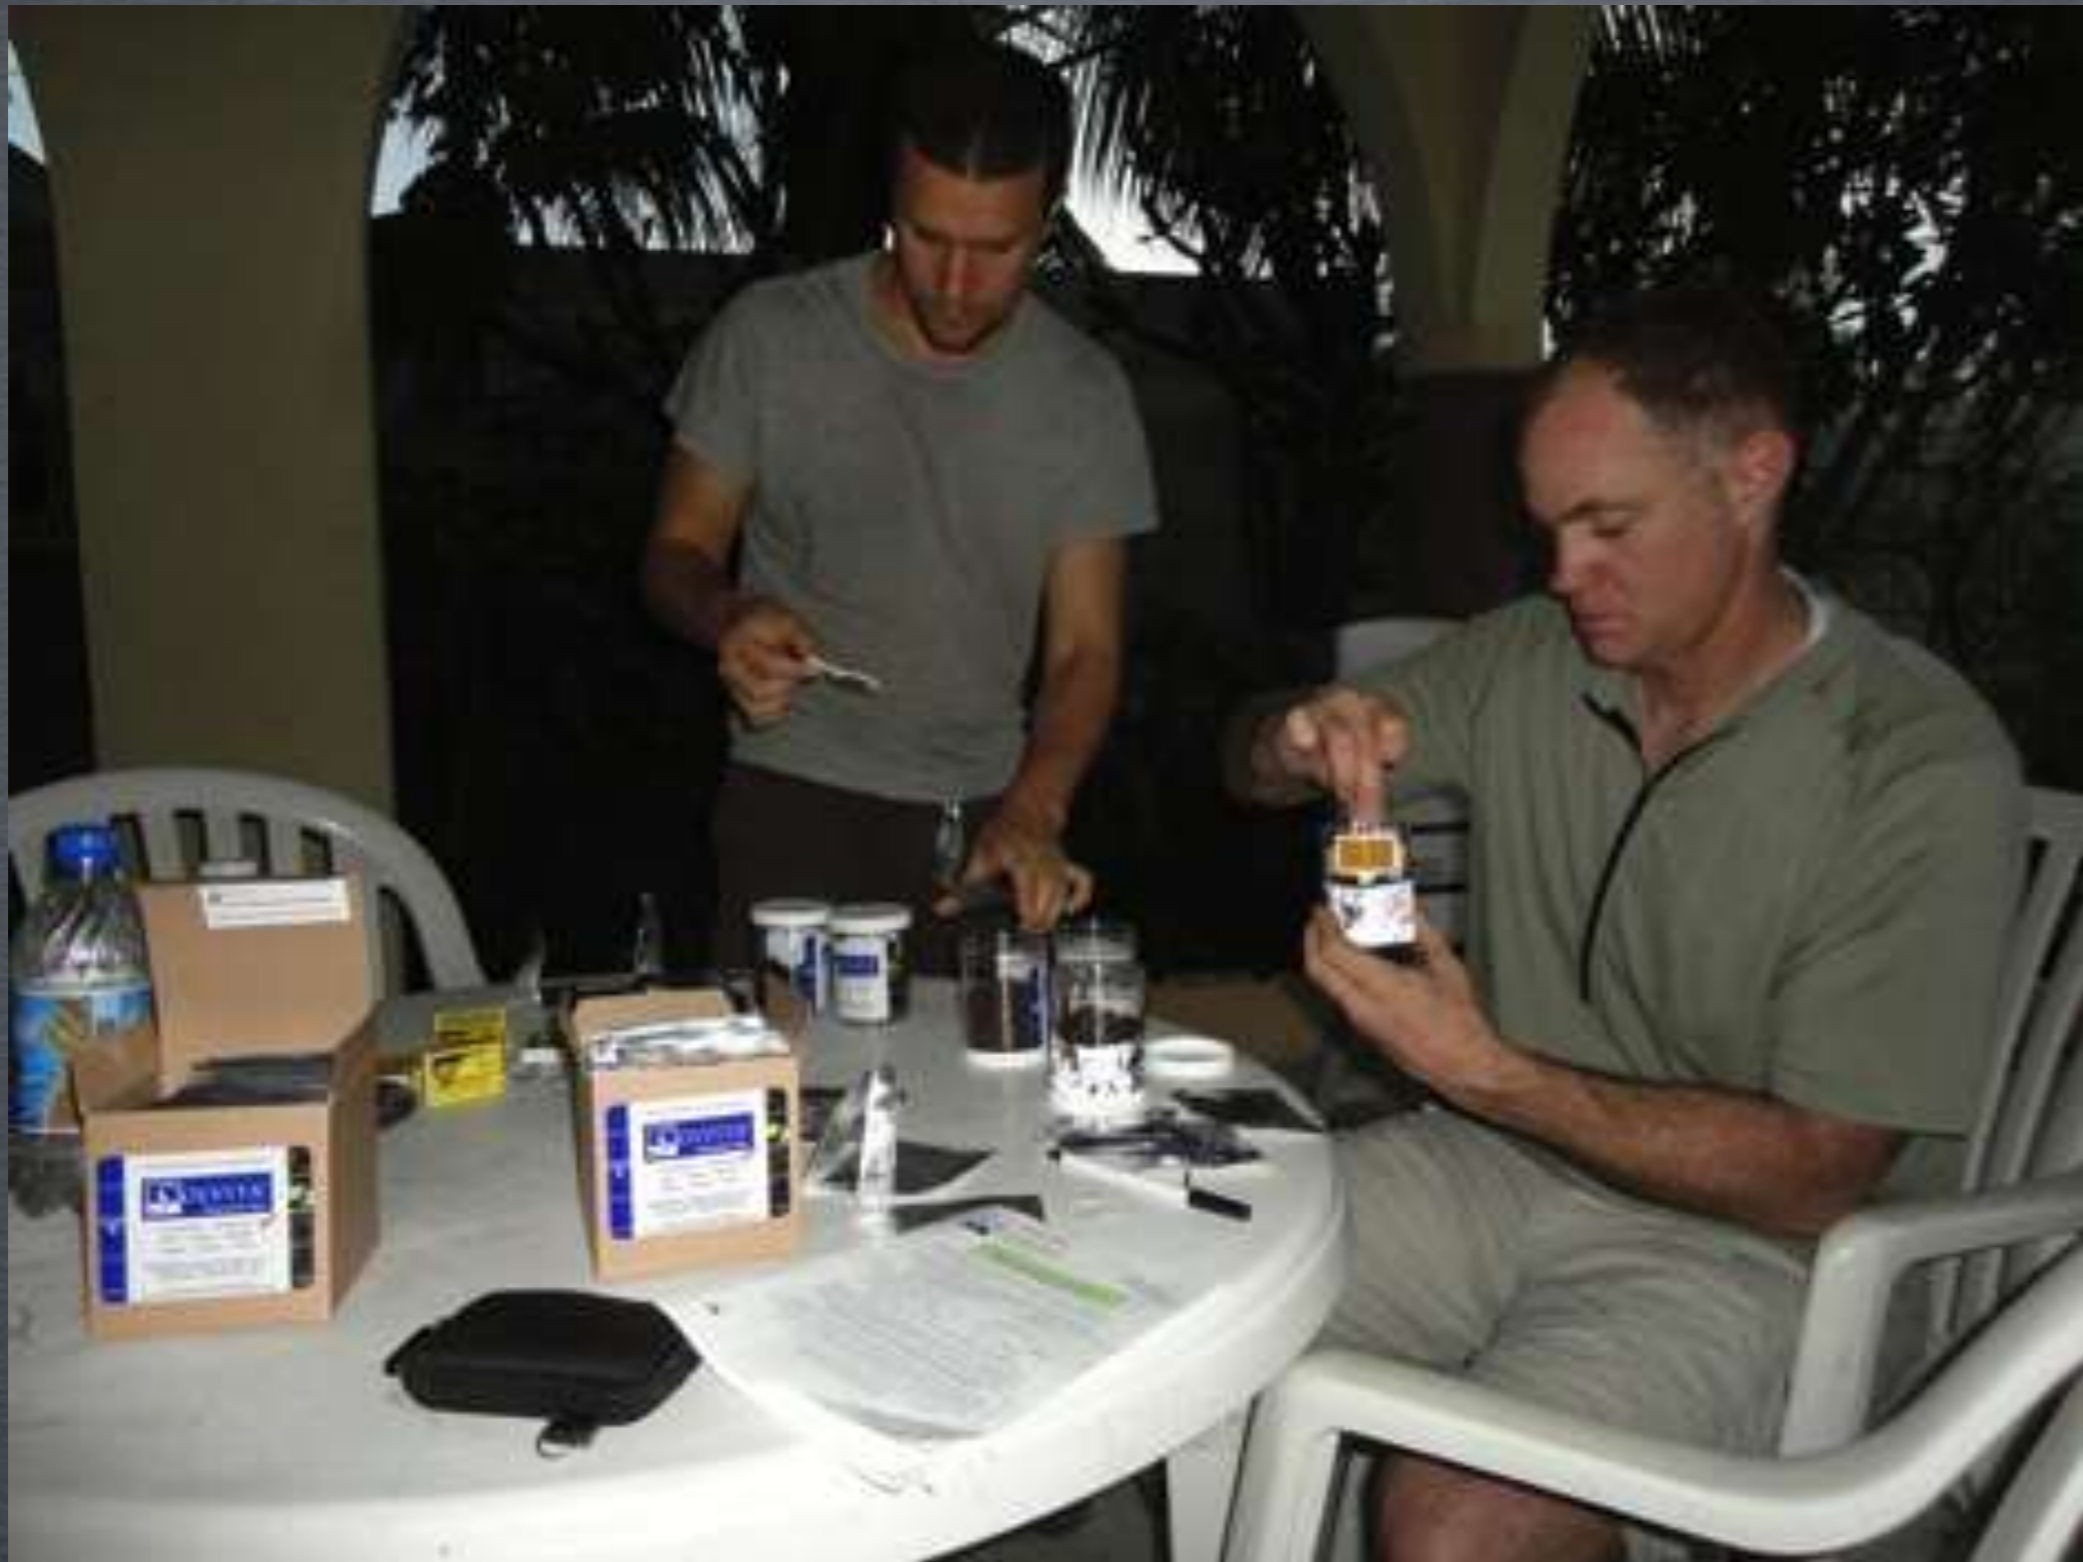
Mike Cloutier and Andrew Larsen using the Solvita[®] Compost Test Kit

Solvita[®] Compost Test

Tests for compost maturity only--not hygienic quality

Simple tests involving carbon dioxide and ammonia measurements using gel paddles

Determines compost maturity from a matrix of these values

Has important limitations which need to be understood
