Low-Cost Sanitation Solutions

A report on progress in Post-Earthquake Haiti

Andrew Larsen & Fontes Foundation

FSM 2 Conference

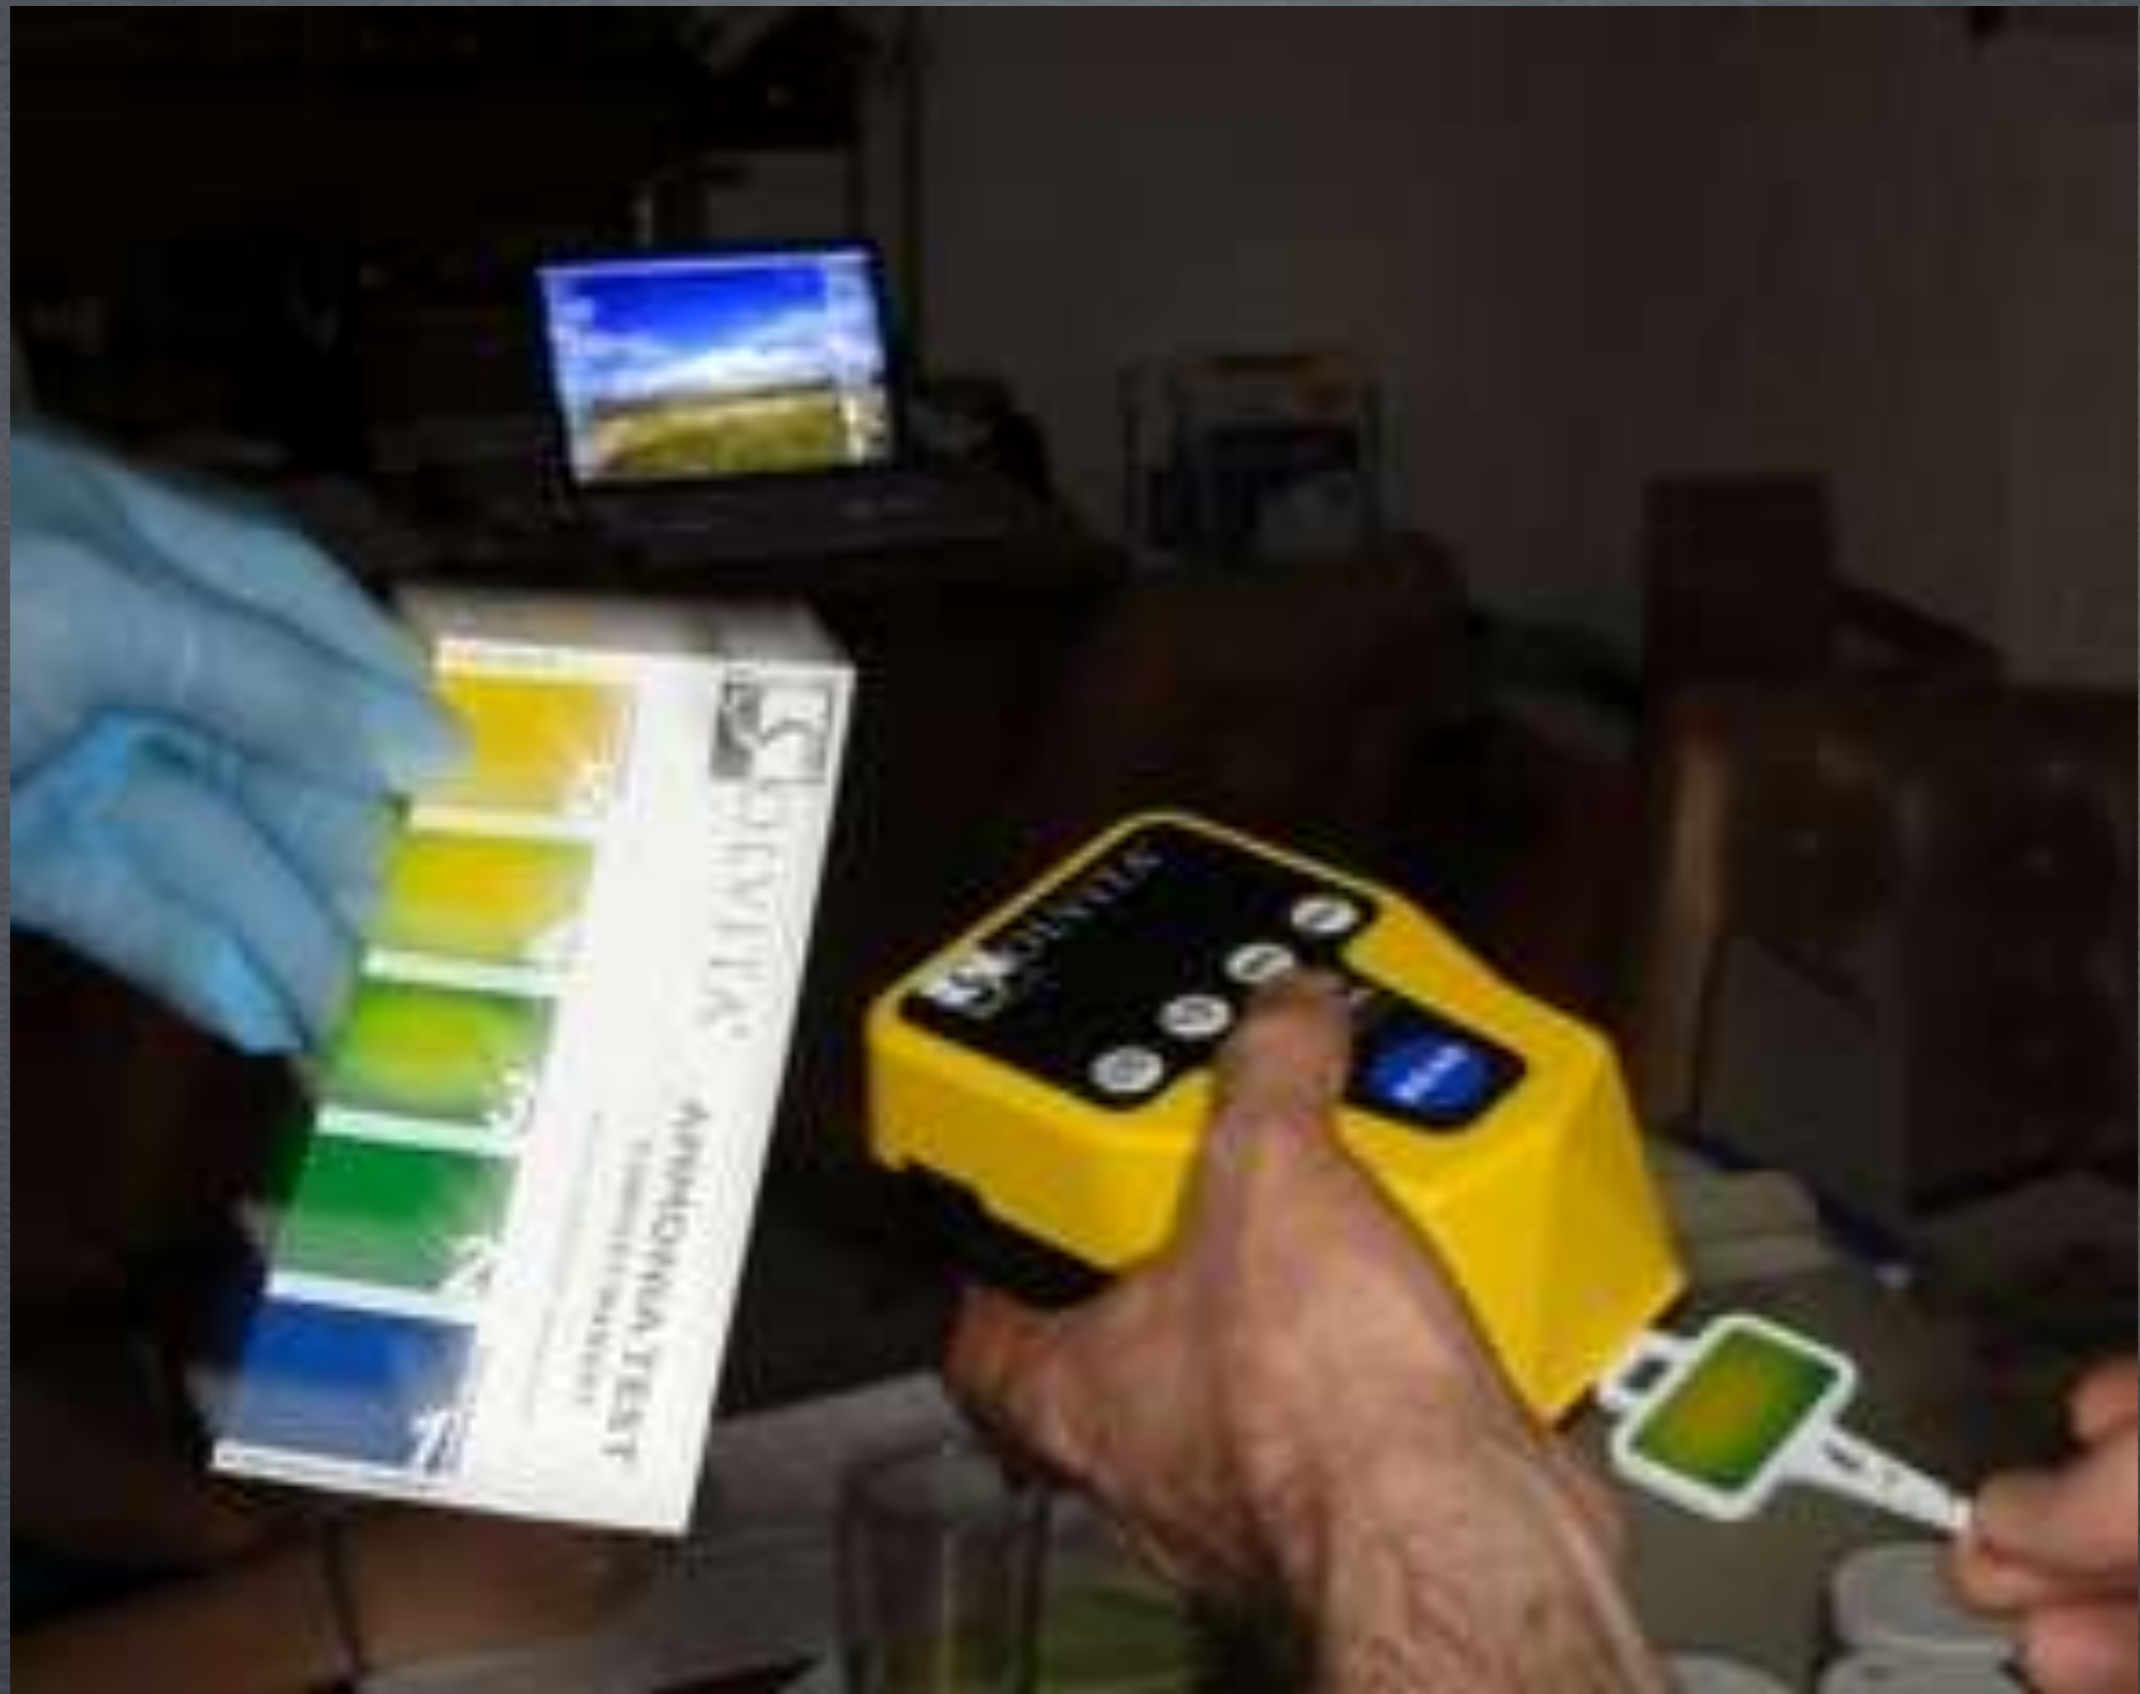
Solvita® test kit with color guide and DCR

Solvita[®] Compost Test

Tests for compost maturity only--not hygienic quality

Simple tests involving carbon dioxide and ammonia measurements using gel paddles

Determines compost maturity from a matrix of these values
