Water quality and sanitation in rural Moldova

Hanna Hugosson
Katja Larnholt

The aim of the project is to do an assessment of the drinking water quality as well as the sanitation situation in the village Condrita in the Republic of Moldova. This was done by studying the existing water and sanitation facilities, sampling the water, evaluating the reason for the poor water quality and mapping the current situation using ArcGIS. Furthermore, technologies for improving the drinking water and sanitation facilities are suggested.

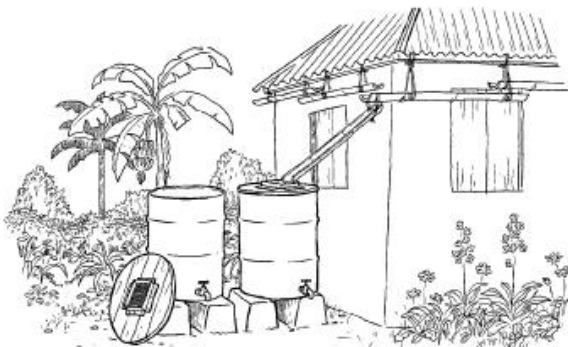
Figure 4 Rainfall collection on rooftop (with permission from Conant & Fadem 2008).

Rainfall can be collected by various technologies, though the main idea is to gather the rainfall on house-roofs and then lead the water through gutters to storage tanks (figure 4). It is important that roof and gutters are kept clean, which means that any bird spilling and leaves needs to be removed (Conant & Fadem, 2008). The area of the rooftop decides the amount of collected water; one millimetre of rain that falls on 1 m² corresponds to 1L of water.

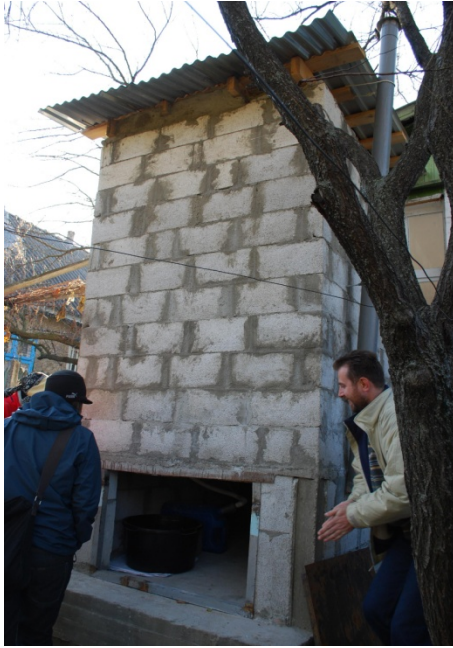
Figure 10 Ecosan toilet built with support from Wisdom (photo by Katja Larnholt).

An ecosan toilet from one of Wisdoms pilot projects is displayed in figures 10-13, where the ecosan toilet building was attached to the main house (figure 10). On the right hand side of the house one can see the ventilation pipe that removes odour from the compartment where urine and faeces are collected. A closer view of this compartment can be seen in figure 11 where the blue tank at the back collects urine, while faeces are collected in the black container. When the black container is full it can be shoved to the back of the compartment where decomposition can be completed. Figure 12 displays a urine separation toilet seat in Styrofoam and figure 13 a ceramic urinal.

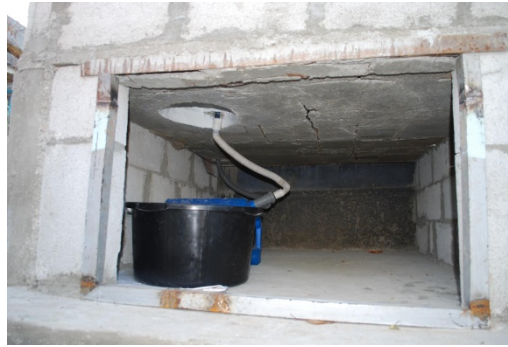
Figure 11 Compartment underneath the toilet. Urine is collected in the tank connected to the hose and faeces in the black container (photo by Katja Larnholt).

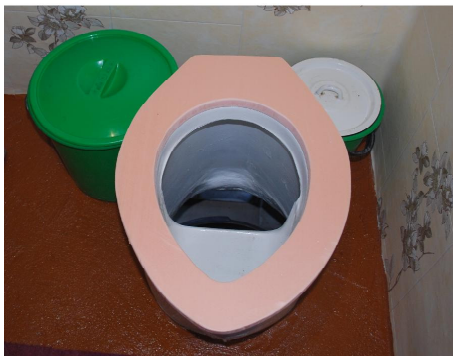
Figure 12 Urine separation toilet with a Styrofoam seat (photo by Katja Larnholt).

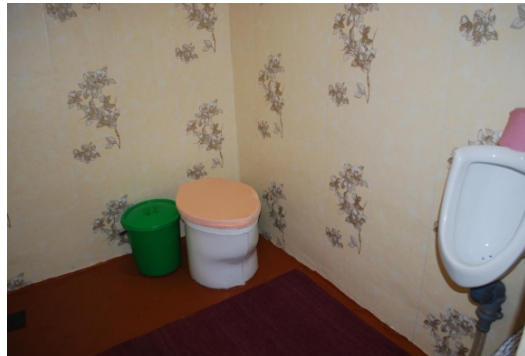
Figure 13 Toilet and urinal (photo by Katja Larnholt).

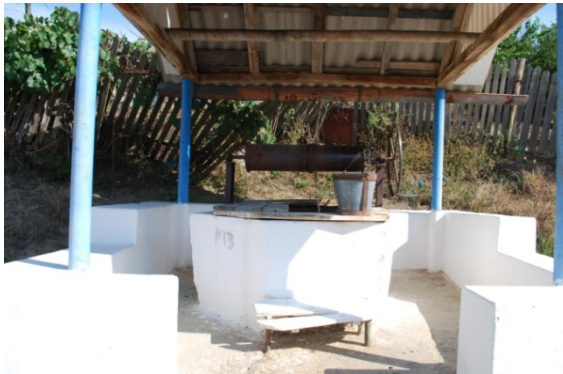
Figure 20 An improved dug well (including lid, roof and runoff protection).

An example of an improved water source in the study area is shown in figure 20, while an unimproved water source is shown in figure 21.

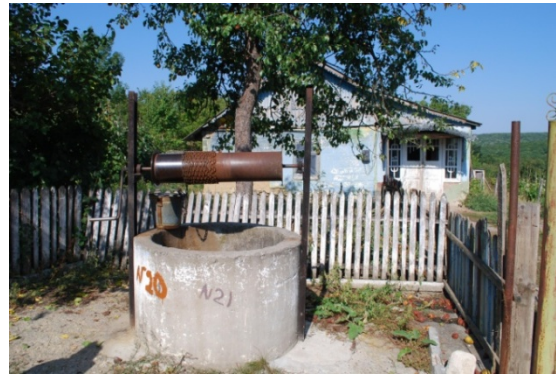
Figure 21 An unimproved dug well (missing both cover protection and apron slab).

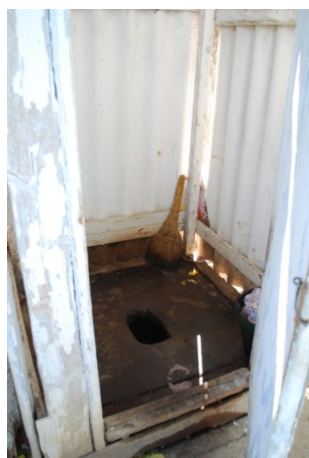
Figure 31 Pit latrine with a solid platform made out of concrete.

Most households had simple pit-latrines though a few had bucket latrines, which were located in the yards. Number of persons that used each toilet was about 2 to 3 persons. The toilets were commonly placed on a solid platform, either concrete (figure 31) or wooden (figure 32), and they often lacked seats. The pits were enclosed by walls and roofs made out of either wood or metal. The ground surface in close proximity of the toilet was in general covered with concrete.

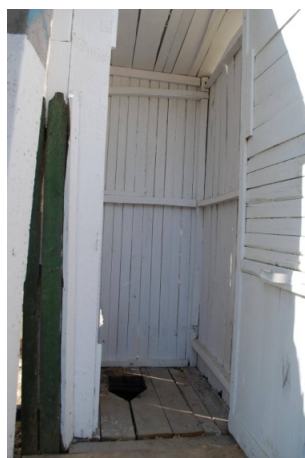
Figure 32 Pit latrine with a wooden solid platform.
