# Investigation into Pollution from On-Site Dry Sanitation Systems

Report to the  
**Water Research Commission**

**WRC Report No. 2115/1/15**

**April 2015**

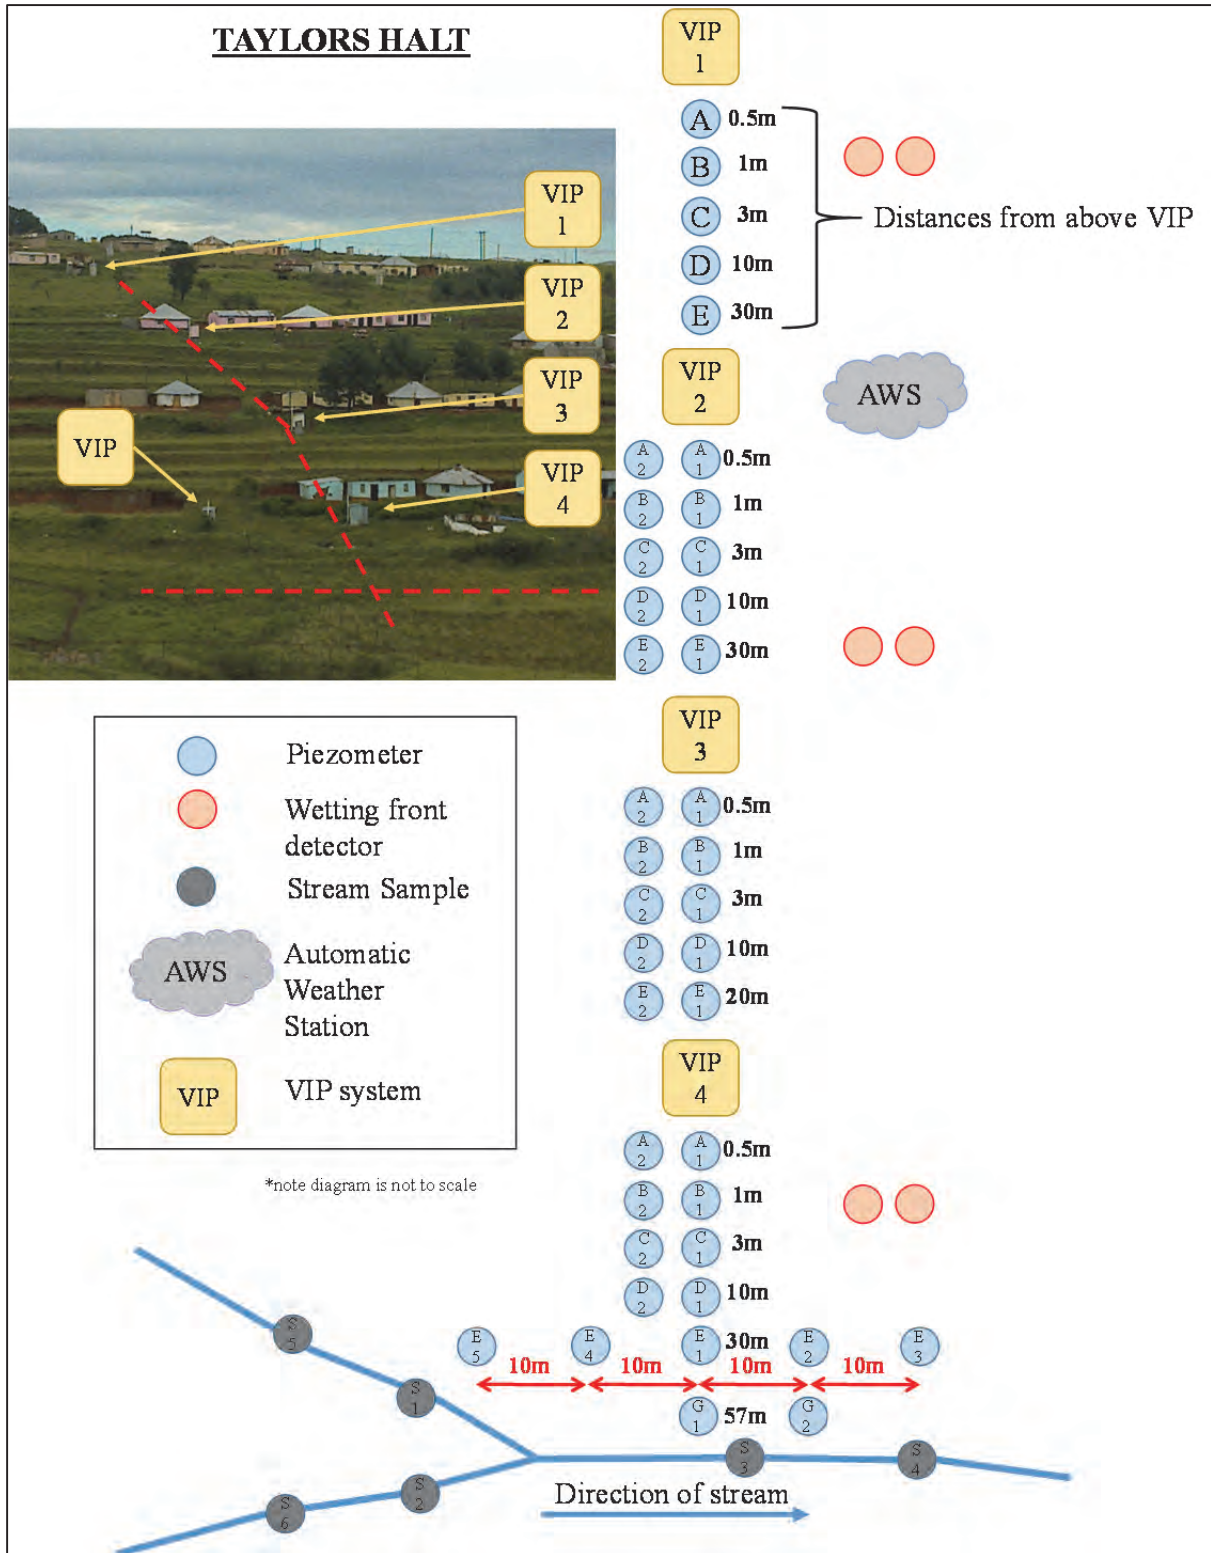
Figure 3.3 Layout of instrumentation at Taylors Halt study site

During a site visit on 19 August 2011 the first site was identified at Taylor's Halt, south of Pietermaritzburg (Figure 3.2). A hillslope transect has been selected for detailed instrumentation and observation. The line of the transect will be finalised on site to intersect as many pit latrines as possible. Instrumentation was placed in nests located various distances from selected latrines along the hillslope. The average slope of the transect is 1:10 with a total fall of 40 m. There are four latrines (VIP1-VIP4) along the general line of the transect. The slope is west-facing and a stream runs from south to north along the western toe of the hillslope. Figures 3.3 and 3.4 describe the instrumentation layout and soil profile at the Taylor's Halt site.

The Taylors Halt site consists of a hillslope transect of a series of VIP toilets on the slope (Figure 3.3). The soil varies in depth and characteristics throughout the hillslope. Near the top of the hillslope, the soil depth averages 1.8 m, whereas the middle of the slope consists of deep, well drained red appedal soil ranging from 3 m to >8 m, with no apparent signs of wetness (i.e. yellow/grey mottling). At the bottom of the slope the soil depth averages 2.5 m, where the upper 1.5 m of soil consists of well drained red appedal soil, with signs of wetness (i.e. yellow/grey mottling) at 1.5 m and more (Figure 3.4). Throughout the years only piezometers located at the bottom of the hillslope (horizontal transect piezometers E1-E5) had any water in them (VIP 3 E2 being the exception), particularly the ones sited within the seepage zone located on the left-hand side of the transect (E4 and E5).

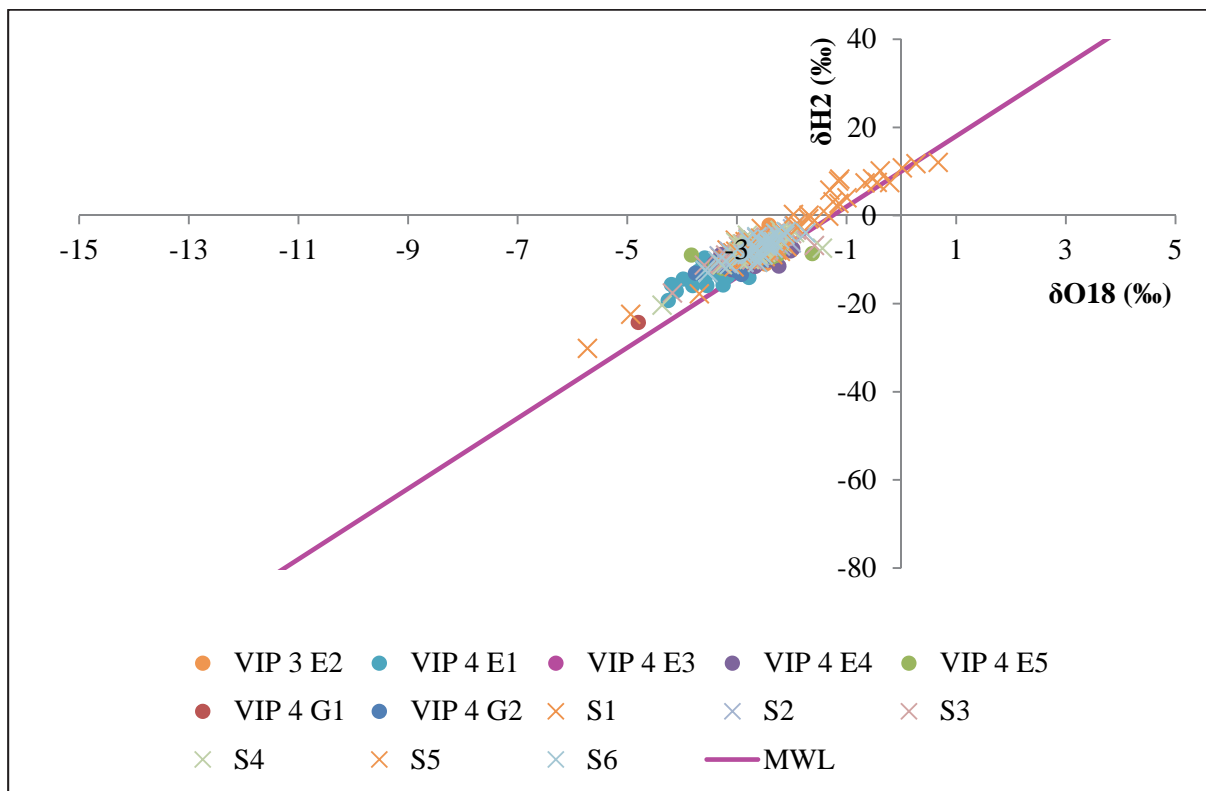
*Figure 4.1 Isotope results for the piezometers and stream at Taylors Halt site*

The isotope data at the Taylors Halt site fell consistently along the meteoric water line (Figures 4.1 and 4.2). The rainfall isotope values vary widely. The small stream (S1 and S5) respond to the rainfall signature, while the larger main stream (S2, S3, S4 and S6) have isotope values similar to the near surface, piezometer isotopes. Hence it is apparent that the main stream is hydraulically linked to the hillslope water, whereas the small upland stream receives predominantly event water.

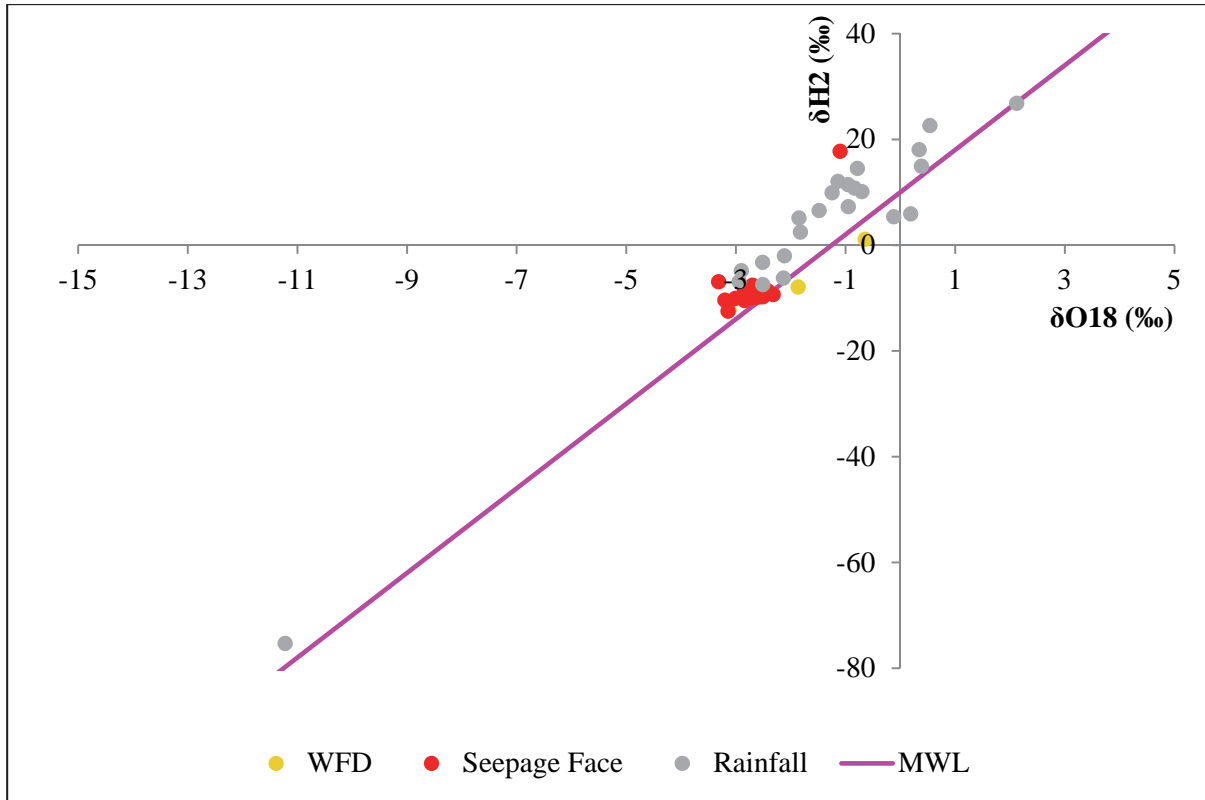
**Figure 4.2 Isotope results for the WFD, seepage face and rainfall at Taylors Halt site**

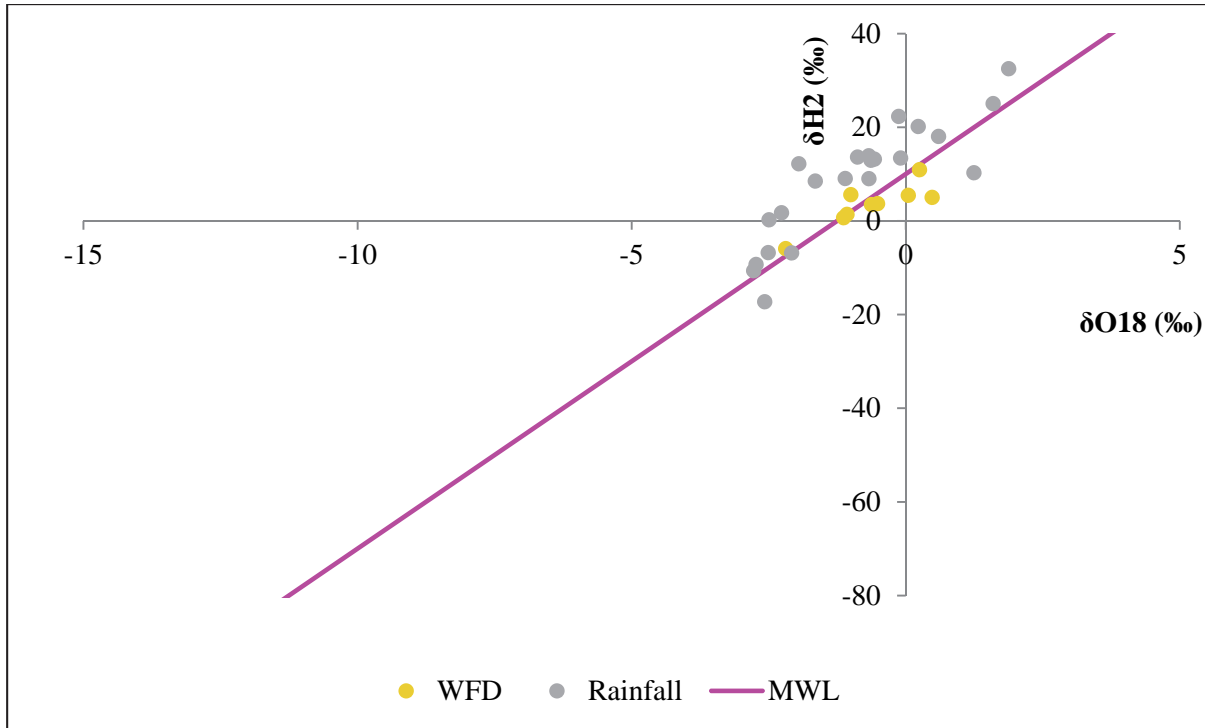
**Figure 4.19** Isotope results for the WFD and Rainfall at Crèche site

The isotope data at the Crèche site fell consistently along the meteoric water line (Figures 4.18 and 4.19). The rainfall isotope values vary widely. The isotope values from the rainfall, wetting front detectors, and piezometers, overlapped consistently with each other and indicated similar isotope signatures. This revealed that there was connectivity between the rainfall and the near surface hillslope through-flow.
