# **Report on Gender Monitoring Survey of Public Toilets: Tirupathi and Shimla**

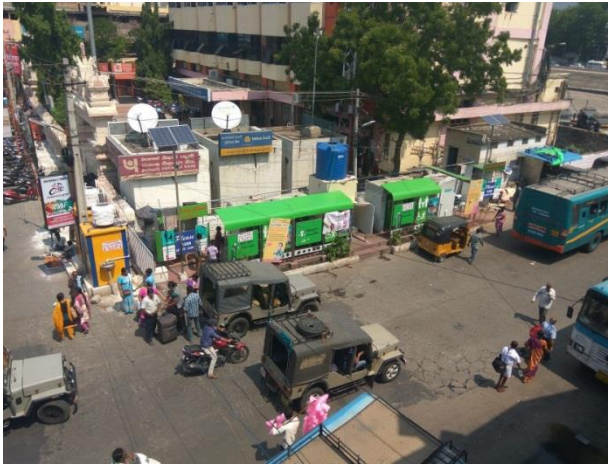
*Pic: Namma toilet opposite to Railway Station, Tirupathi*

The *Namma toilet* is a fabricated structure with walls, roof and floors of the cubicles being made out of Fibre reinforced plastic (FRP). The closets all Indian style are made of stainless steel. The structure had four urinals (two on each side) and had three toilet cubicles in each section for men and women. The toilet was built elevated one foot from the ground level. The advantage in using such material was it is highly cost-efficient and capable of assembly at site, savings in construction time are envisaged compared to other type of structures. In this context, the location centrality, pedestrian & vehicular traffic has limited the choice of material. The linear layout of the toilet is equipped to handle higher footfall as well.

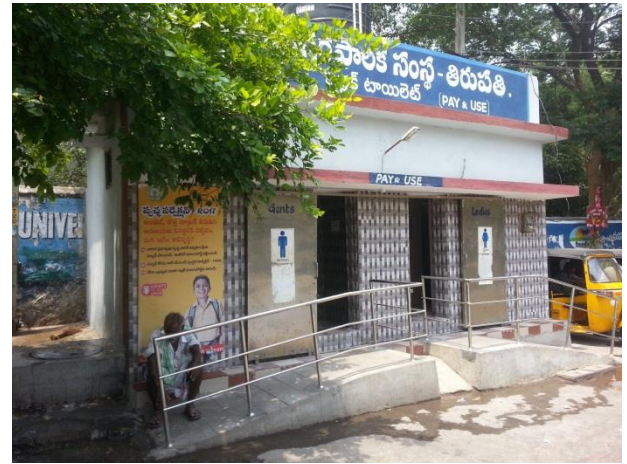
*Pic: Public toilet opposite to Medical College, Tirupathi*

This toilet block is built of Reinforced Cement Concrete (RCC). The walls and floors are well finished with ceramic tiles and the closets are made of ceramic. Given its longevity in life (>25 years) and the residential area where it is located, RCC has been preferred over other materials. The toilet location and the surrounding conditions were amenable to constructing a RCC structure.

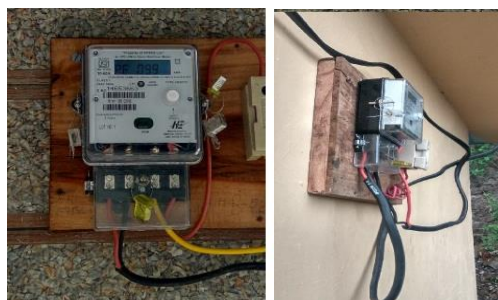
The toilet cubicles and the common area in the toilet are well lit naturally and by electricity. The specifications in PT guidelines are met with in both the PTs. However, electricity complaint through a dedicated contact number or back-up mechanism was missing at both locations.

*Pic: Electricity Meter exposed @ Ram Mandir Public toilet, Shimla*

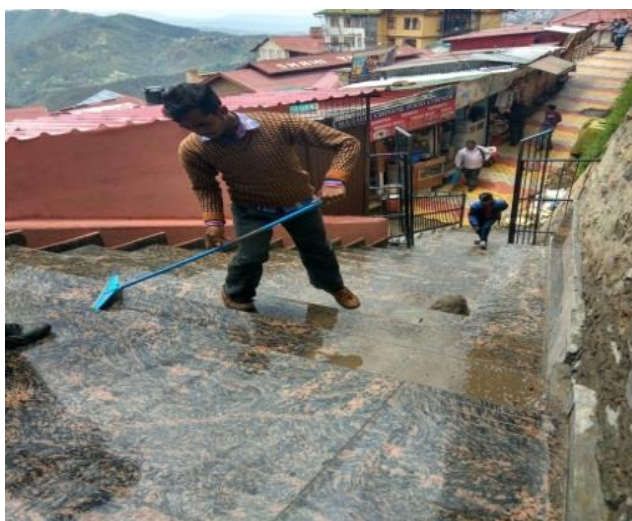
*Pic: Cleaning of Stairs after a spell of rain @ Ram Mandir Public Toilet, Shimla*

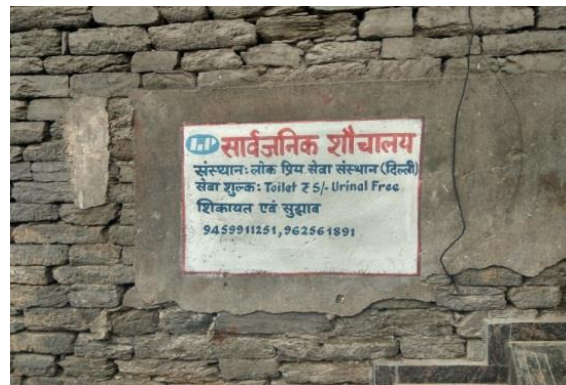
*Pic: Contact & user fee details @ Ram Mandir toilet, Shimla*

noted that absence of emergency contact numbers, at Totu Chowk PT has serious implications with regard to safety, more so due to the centrality of the location. However, Ram Mandir PT scores only with regard to display of emergency number. Nevertheless, availability of the person to take complaint and trigger action is as important to the display of the number(s).

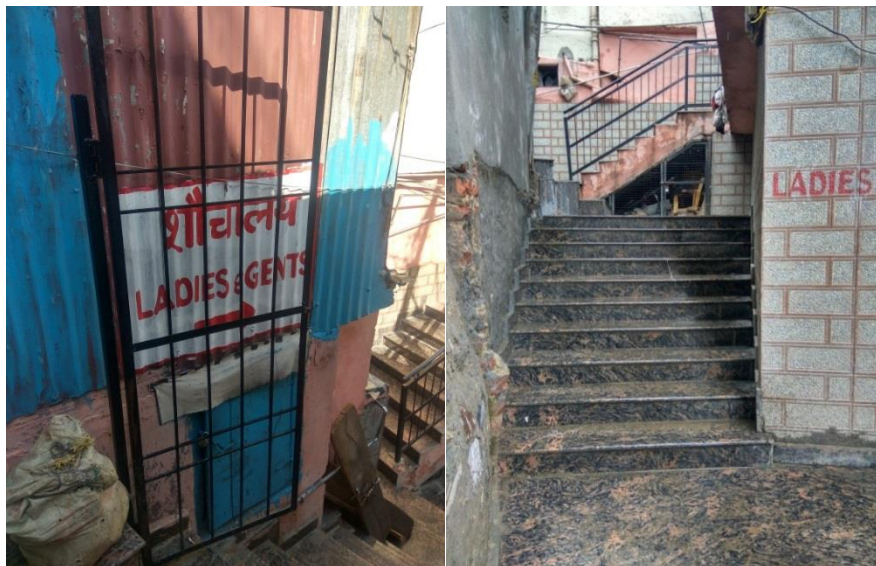
*Pic: Signpost showing direction to Ram Mandir (Left, accessed from market path); Direction showing women toilet (Right, accessed from shops situated below the toilet complex) @ Ram Mandir, Shimla*

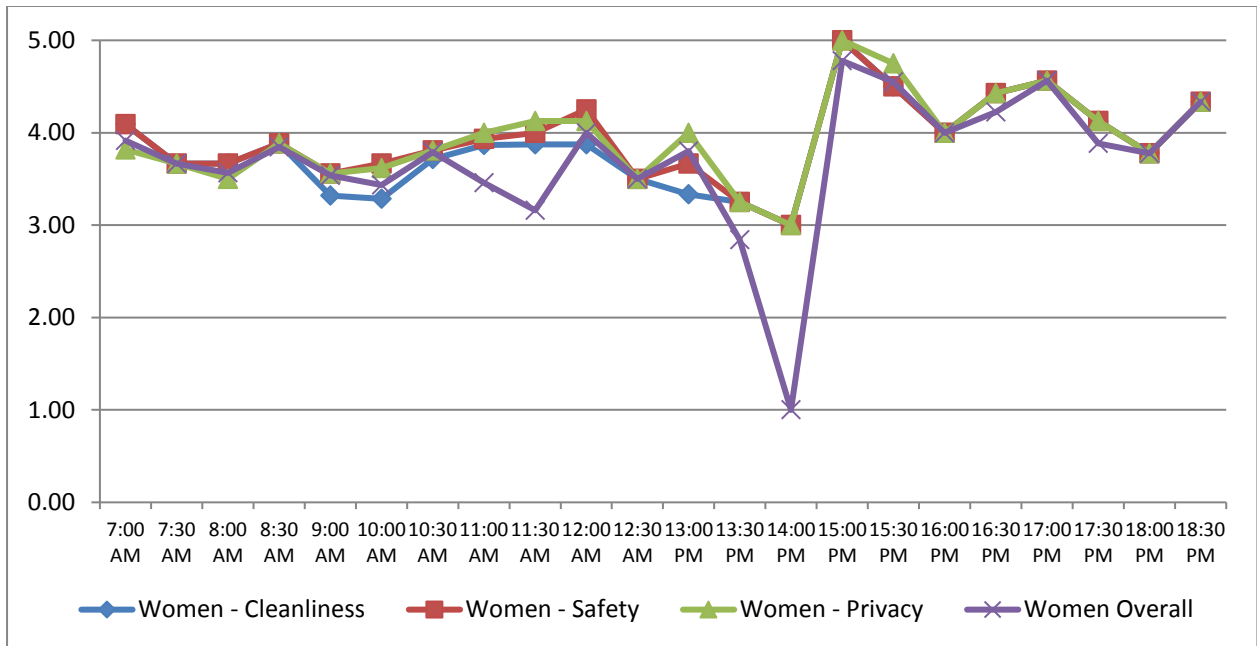
**Chart 13: Time-wise Ratings at Namma Toilet – Women**

As can be seen from the above graph, the location rating dips in the afternoon period – and is high in the morning and evenings, this could be attributed to the reflection of the local weather conditions into the rating offered – that is, by canvassing for the distance travelled, centrality of the location for the location rating, the impact of harsh weather conditions can be attributed to the same. As can be seen from the above graph, the cleanliness rating drops from being around 4 in the morning, after opening of the toilet and succeeding the first set of early morning users to 8 AM and further to 10 AM – the drop could be associated with the rush of users due to arrivals of trains and buses due to which factors like user behaviour, odour, which are factors feeding into the ratings leading to significant drop.

The said ratings are to be seen from the perspective of cleaning and maintenance timing in the said location. As per schedule and observed from field, the first cycle of cleaning takes place morning 6 - 7 AM; the second cycle happens between 11.30AM to 12.00 PM – the rationale for the second cycle is to ease the impact of high usage in morning and to ready the units for users arriving from afternoon trains and post-lunch usage, both by tourists and regular users. The third cycle of cleaning timing is for the evening session, between 5.30 PM to 6.00 PM. It is to be noted that the caretaker does clean the units and pathway based on complaints or suggestion from the users.

The fall in safety and privacy between 1 PM and 2 PM hours can be attributed to buses being parked in front of the toilet. The drop in cleanliness rating is caused by over usage of the toilet during this time period, which in turn is a result of the greater number of people, brought to the toilet by the buses.
