Pintakasi

A REVIEW OF SHELTER/WASH DELIVERY METHODS
IN POST-DISASTER RECOVERY INTERVENTIONS

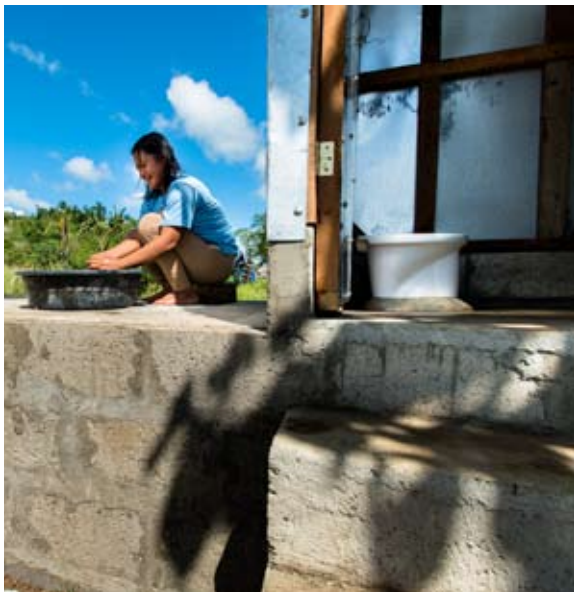
Left: The Type 6 toilet and septic tank is for households whose groundwater level is higher than 0.65 meters from the natural ground.

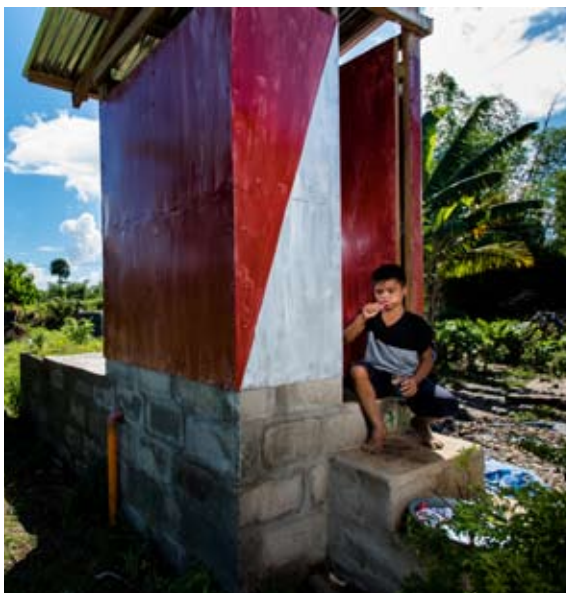
Below: The Type 7 toilet and septic tank is for households whose groundwater level is between 0.65 and 1.5 meters from the natural ground.

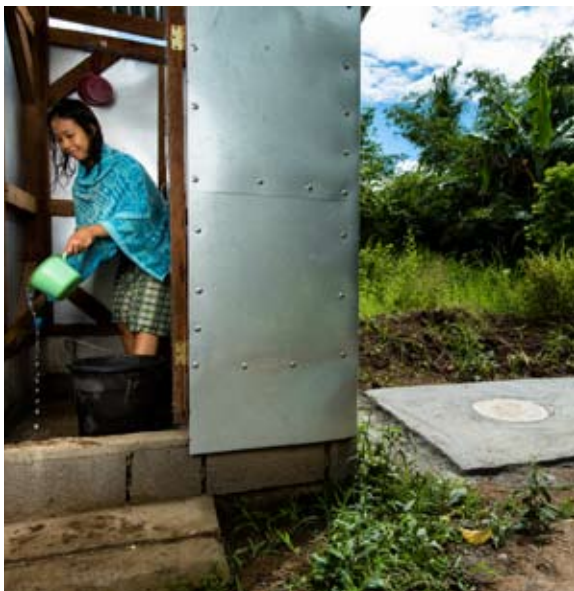
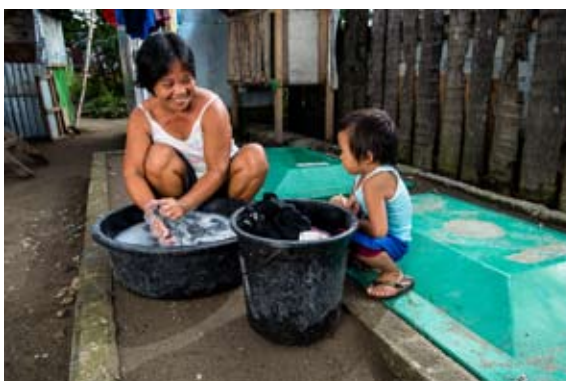
Above left: The Type 8 toilet and septic tank is for households whose groundwater level is below 1.5 meters from the natural ground. Above right: Anaerobic baffled reactors⁵ were used for clusters of households where there was not enough space to build individual septic tanks.

5. Anaerobic baffled reactors (ABRs) are improved septic tanks that use baffled walls to help channel the water through active sludge resulting in improved wastewater treatment. CRS partnered with the Bremen Overseas Research and Development Association to manufacture ABRs using fiber-reinforced plastic so that they were portable and could withstand a high water table and flood-prone conditions

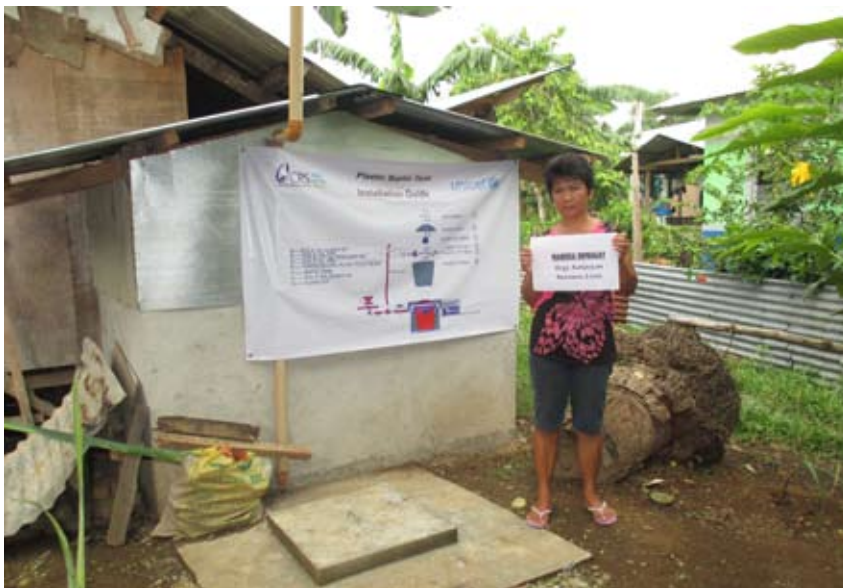
CRS engineers constructed a demonstration toilet in each *barangay*, showcasing the correct way to construct a septic tank using mock-ups and actual model construction.
