BASELINE STUDIES FOR URBAN SANITATION: TIRUCHIRAPPALLI, PERIYANAICKEN-PALAYAM, NARASIMHANAICKEN-PALAYAM

December 2016

This document is produced as part of Tamil Nadu Urban Sanitation Support Programme (TNUSSP). TNUSSP supports the Government of Tamil Nadu (GoTN) and cities in making improvements along the entire urban sanitation chain. The TNUSSP is being implemented by a consortium of organisations led by the Indian Institute for Human Settlements (IIHS), in association with CDD Society, Gramalaya, and Keystone Foundation.

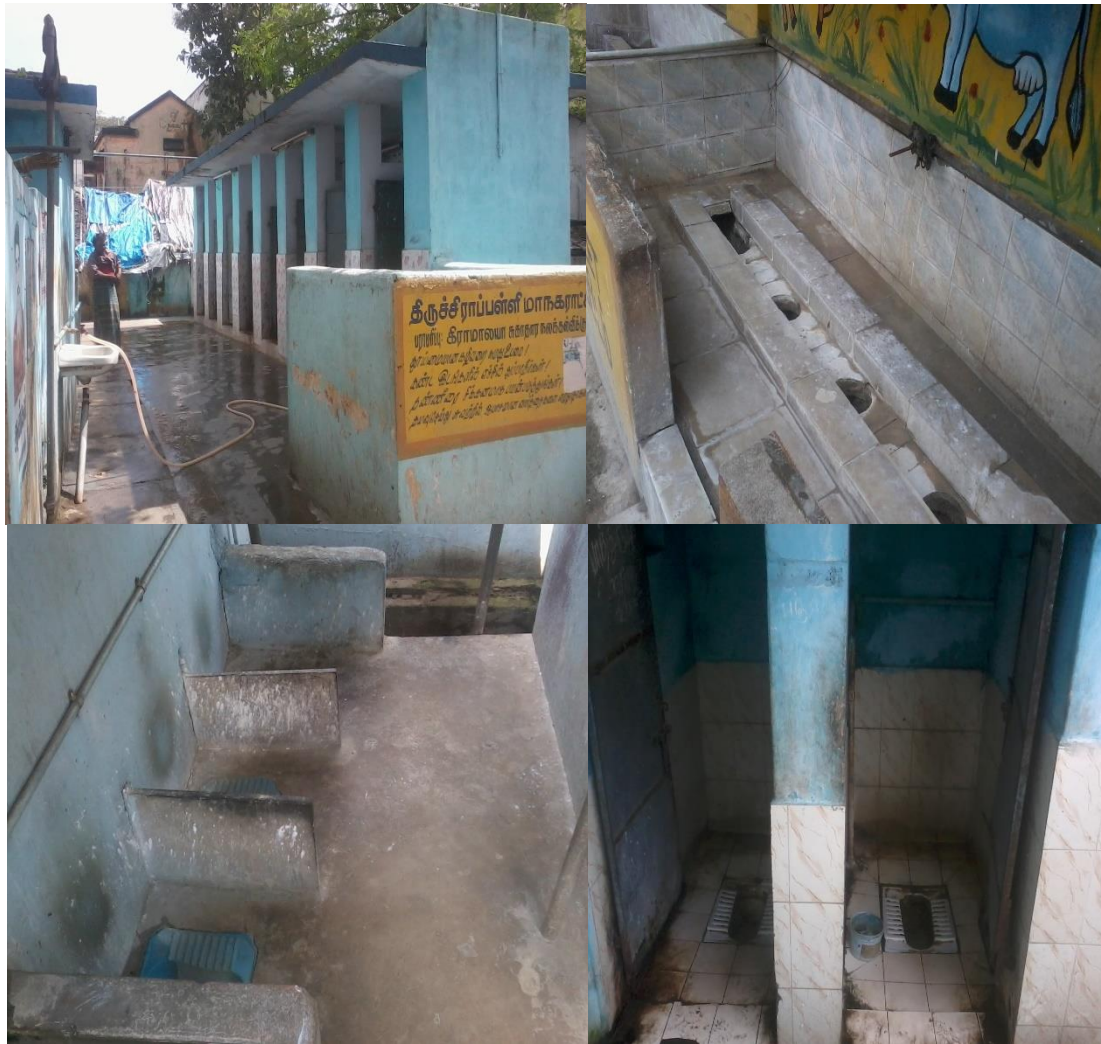
Figure 3.2: Community toilets in Tiruchirappalli

The number of toilets across CT/PTS ranges from 5 to 10 with same number of toilet rooms for women and men. CT/PTs run by Corporation and WAVES had separate toilet rooms for the differently-abled (with only the latter offering ramp access to disabled persons) and CT/PTs run by Corporation and private organisations offer bathing facility also. Every day on an average 250 men and 180 women use CT/PTs, across corporation, WAVES, and NGO run CT/PTs. Private CTPT, report 250 men and 50 women using their toilets on a daily basis.

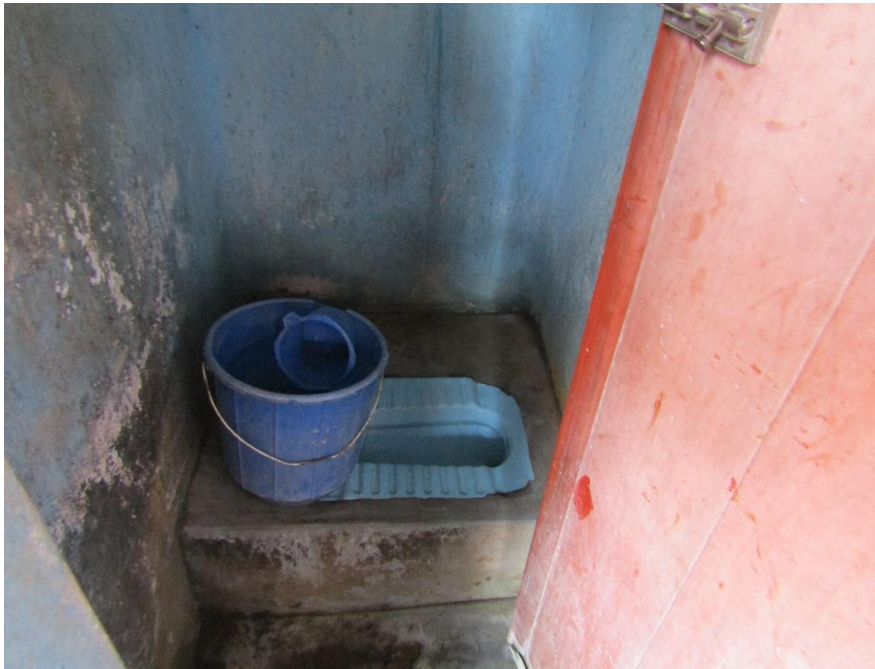
Figure 3.3: Community toilet showing small plinth area

The number of toilets across CT/PTS ranges from 5 to 10 with same number of toilet rooms for women and men. CT/PTs run by Corporation and WAVES had separate toilet rooms for the differently-abled (with only the latter offering ramp access to disabled persons) and CT/PTs run by Corporation and private organisations offer bathing facility also. Every day on an average 250 men and 180 women use CT/PTs, across corporation, WAVES, and NGO run CT/PTs. Private CTPT, report 250 men and 50 women using their toilets on a daily basis.

in each toilet for disposal as the toilets have small plinth area. Women complained that despite several instructions, most users of community toilets either throw the napkins into the toilet, thereby clogging the drain or wrap it in paper and stuff it in the window sill, with a risk of it falling on the next user. Further, sanitary workers refuse to collect bins with sanitary napkins, thereby leaving them no choice but to burn them.

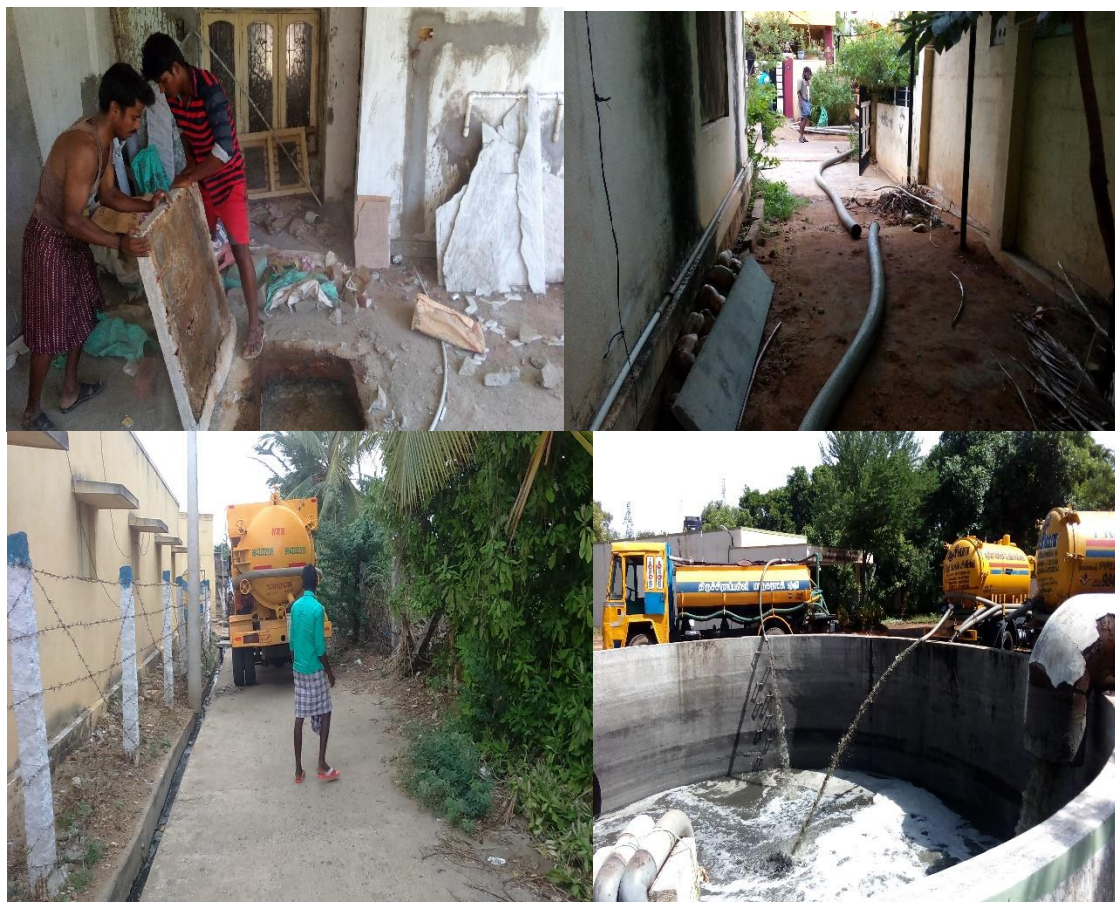
Figure 3.11: Collection and disposal of fecal sludge from households in Tiruchirappalli

Most containment units observed were septic tanks with provision for access. Operators had to break open the manhole with crowbar and improvised tools such as drilling machines. Tankers used for de-sludging were professionally designed, with ladder, storage space for pipes and tools. Tank capacity ranges from 4,000 to 10,000 litres and are rubber lined for long life. Suction piper are up to 100 feet in length, with operator using couplers for joints. Many operators work bare chested.

Households largely seem to be unaware about where the fecal sludge is disposed once it has been removed from their on-site systems. Only nine households knew where the fecal sludge is emptied in the river or stream (4), buried on land (1) and dumped in farms (4).

Two de-sludging proprietors report transporting matter via tankers to the Sewage Treatment Plants (STPs) and neither of them mentioned facing any problems. Both proprietors report to operate well maintained tankers which are leak proof. They dispose the fecal sludge at the STPs as that is the prescribed site by the law. Both drivers reported using the Panjapur STP and also mentioned the existence of a second STP (one driver recalled that it was located at Jamamal College and the other, at Anna Stadium). Secondary research indicates that these are actually two decanting sites which are run by the Corporation for the collection of fecal sludge in case of Panjapur STP is not accessible. This narrative is however, not consistent with observations from other stakeholders.

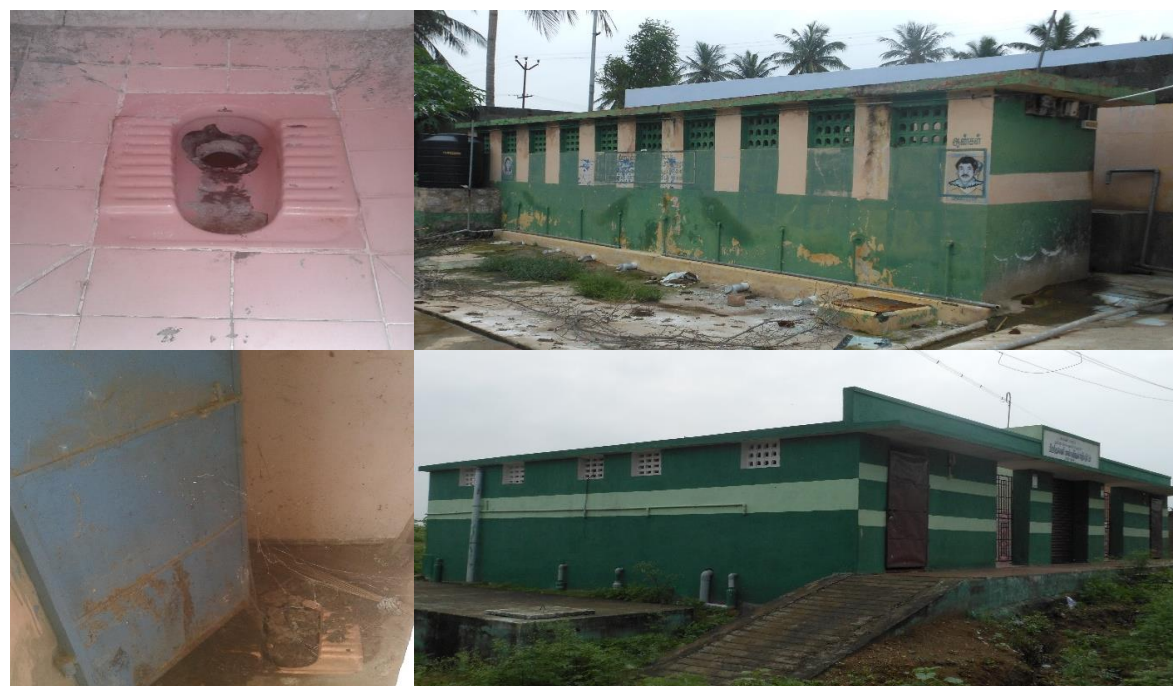
Figure 4.3: Community toilets in Town Panchayats

Despite the growing demand, the quality of community toilet maintenance in TPs leaves a lot to be desired. Common complaint is that insufficient number of toilets to serve the user population leads to long queues in the morning. This is exacerbated in TPs with those who have individual toilets also preferring to use community toilets. Among the main problems reported in using community toilets, were long waiting hours, lack of availability of water and lack of cleanliness.

Across all the locations, community groups expressed strong displeasure with the current management and need for improvement in management of community toilets, their infrastructure, cleanliness and maintenance. For one, there is no designated person to maintain the toilet due to lack of manpower and toilets are cleaned mostly once in a day by the sanitation workers. Children stated that the doors are broken, there are no buckets, and water taps are damaged. In the absence of water taps inside the toilets, users need to carry water for cleaning. None of the toilets have exclusive seat for aged people or children. However, community groups report approaching town panchayats and ward councillors only when the sanitation workers failed to address the water clogging and blockage in septic tank. Not surprisingly, user experiences of community toilets are not highly rated.

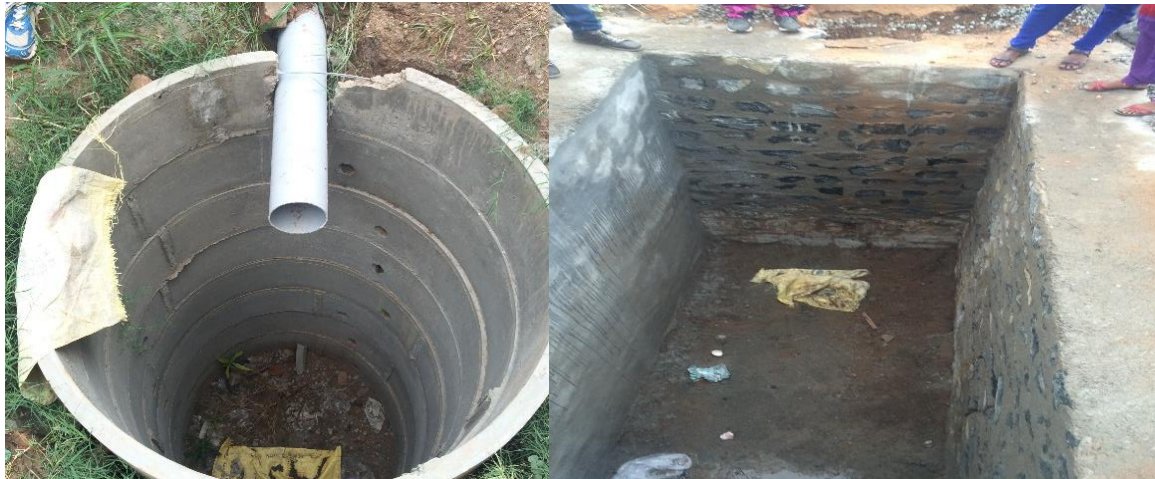
Figure 4.9: Containment structures in Town Panchayats

Pits are typically constructed by lower income households with area constraints. Average volume of the pit is about 3.37 M3 with no history of de-sludging pits at all. All pits were unlined at the bottom and had perforation on the side walls. Average volume of septic tanks were 16.4 M3, with 20 per cent of the tanks in the survey de-sludged although with a desludging frequency greater than 5 years. While 24 per cent of the septic tanks were lined at the bottom, 8 per cent of the household's report that their septic tanks were built as per CPHEEO standards. In terms of outlet —21 per cent of septic tanks had an outlet provided; 3 households were connected to storm water drains and 3 households had a soak pit arrangement.

When the WHO criterion is employed, only 8 non-slum and 6 slum households in PNP, and 2 slum households in NNP actually have septic tanks and the remaining households in PNP and NNP are variations of pits.

'Most of the earthen tiles houses (poor households) use pits while the RCC houses have Basalt septic tanks. The primary reason for this difference is the price point of the containment structure. The pits are largely constructed under the government subsidy whereas the septic tanks tend to be self-funded' - Mason, PNP

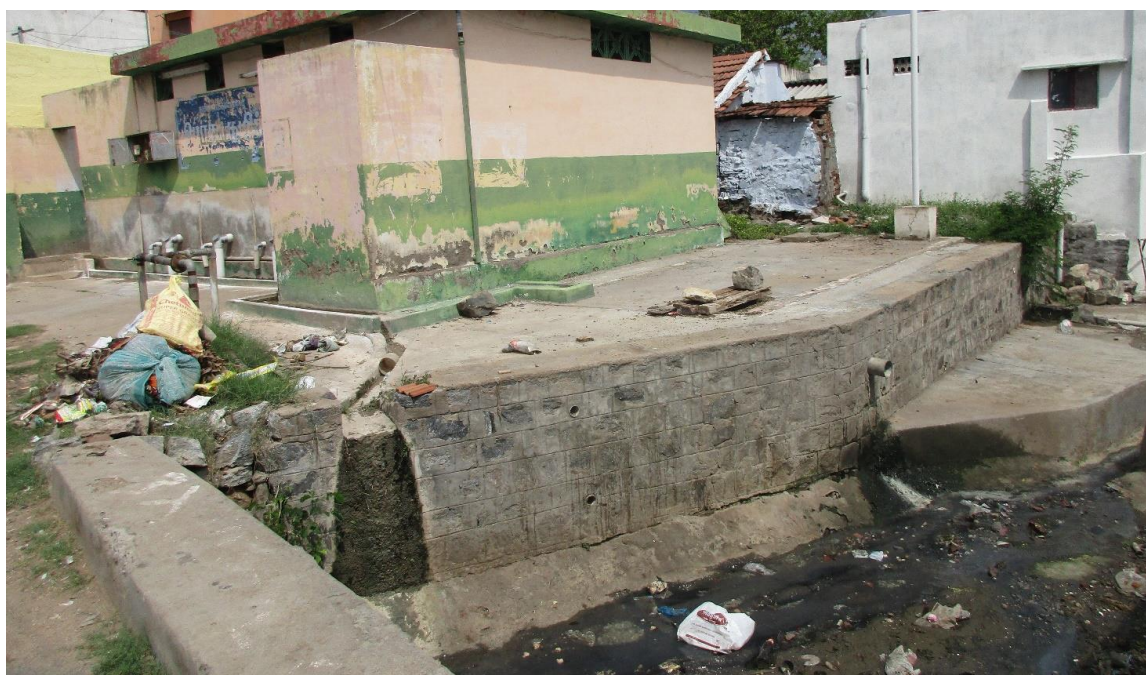
Figure 4.15: Household wastewater connected to open drains in Town Panchayat

Grey water from kitchen is mainly disposed-off in to the drain directly across both slums and non-slums in NNP and PNP. In the slums in NNP however, it is also used in the kitchen garden (16 per cent) or sent to a separate soak pit (14 per cent). Waste from bathrooms is also disposed-off in a similar as kitchen waste.
