SFD Promotion Initiative

Domiz 2 Syrian Refugee Camp Kurdistan Region of Iraq

Final Report

This Comprehensive SFD Report was prepared
by GIZ.

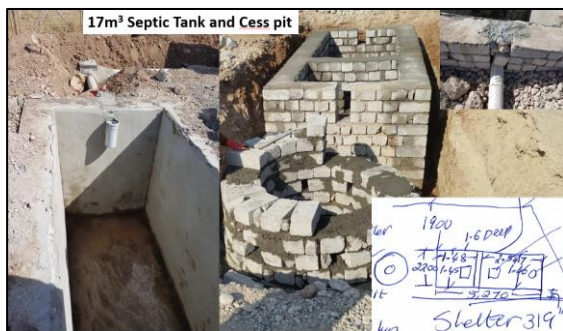
Figure 1: Recent Septic tank & soak pit design, Domiz 1. Similar construction in Domiz 2. (Source: Author, 2018)

During the sanitation assessment it was established that the holding tanks are in fact lined pits with semi permeable walls and open bottom and are not connected to a soak pit. These pits are also sometimes called septic tanks, as they have some of the characteristics of these such as two chambers, with partition wall. They are built with unplastered block work.

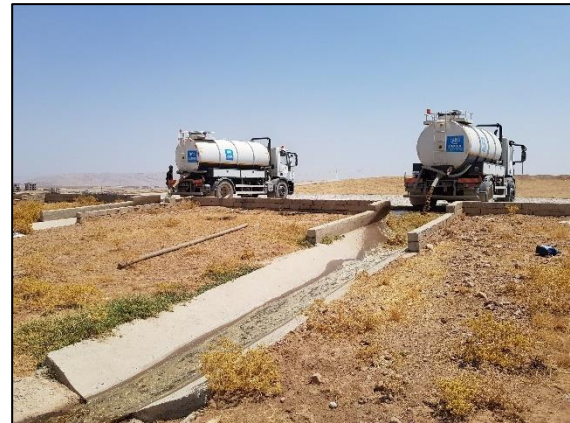
The desludged material is dumped into the environment without any treatment, about 2km from the camp, at a designated dumping site. However, it is a regular occurrence that, owing to the pressure on the desludging trucks, they frequently empty near the Domiz 2 camp, in an informal dumping site. It's noted that the end effect is the same, as both locations are simply points where the material is emptied into the environment and the catchment is part of Mosul Dam.

Figure 2: Desludged material being dumped at the designated site, near Domiz 1 Camp. (Source: Author)

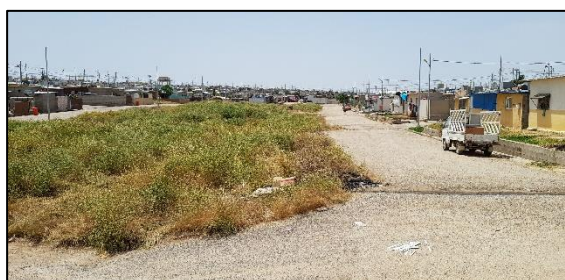
Grey water is directed from within to the household's into the street drainage for collection through V-shaped channels, which also collect surface run off and then deliver this through increasingly larger channels into the natural drainage.

Figure 4: Grey water collection channel system, Domiz 2. (Source: Author 2019)

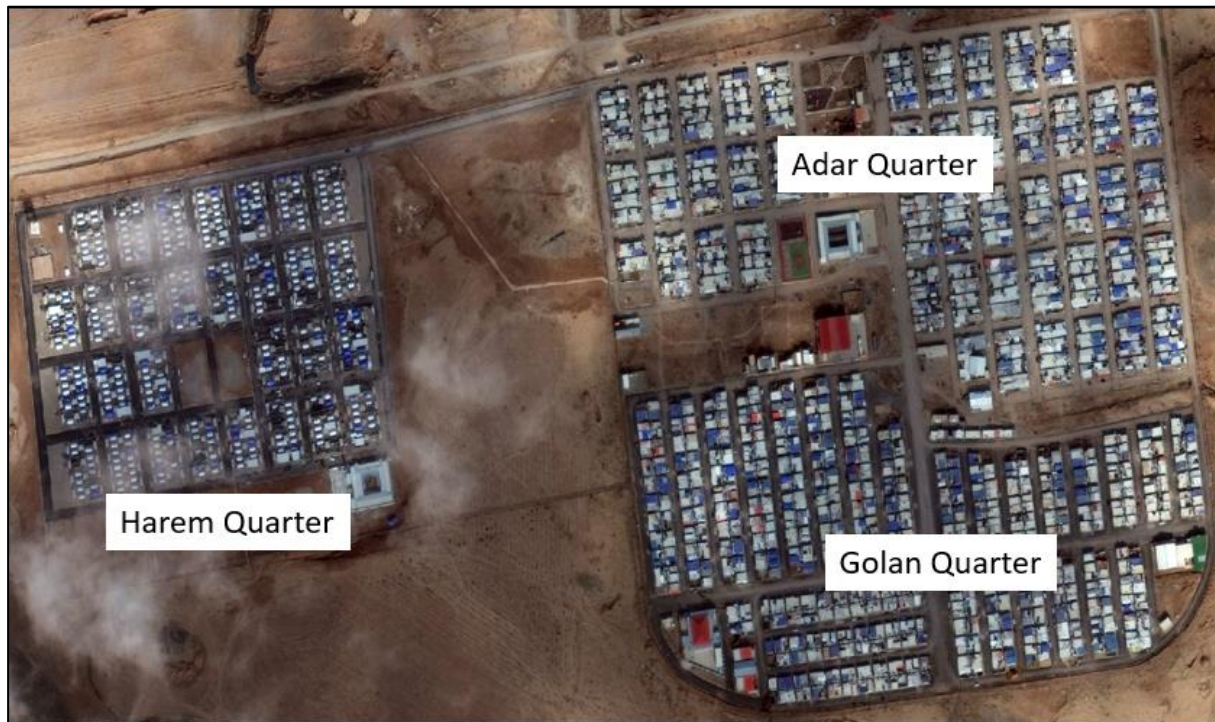
Figure 8: Domiz 2 Camp, showing 2017 expansion on left. (Source: UNHCR, 2018)

The Domiz 2 camp is laid out in 3 distinct residential sectors or quarters and within each quarter, the shelters are arranged in blocks. The black water connections generally consist of anywhere from 5 to 20 shelters per septic tank, though there are some exceptions. The septic tanks are arranged such that they collect waste from these blocks either through pipes connected directly from the household to the tank or through a basic collection system, with household connections joining a collector pipe through connection boxes (called manholes here). This collector pipe then connects into the tank.

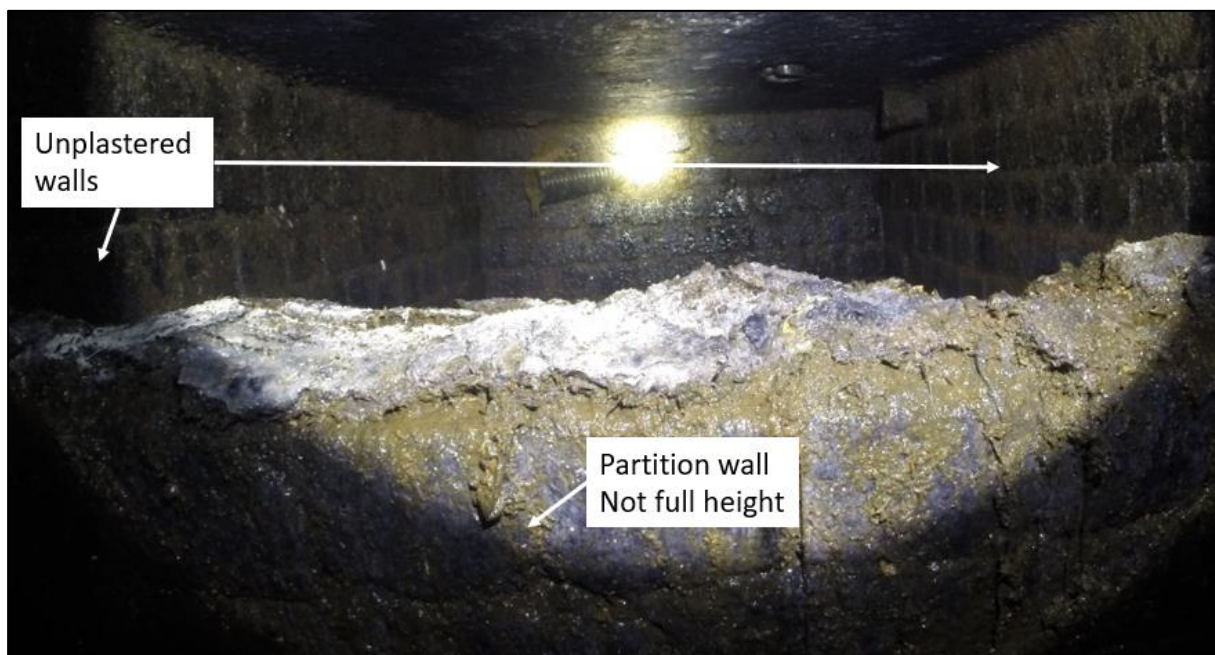
2. Lined pit with no outlet and semi-permeable walls – These are also referred to as septic tanks locally, and do include a partition wall, though this does not go to the top water level. At the time of writing there were 56 of these in Domiz 2 camp, all in the Golan quarter, comprising 28% of the total amount of containment systems (203). They are either 12m³ (10 no.) or 15m³ (46 no.) total volume. These are locally called septic tanks, because they do have a partition wall of sorts installed, but they differ fundamentally because they are not lined properly, the partition wall does not rise to the topwater level, and they don't have a soak pit connection for the treated effluent. Because of this, they are more accurately described as a lined pit with semi-permeable walls and no base. It was not able to be determined during the assessment if there was a base installed, but the camp management staff felt that this was unlikely because of the type of construction. The intention of this containment system is to let as much liquid as possible infiltrate into the ground, through the permeable walls and the open bottom. The system requires regular desludging, between two and four times per month, as with up to twenty households connected to it, there is more liquid being added than what usually can infiltrate into the ground, particularly where grey and blackwater are mixed. This infiltration reduces the amount of desludging that must happen, thereby minimising the cost, but that does create a potential risk for groundwater.

Figure 11: Lined pit with impermeable walls and open base, called a "holding tank" locally. (Source: Author, 2019)
