SFD Lite Report

Dodoma City Tanzania

This SFD Lite Report was prepared by GFA Consulting
Group GmbH.

Date of production/ last update: 02/12/2018

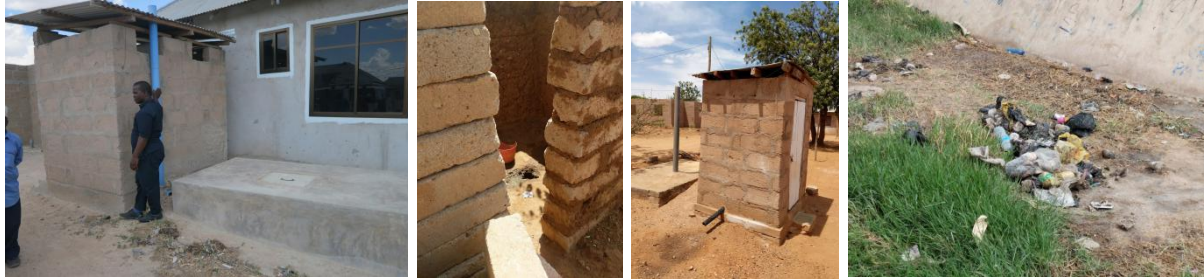
Figure 3 Examples of OSS and “Flying toilets” in Dodoma City Council

During the rainy season, poorly constructed traditional pit latrines easily collapse (GFA Consulting Group GmbH, 2018). Another factor in containment is that according to our KII, solid waste is often disposed

directly in the latrines or with the final disposal of faecal sludge (KII-1, 2018). We also observed many cases of “Flying toilets” which we consider as Open Defecation (ODF) (FGD-2, 2018).

- We observed that some households cover their traditional pits with cement and others with soil inadequately. In addition, most of the traditional pit latrines have no roof, no privacy doors, have weak slabs (soft wood used), that imply inadequate safety to users, superstructures are not stable, made up of mud bricks (48.6%), no lining for the pit thus susceptible to collapse during

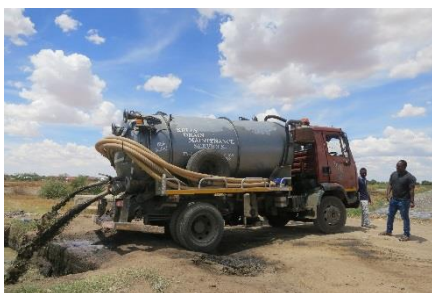
Figure 4 Private cesspit emptier disposing at Swasa WSP

Emptying and transportation services are available and are provided by cesspit emptiers provided by both the private sector and the respective councils (GFA Consulting Group GmbH, 2018). There are Private (7 companies) and DUWASA (1) trucks. DUWASA monitors and issues permits to the private trucks.

Households pay about 30,000 (USD 15) to 60,000 (USD 30) Shillings per trip. When using a private service, households pay 45,000 (USD 22) to 120,000 (USD 60) Shillings (KII-1, 2018). One truck carries about 7,000 litres per trip and can make seven to ten trips per day (KII-3, 2018). It also occurs that during the rainy season with difficult roads, private trucks dump the FS on illegal sites (KII-1, 2018).

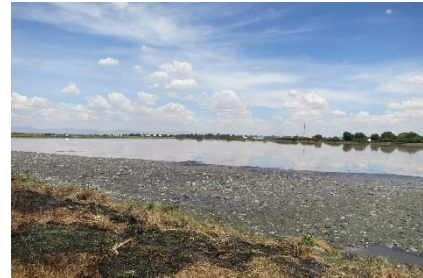
Figure 5 Swaswa WSP

The collected wastewater and faecal sludge are treated using four (4) temporary waste stabilization ponds (WSP) comprising of only anaerobic and facultative ponds, located at Swaswa area, about 7km north-east of Dodoma city (GFA Consulting Group GmbH, 2018). However, the SWASA WSP was meant to treat wastewater and not sludge. There is a need for dry beds for sludge treatment. In addition, Dodoma City Council allocated a new area for WW Treatment system at Nzughuni with an area of 60 hectares. The design involves the provision of sludge drying beds (GFA Consulting Group GmbH, 2018).

According to our KII, there is 70 to 80% treatment efficiency, but the results of the effluent analysis reveal that it does not comply with the Tanzania Standards (GFA Consulting Group GmbH, 2018).

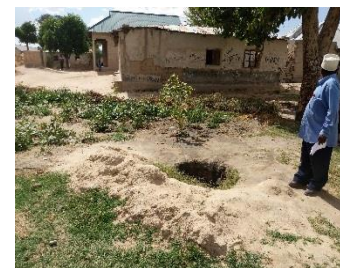
The depth of the groundwater is very shallow between 2-5 m (KII-2, 2018). **Figure 6 Shallow Well**

The area has three principal soil types; white sandy soil, red loamy soil, and poorly drained black clay soil called 'mbuga'. The groundwater is mostly found in fractured formation. Despite these fractured aquifers, groundwater is also found in the upper regolith part of the catchment. Studies have shown that high values of Nitrate levels and high groundwater pollution risk linked to pollution from sewage effluents with penetration of the pollution to deep levels in the crystalline aquifer via fractures occur in Dodoma City (Massawe, 2017)(British Geological Survey, 2000).
