SFD Lite Report

Shinyanga Municipality

Tanzania

This SFD Lite Report was prepared by GFA Consulting
Group GmbH

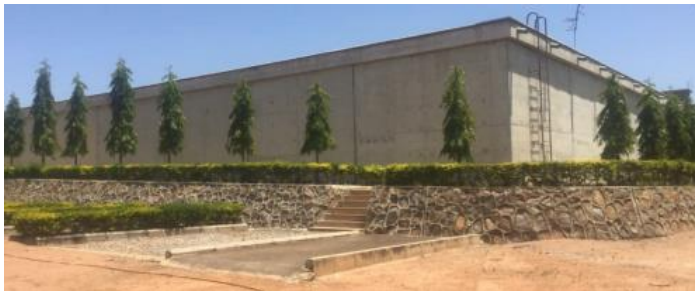
Figure 3: Main drinking water tank, source: Lake Victoria

The Authority purchases treated water from Lake Victoria through Kahama Shinyanga Water Supply and Sanitation Authority (KASHWASA). Water from Lake Victoria Water project is designed to deliver to Shinyanga 28,000 m³/day in 2024. SHUWASA receives its bulk water through Old Shinyanga Tank shown in Figure 3 and is distributed to four elevated towers each with a capacity of 250m³.

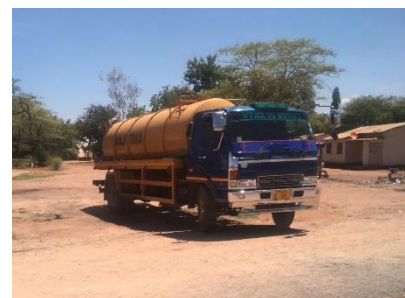
Figure 4: Emptying truck

Both, public and private service providers offer emptying services with vacuum tanks in Shinyanga. According to an interview with private pit emptiers, solid waste dumped into the toilets cause problems and can block the pumps during the emptying process. Therefore, often, the vacuum truck do not empty the containment tanks completely and mainly suck the liquid part from the tanks, the solid part of the sludge remains (KII-4, 2018). Some Households empty the containments manually and dispose the content into a newly dug hole nearby. The proportion of emptiable systems from which faecal sludge is emptied was therefore assumed as 50%. Emptying of collapsed containment system is considered as more complicated (KII-4, 2018), therefore, for failed, damaged, collapsed or flooded systems (T1B10C10) the percentage of emptied systems is set to 25% instead of 50%. More investigation is needed to fully understand the emptying scenarios. As in many cases, the content remains in the neighbourhood and is only dumped into a nearby hole, the proportion of faecal sludge that is transported is considered as low (10 %).

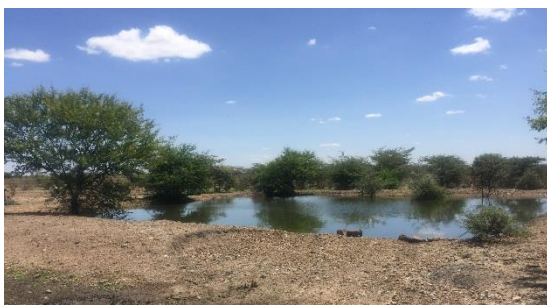
Figure 5: Wastewater dumpsite

The disposal place *Nhelegani* is a small pond in the peri-urban area of Shinyanga. There are no houses nearby and the area is not fenced. Infiltration into the ground is slow and, especially in rainy season, the pond overflows (KII-4, 2018).

The wastewater emptied with vacuum trucks is transported to the official disposal place *Nhelegani* in the Kisumbi Ward. A treatment plant for wastewater or faecal sludge does not exist in Shinyanga.

The service providers mention the long distance to the disposal place and high costs for fuel as a serious challenge. Some of the trucks do get special permission of dump the wastewater at other places, such as the football pitch in the stadium to water and fertilise the grass. An informal disposal in other places cannot be precluded.

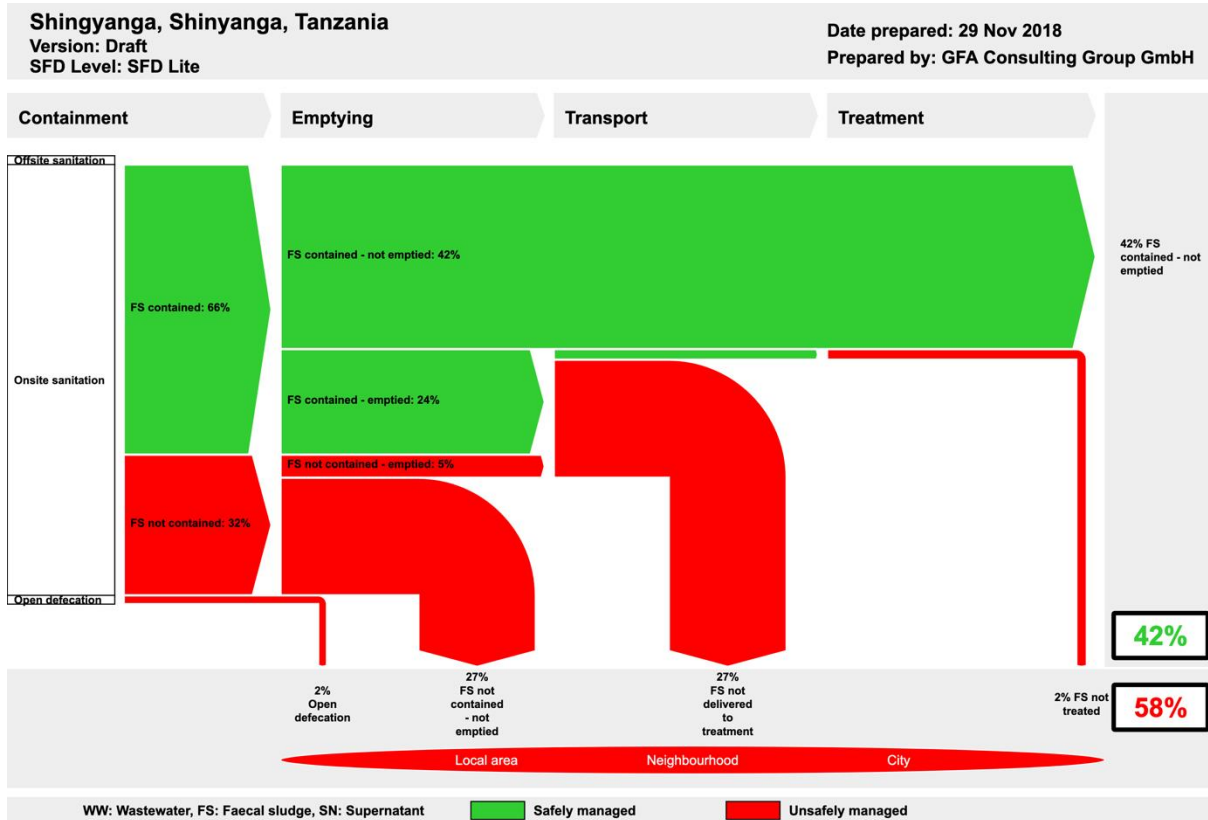
Figure 6: SFD Graphic for Shinyanga

The above-described sanitation chain of Shinyanga is summarised in the following SFD Matrix (Table 2) and SFD Graphic (Figure 6).

The safely managed excreta (42%) originate from FS contained but not emptied from onsite systems located in areas of low groundwater pollution risk. All the safely managed FS is from the practise of covering and digging new pits when the old one gets full, and FS contained in pits and tanks that have not yet been emptied. In the medium- to long- term, these practises are not sustainable and FSM improvements to emptying, transport and treatment services will be required in the future.

The balance (58%) of excreta are unsafely managed. Most of which is from FS not contained and not emptied from unsafe pits (27%), and FS emptied but not delivered to treatment (27%).
