SFD Lite Report

Ng'hong'ohna Mtaa Tanzania

This SFD Lite Report was prepared by GFA Consulting
Group GmbH.

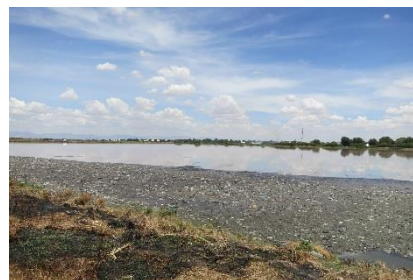
Figure 3 Swaswa WSP

For the small proposition of faecal sludge that is transported to the treatment site, the FS is disposed at the inlet anaerobic pond of the waste stabilization ponds (WSP) at Swaswa area, about 7km north-east of Dodoma city (GFA Consulting Group GmbH, 2018). However, the SWASA WSP was meant to treat wastewater and not sludge. There is a need for dry beds for sludge treatment. In addition, Dodoma City Council allocated a new area for WW Treatment system at Nzughuni with an area of 60 hectares. The design involves the provision of sludge drying beds (GFA Consulting Group GmbH, 2018).

According to our KII, there is 70 to 80% treatment efficiency, but the results of the effluent analysis reveal that it does not comply with the Tanzania Standards (GFA Consulting Group GmbH, 2018)

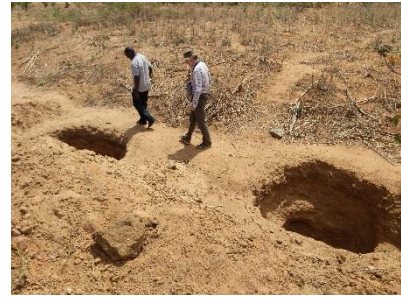
Figure 4 Dug wells during Dry Season

The depth of the groundwater is very shallow between 1.5 and 2 m. during the rainy season and 25 m. during the dry season (FGD-4, 2018). The area has three principal soil types; white sandy soil, red loamy soil, and poorly drained black clay soil called 'mbuga' (Massawe, 2017). The groundwater is mostly found in fractured formation. Despite these fractured aquifers, groundwater is also found in the upper regolith part of the catchment (Massawe, 2017). Studies have shown that for Dodoma City, high values of Nitrate levels and high groundwater pollution risk are also partly linked to pollution from sewage effluents with penetration of the pollution to deep levels in the crystalline aquifer via fractures occur (Massawe, 2017) (British Geological Survey, 2000).

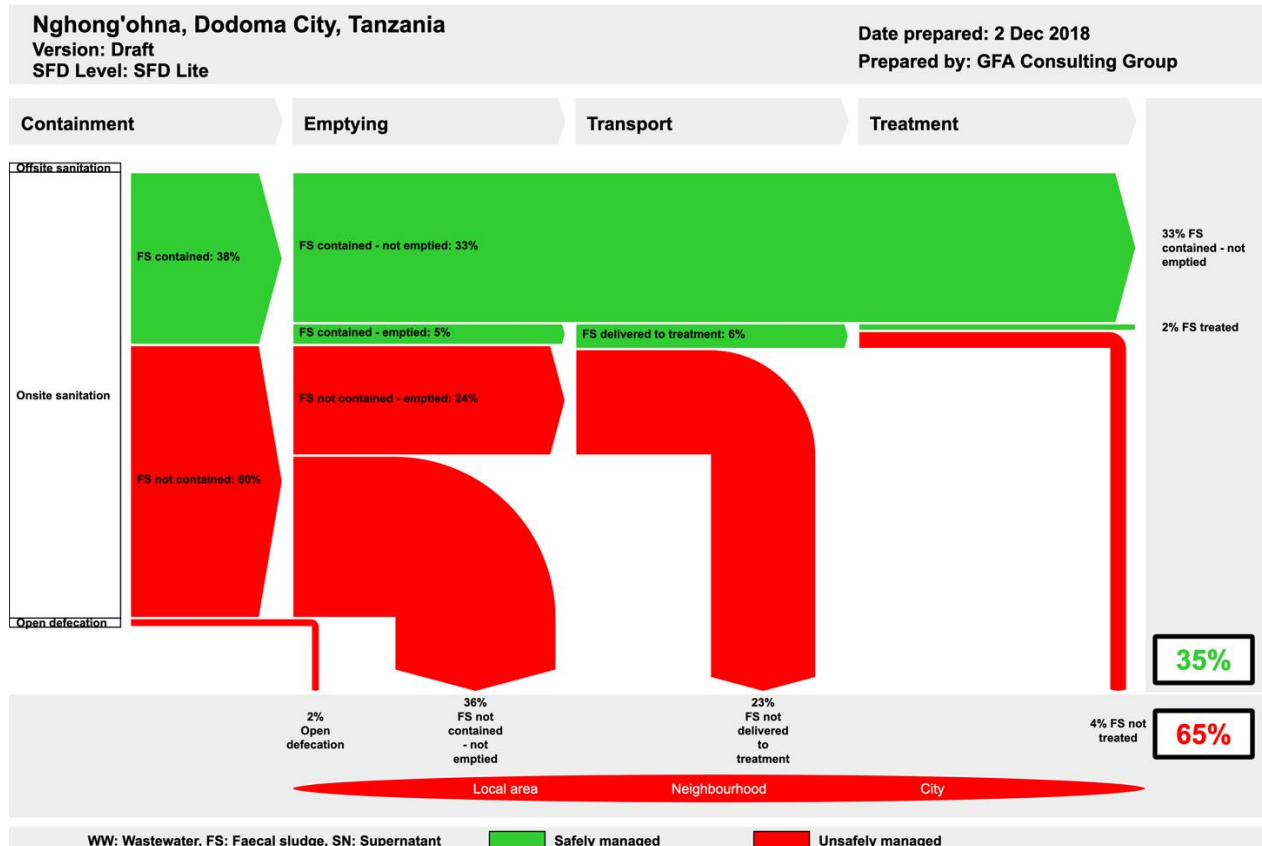
Figure 5: SFD Graphic for Nghong'ohna

The safely managed excreta (35%) originate from FS contained but not emptied from onsite systems located in areas of low groundwater pollution risk. Most of that safely managed FS (22%) is from the practise of covering and digging new pits when the old one gets full. In the medium- to long- term, this practise may not be sustainable and FSM improvements to emptying, transport and treatment services will be required in the future.

The balance (65%) of excreta are unsafely managed. Most of which is from FS not contained and not emptied from unsafe pits (36%), and FS emptied but not delivered to treatment (23%).

The produced SFD graphic shows that 65% of the population from the area produces Faecal Sludge (FS) that is unsafely managed. A large proportion of this 65% comes from pits never emptied and abandoned when full but not adequately covered by soil (T1B8C10) and onsite systems where containment failed, collapsed or flooded (T1B10C10), representing 17% and 36% of that percentage, respectively. The area depends mostly on On-Site Sanitation (OSS) as it is not connected to the

The above-described sanitation chain of Nghong'ohna is summarised in the SFD Graphic (Figure 6).
