SFD Lite Report

Masekelo and Ndala Tanzania

This SFD Lite Report was prepared by GFA Consulting
Group GmbH

Date of production/ last update: 01/02/2019

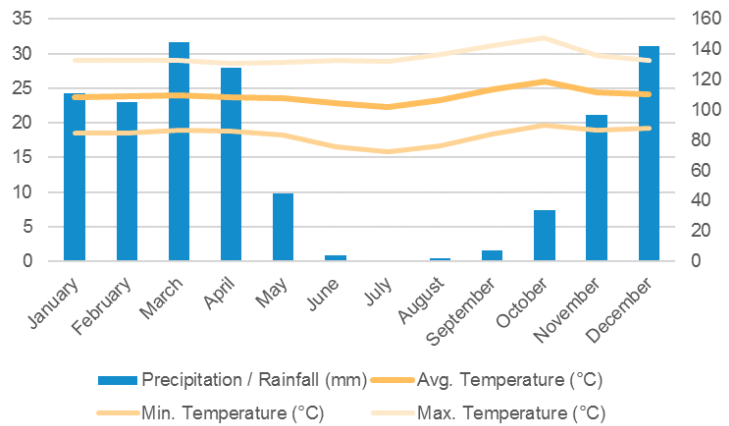
Figure 2: Climate data for Shinyanga

The climatic condition in Shinyanga town is tropical semi-arid with two rainy seasons per year. Short rains fall between mid-October and December, the main rain season is between March and May. The area receives between 800 mm and 900 mm rainfall annually. The dry spell extends from June to early

October. The temperatures range from a minimum of 16°C between June and mid-October, to a maximum of 35°C between January and mid-March. The annual potential evaporation for Shinyanga town area is 2,004 mm while the relative humidity during the day ranges between 61% and 74%. (GFA Consulting Group GmbH 2018) (Climate-data.org 2018).

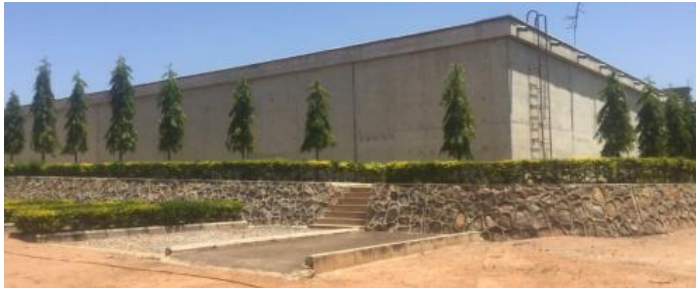
Figure 3: Main drinking water tank, source: Lake Victoria

The Authority purchases treated water from Lake Victoria through Kahama Shinyanga Water Supply and Sanitation Authority (KASHWASA). Water from Lake Victoria Water project is designed to deliver to Shinyanga 28,000 m³/day in 2024. SHUWASA receives its bulk water through Old Shinyanga Tank shown in Figure 3 and is distributed to four elevated towers each with a capacity of 250m³.

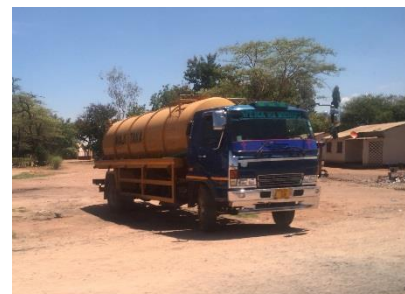
Figure 4: Emptying truck

Both, public and private service providers offer emptying services with vacuum tanks. According to an interview with private pit emptiers, most clients of the vacuum truck emptiers are in the town centre and not in the project area (KII-4 2018).

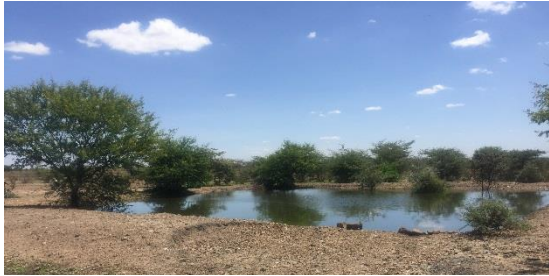
Figure 5: Wastewater dumpsite

The wastewater emptied with vacuum trucks is transported to the official disposal place *Nhelegani* in the Kisumbi Ward. A treatment plant for wastewater or faecal sludge does not exist in Shinyanga.

The disposal place *Nhelegani* is a small pond in the peri-urban area of Shinyanga. There are no houses nearby and the area is not fenced. Infiltration into the ground is slow and, especially in rainy season, the pond overflows (KII-4 2018).

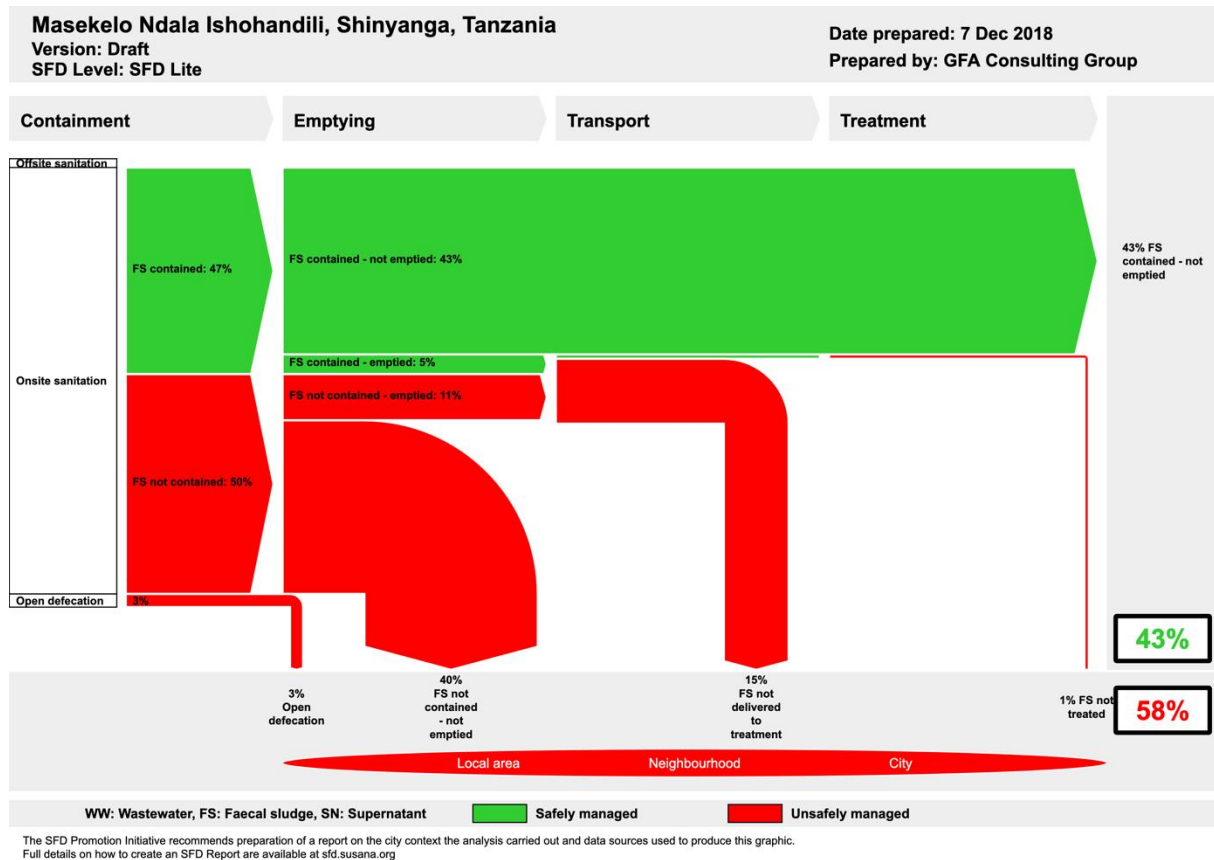
Figure 6: SFD Graphic for Masekelo and Ndala wards

The above-described sanitation chain of Masekelo, Ndala and Ishoshandili is summarised in the following SFD Matrix (Table 4) and SFD Graphic (Figure 6).

The safely managed excreta (43%) originate from FS contained but not emptied from onsite systems located in areas of low groundwater pollution risk. Most of that safely managed FS (35%) is from the practise of covering and digging new pits when the old one gets full. In the medium- to long- term, this practise may not be sustainable and FSM improvements to emptying, transport and treatment services will be required in the future.

The balance (58%) of excreta are unsafely managed. Most of which is from FS not contained and not emptied from unsafe pits (40%), and FS emptied but not delivered to treatment (15%).
