Report on Visit to eThekweni Sanitation Programme 8 April 2004

1. Purpose of Visit

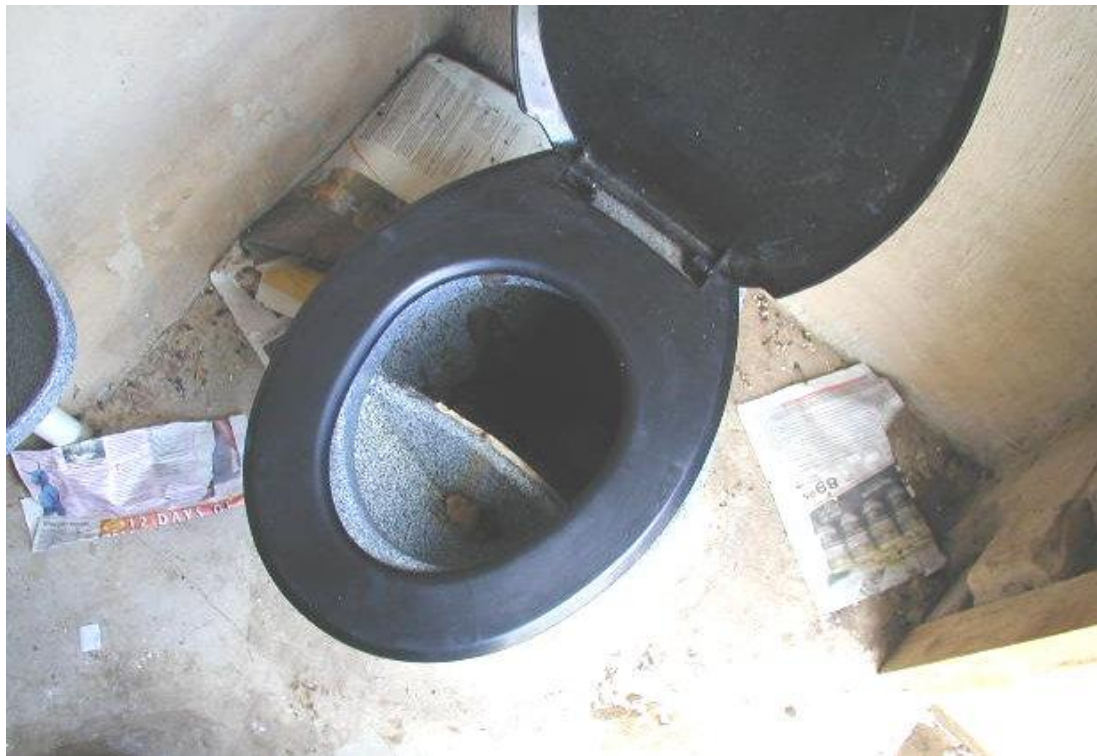
We than visited a 2nd house. This house was constructed from wattle and daub and in a lot poorer condition than the 1st, yet the household was using the toilet. The toilet was not in a good condition there being:

- Paper in the urinal;
- Fouling of the top and insides of the pedestal;
- The chamber appear to be full; and
- The floor of the toilet had not been kept clean.

Figure 2: Poorly maintained UD Toilet (source: Holden, 2004)

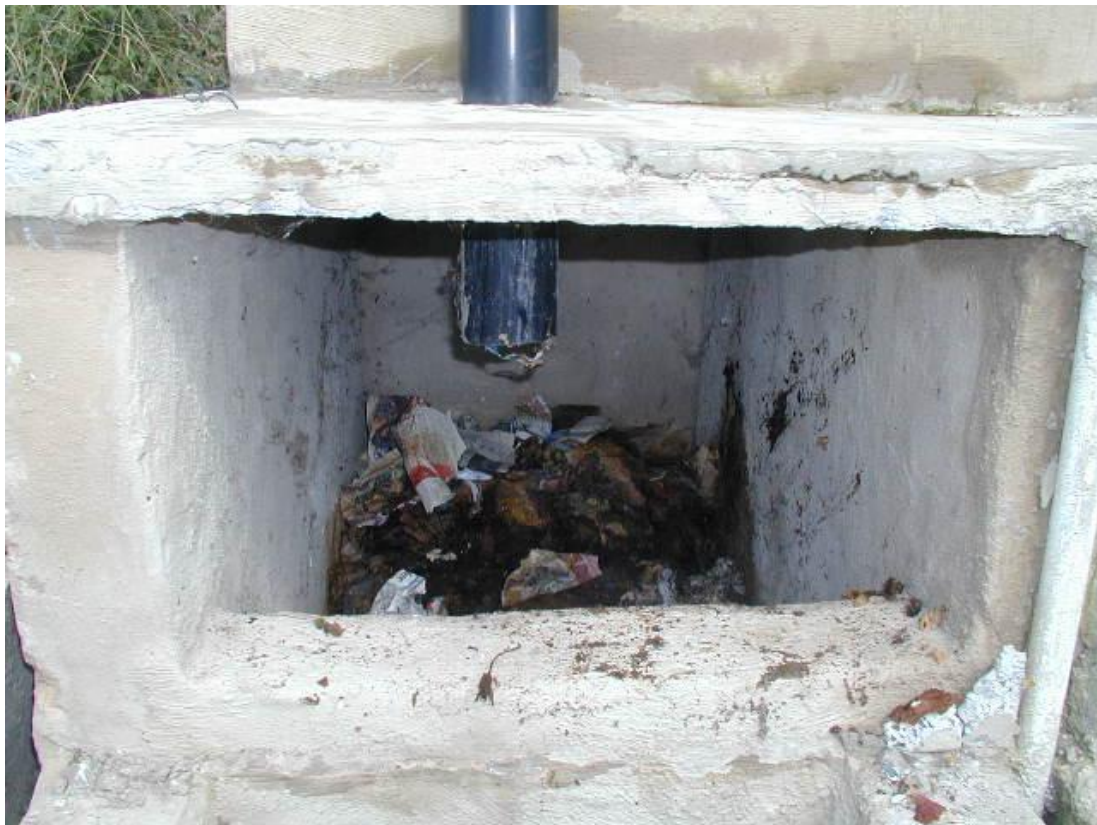
The toilet was then opened and in 20 minutes the contents emptied and buried alongside the toilet. During this process the following was discovered:

1. The back slab had been broken during construction and when breaking the mortar to remove it further breakage occurred;
2. The ventpipe extends 200mm into the chamber. This causes two problems, it reduces the effectiveness of the venting action as any gasses will rise to the top of

- the chamber and the highest vent point is the opening for the pedestal rather than the ventpipe and the ventpipe obstructs the opening when emptying the chamber.

3. Although the chamber appeared full it was in fact quite empty. What had happened was that a pile of toilet paper (newspaper in this case) and faeces had built up directly under the pedestal, whilst the remainder of the chamber was relatively empty.

4. There was no evidence that dry soil had been used in the chamber. The officials with us reported that this is common although buckets and scoops are given to the households they are not found in any of the projects.

5. The top of the pile was very dry and it was possible to set fire to it. However the bottom was very wet meaning that within the chamber 2 different processes were happening. Desiccation at the top and anaerobic digestion at the bottom. There was, however, very little smell so the water causing the digestion was probably not from urine but from rainwater entering through the ventpipe.

6. It was difficult to empty the chamber. The back ramp was too steep, the ventpipe got in the way and one had to be careful to avoid raking the contents onto your shoes. It was also very difficult to reach the front of the chamber.

7. The chamber contained plastic bags, bottles and disposable nappies. These, however caused no problems in emptying in contrast to the problems they cause in VIPs.

Figure 3: Chamber opened for emptying, ventpipe can be seen clearly (source: Holden, 2004)

If desiccation is the desired result then there is no need for the ventpipe. The ventpipe is required when decomposition occurs in the toilet and smell is generated. If desiccation is occurring then no smell will be generated thus removing the need for the ventpipe and a potential entry point for water. However if the ventpipe is removed it must be ensured that the contents stay dry.

By moving to a single chamber, with a permanently fixed pedestal and no ventpipe, 3 possible sources of moisture entering the chamber are eliminated. To eliminate the next point of water entry, the back slab, requires a total redesign. Neville Slee was reporting that water still enters in the new design and it is still a concrete slab, which is difficult to move. This must be a lightweight lid, which anyone can lift on their own, with a raised lip to prevent water entering. Once the lid can be removed and replaced with minimum effort, and without water entering the chamber, householders will become far more willing to open and empty the toilet.

1. Use only a single chamber with desiccation in the chamber, removing the contents on a regular basis for them to be composted. The savings on the second chamber can be used to construct a above ground composter;
2. Remove the ventpipe (as this is no longer required), permanently fix the pedestal to the floor and seal to prevent water entering and affecting the desiccating process;
3. Totally redesign the back opening so that it prevents water entering and the lid is light enough to handle;
4. Redesign the chamber so that it is watertight or use a container so that moisture from the surrounding soil cannot reach the faeces; and
5. Allow for and inside toilet.

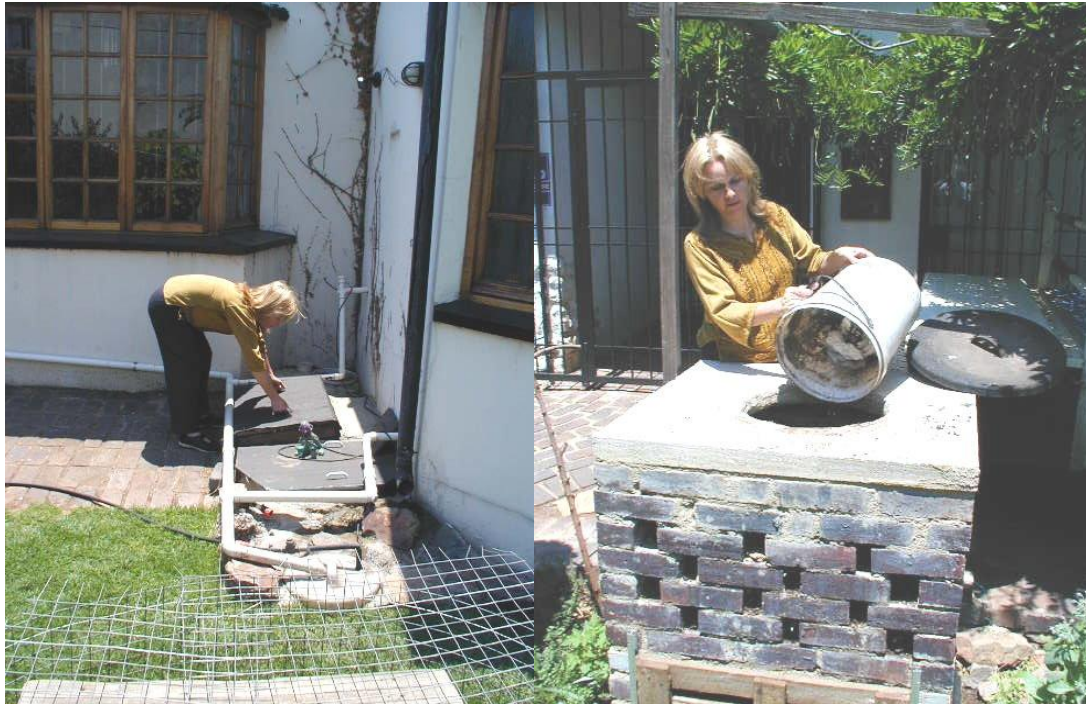
Figure 4: (left) Removing lightweight pit cover, (right) emptying the container into a composter, Johannesburg (source: Holden, 2004)
