EXPERIENCES IN SETTING UP ECOSAN TOILETS IN SHORELINE SETTLEMENTS IN UGANDA.

Abstract

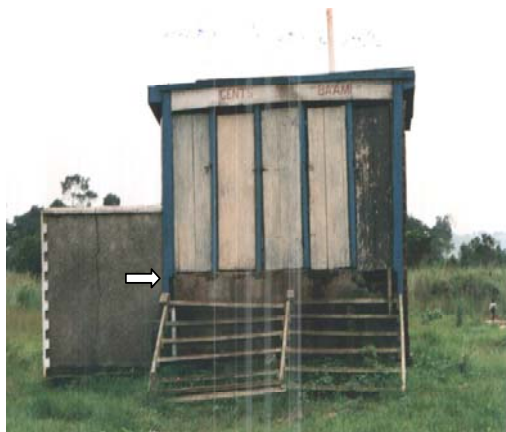
Figure 2: The old disused VIP toilet (note the raised structure due to ground water table)

In Ddimo with a population of over 2500 people, handling 8 tonnes of fish and 120 boats landing daily we could find only 25 pit latrines a ratio of 1 toilet per 100 capita (Mott MacDonald, 2001). In addition, sand soils, sloping terrain and high table made construction of the VIP toilets very costly and with no guarantee for no collapse (Fig. 2). The quest to overcome the above constraints and look forward to achieving better and proper sanitation conditions at the fishing village level drove NWSC and its partners to devise strategies to avert the poor sanitation

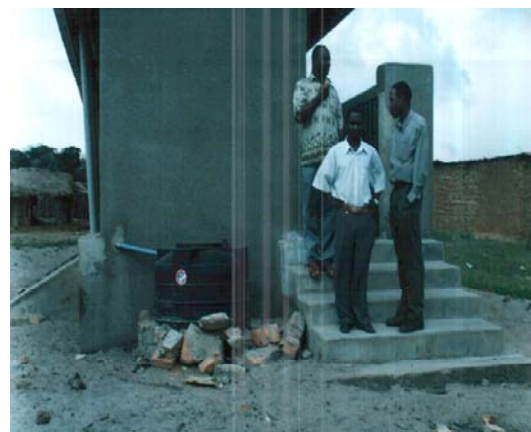
Figure 3: The newly built Ecosan toilet for the shoreline fisher village in Dimo Rakai District, Uganda. In the fore is the urine container.

In each village, the local authorities provided land on which the toilets were built. Each block of toilets had 4 stances, 1 urinal and 1 shower room. Figure 3 show one of the completed blocks in Ddimo. The cost of construction the two units blocks was US\$ 15,000, that is US\$ 6 per person in Ddimo. In each village, a micro project committee was set up that comprised of 6 people including a representative of the women. This group then administered the account. A contractor was employed who carried out the design, preparation of bills of quantities (BOQ) and supervision of the works. The community contributed 10 % of the total cost. Construction of the toilets took 15 weeks, being slowed down by scarcity of some materials particularly cement availability which had to be got 32 Km away in the case of Ddimo and for Musonzi an island it took 2 hrs on water from the mainland. The toilets were then commissioned within a month of completion. To sustain the system a monthly fee of US\$ 0.6 per family or US\$ 0.06 per person per use/visit was fixed. Wood ash was to be used every after each defecation; to absorb moisture making it less attractive to flies, and to reduce odour. The use of human waste as a valuable by-product was another positive aspect of this technology that was considered useful to the community.
