# **Ecosan: An unsuccessful sanitation scheme at a rural school: Lessons learned from the project failure**

**Aussie Austin** CSIR Building & Construction Technology  
P O Box 395  
Pretoria  
0001 South Africa  
Laustin@csir.co.za

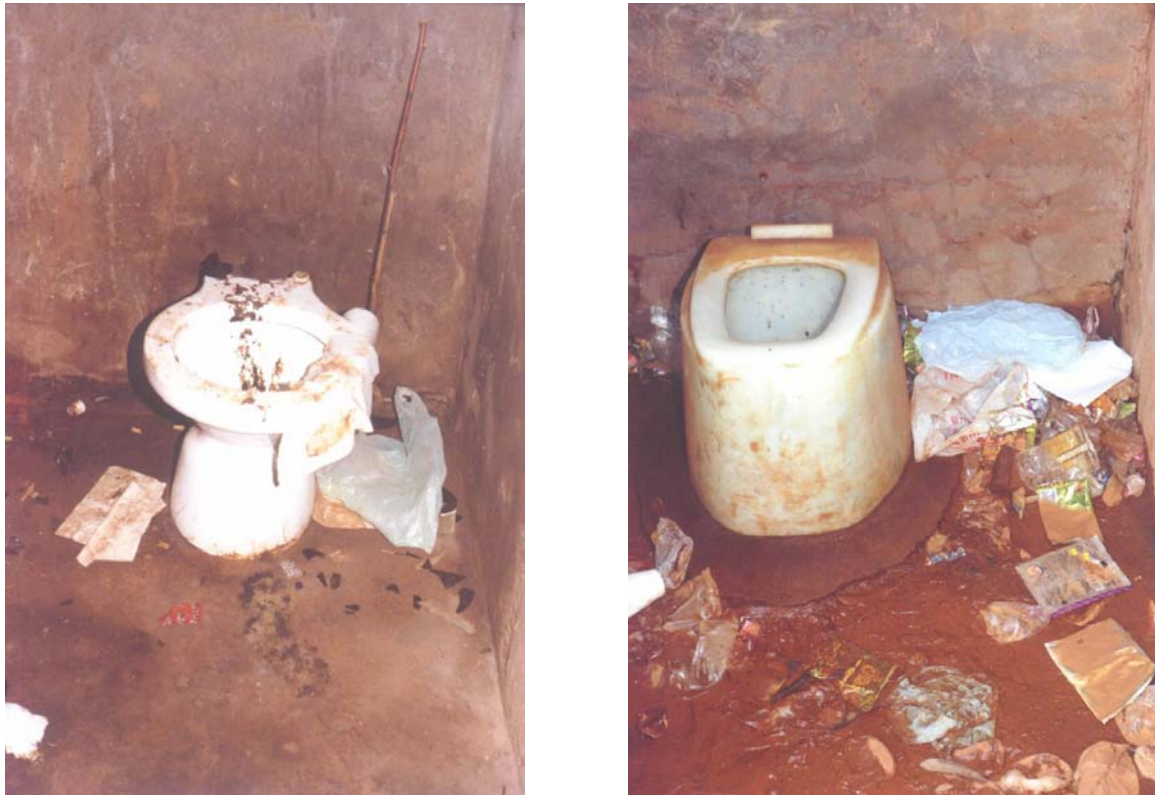
Emzamweni High School is a rural educational institution situated within the municipal boundary of Msunduzi, in KwaZulu-Natal province, South Africa. It is located in a scenic area and serves a number of low-income communities in the surrounding district. In the majority of schools populated by Blacks, sanitation had been badly neglected by the previous authorities, and while the present government has committed itself to improving school sanitation, it is struggling to catch up with the backlog of inadequate amenities. Emzamweni's "toilets" consisted of dilapidated, smelly and unhygienic ordinary pit latrines, with no handwashing facilities. They were also in a filthy condition, due partly to vandalism, but mostly because of a lack of proper care and maintenance (Figure 1). The latter problem was largely the result of the teachers' poor attitude – they had the use of flushing toilets connected to a septic tank, as well as proper washbasins with running water, and were either completely unaware of the pupils' plight or did not care. The school janitor obviously also avoided cleaning the pupils' toilets, because the floor was never even swept. The result of this neglect was that female pupils did not make use of the facilities, preferring to wait until they returned home, while male pupils simply relieved themselves behind the nearest convenient tree or against the wall. Interestingly, the teachers' toilets were also neither clean nor properly maintained.

**Figure 1:** The existing school latrines

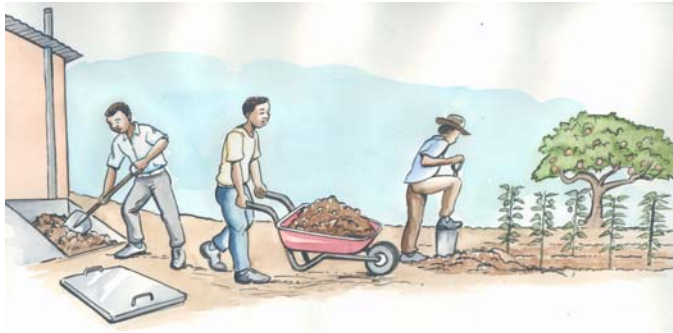
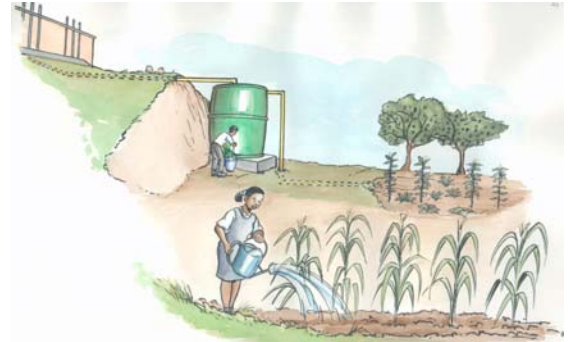
**Figure 4:** Examples of ecosan posters

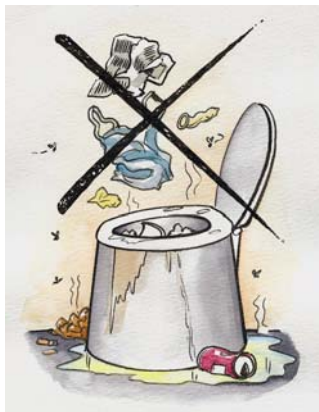
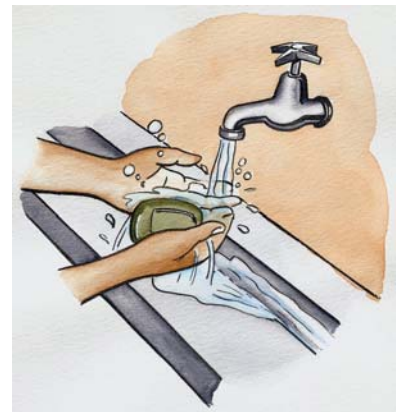
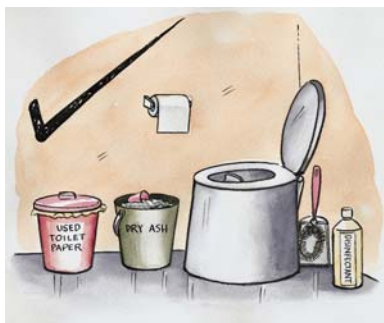
**Figure 5:** Examples of illustrations in teaching aid booklet

The booklets contained a written and pictorial description of urine diversion sanitation, as well as information on basic health and hygiene, water- and excreta-related diseases, operation and maintenance of the toilets, and re-use of urine and dehydrated faeces. Figure 5 shows some of the illustrations contained in the booklets.

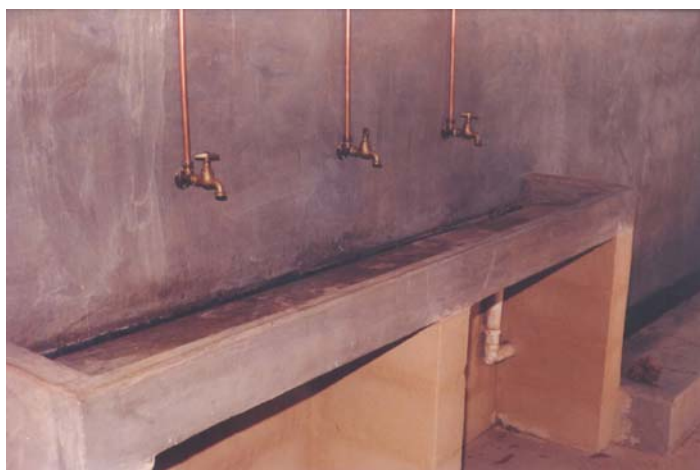
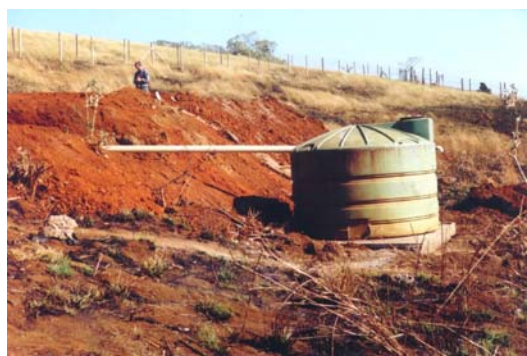
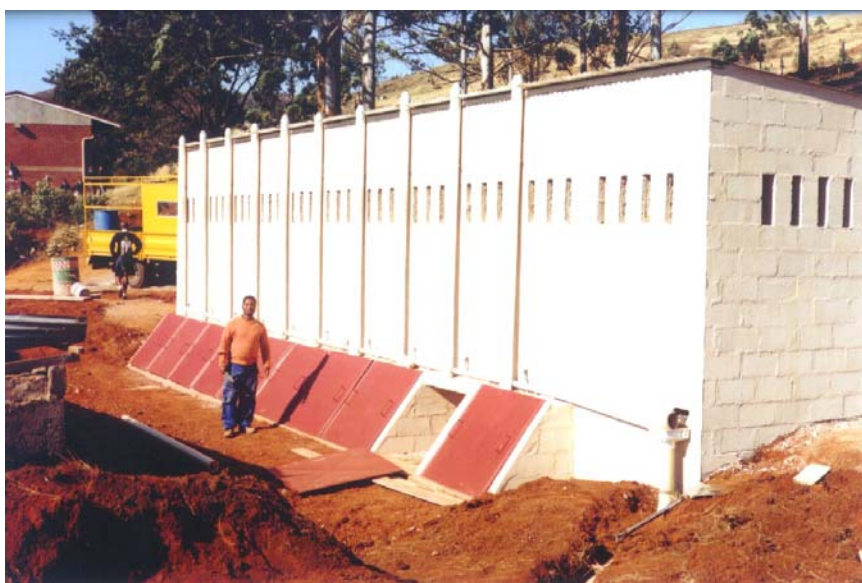
Meanwhile, construction of the toilet block had begun. The pupil numbers dictated that, for the first phase construction decided upon, 6 toilet pedestals for girls and 4 for boys were required. The boys would also be supplied with a urinal. The faeces vaults were designed to be easily accessible, while the urinal was flushed by wastewater from the handwashing trough. All urine was collected in a single pipe and led to a storage tank, where it would be available for agricultural use if desired. Figure 6 illustrates these aspects, while Figure 7 shows the relevant design details.

**Figure 6:** Construction details: left, handwashing trough and part of urinal; right, urine tank; below, nearly completed structure showing vaults

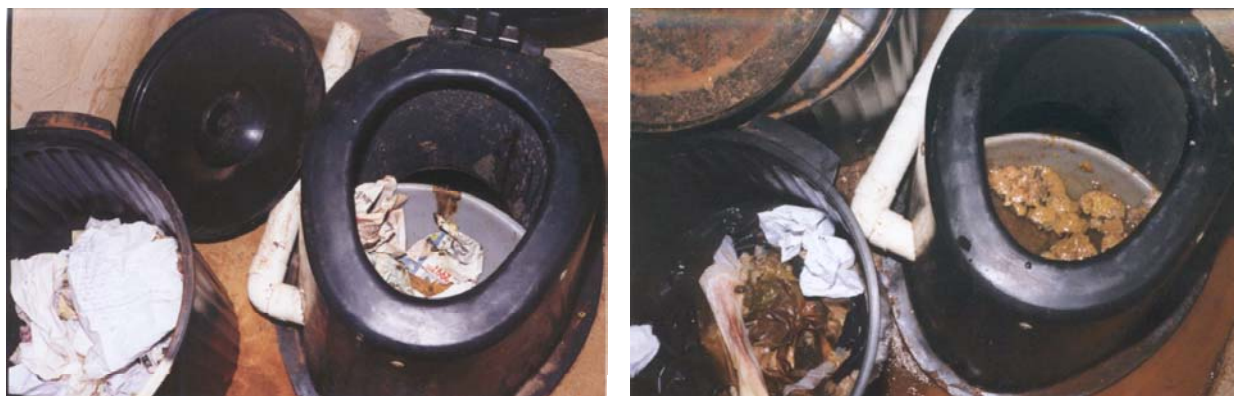
While the teachers made an initial attempt to explain the technology to the pupils, it very soon became obvious that they were not committed to the task. During a visit made a few weeks after the toilets were put into use, it was found that pupils had been defecating in the urine bowls of the pedestals and throwing anal cleansing material into the vault instead of into the plastic containers provided. Some of the urine outlet pipes were blocked as a result of the misuse, and the toilets were malodorous. It was also discovered that the principal was not aware of the problems. On being informed, however, he castigated the toilet manager who subsequently arranged for the facilities to be cleaned up.

A further visit was undertaken approximately seven months later, in February 2003. This occurred about six weeks into the new school year, and was unannounced. A foul odour, similar to that found in the school's old pit latrines, was detected from outside the toilet block already. An inspection revealed that the toilets had again been misused very badly, with nearly all the urine bowls being blocked with faeces and rubbish, the plastic containers intended for used cleaning material filled with urine, the handwashing troughs littered with cigarette butts, and the faeces vaults containing paper and rubbish but very little ash. The facility had also been vandalised, with the educational posters having been torn off the walls and some fittings broken. When the principal was approached concerning the matter, it was again evident that he was not aware of the problems. In fact, his only comment was that there were not enough toilets for the whole school, that any problems that may have arisen were due to congestion, and that the second phase facility should be built. The teacher who had been appointed manager of the facility also claimed that cleaning had been carried out on a regular basis, but this was obviously not the case. Figure 8 shows some results of the misuse.

**Figure 8:** Some graphic examples of toilet misuse

- There has generally been much success in the domestic sanitation scene with the implementation of urine diversion toilets, for reasons already mentioned (ownership, etc). It is probably advisable, therefore, to ensure implementation in the school's feeder community before attempting to install these toilets at the school itself. In this way, pupils will be fully conversant with the technology and will understand the operational issues without needing any training by the teachers, who are in any case unwilling to do it.

- Unless the education authorities make it compulsory for the teachers to ensure proper training for the pupils, it is unlikely that they will have any incentive to do so. The education and health departments should enforce proper care and maintenance, to be carried out by the schools themselves, by means of regular visits by inspectors and sanctioning for non-compliance. This could be linked to incentives such as more or better educational aids.

- Both teachers and pupils should have the same type of toilets, so that teachers and pupils can share the same experiences.
- The problem of ownership will always occur when something is given for nothing. Every school, no matter how poor, should contribute **something** towards new sanitation facilities in order to obtain some sort of commitment to proper care.
