PILOTING AND TESTING THE POUR FLUSH LATRINE TECHNOLOGY FOR ITS APPLICABILITY IN SOUTH AFRICA

Report to the
Water Research Commission

WRC Report No. 1887/1/12
ISBN 978-1-4312- 0289-8

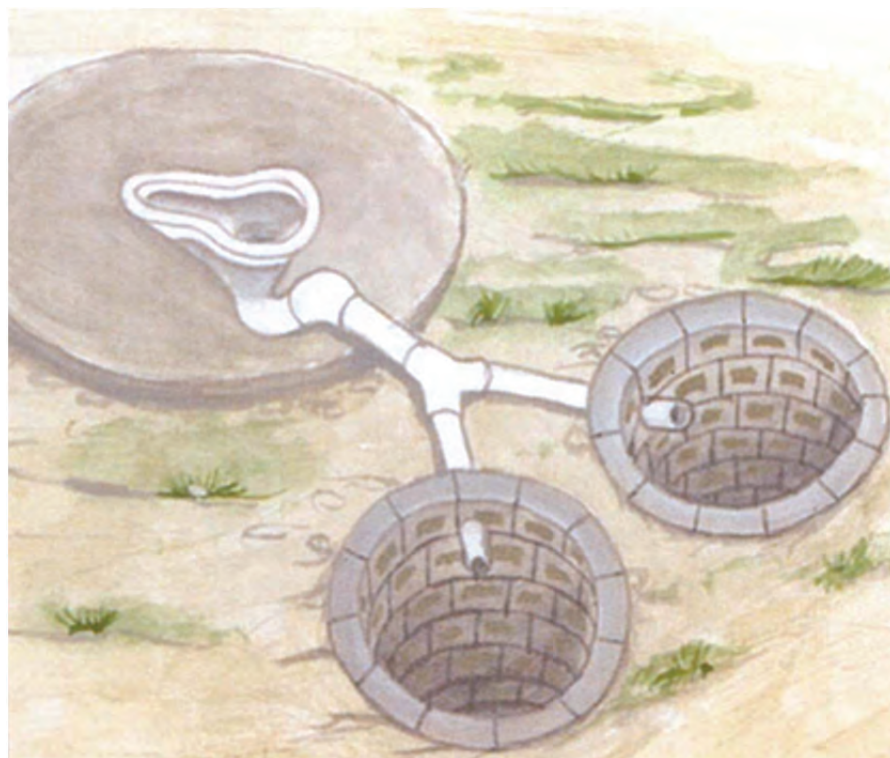
Figure 2.3 Twin pit pour flush design (Obika, 2004)

A twin pit pour flush latrine is an offset design which incorporates a junction box close to the outlet from the pedestal. A Y configuration allows one pit to be blocked off while the other is used. The advantage of using two pits is that the volume of the sludge in the pit that is not in use will reduce through degradation and drainage. When the contents are removed, the volume of the sludge will be less. Using two pits could allow for a smaller pit size which then facilitates easier emptying. Twin pits should be sealed off from each other or separated by an adequate distance to prevent cross

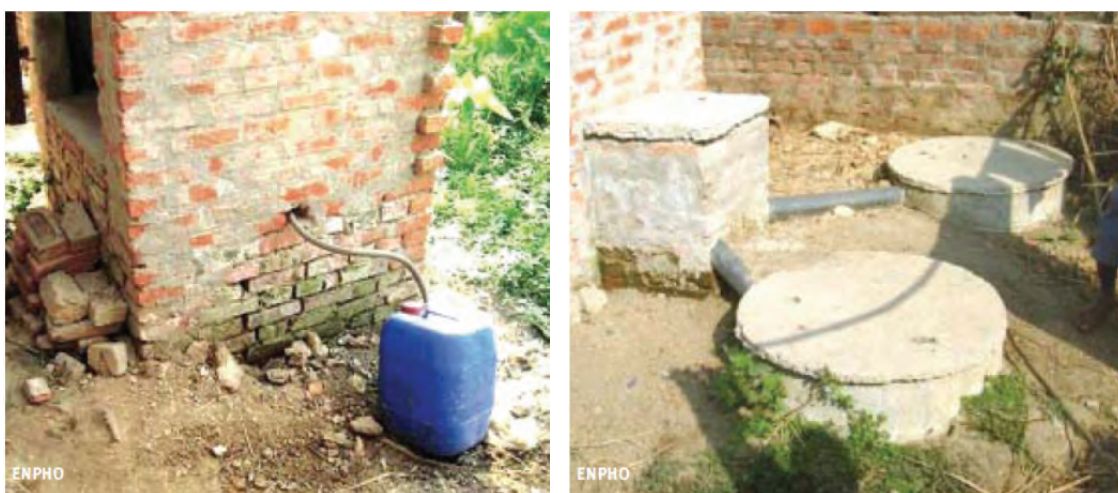
Figure 2.10 Wet Ecosan system in Parsa, Nepal (ENHPO in WaterAid, 2008)

In 2002, WaterAid introduced a urine diverting pour flush toilet, called the Wet Ecosan, to Nepal (WaterAid, 2008). Water used for anal cleansing and flushing enters the pan and passes through a 110 mm pipe to twin pits. Urine is collected in 20-30 litre plastic containers. While users were initially resistant to the idea of using excreta for agriculture, the use of urine was accepted and has resulted in enhanced growth of vegetables grown in soil to which it was applied. The Wet Ecosan systems cost approximately 16 500NPR (ZAR 1 600).

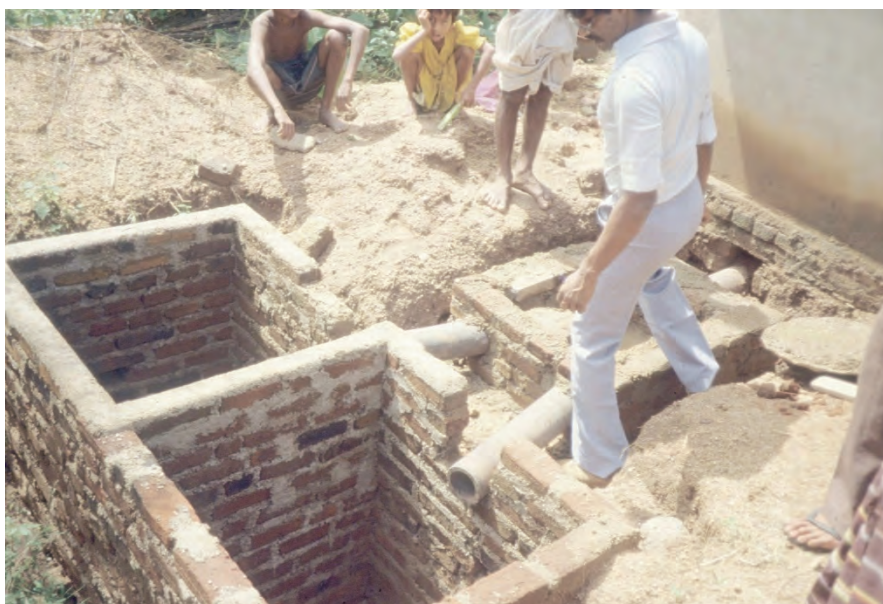
Figure 2.11 Double pit pour flush latrine construction in Sri Lanka (Rebecca Scott, WEDC)

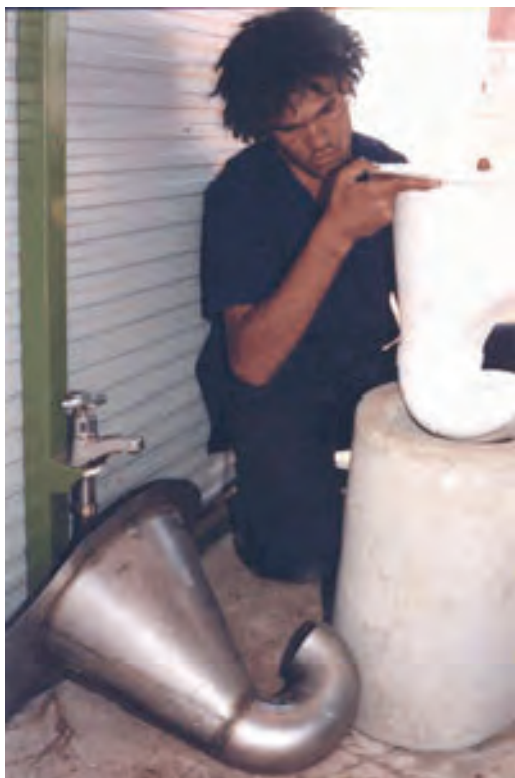
Figure 2.12 Australian pour flush pedestal (RADG, 2003)

Pour flush latrines with pedestals have been developed successfully in the Caribbean, where toilet tissue is used for anal cleansing (Scott, 2005). In Australia, pour flush latrines are used for indigenous settlements in remote areas (Anda et al, 2001). These are built with a septic tank directly underneath the pedestal and a reversed (forward facing) U bend.

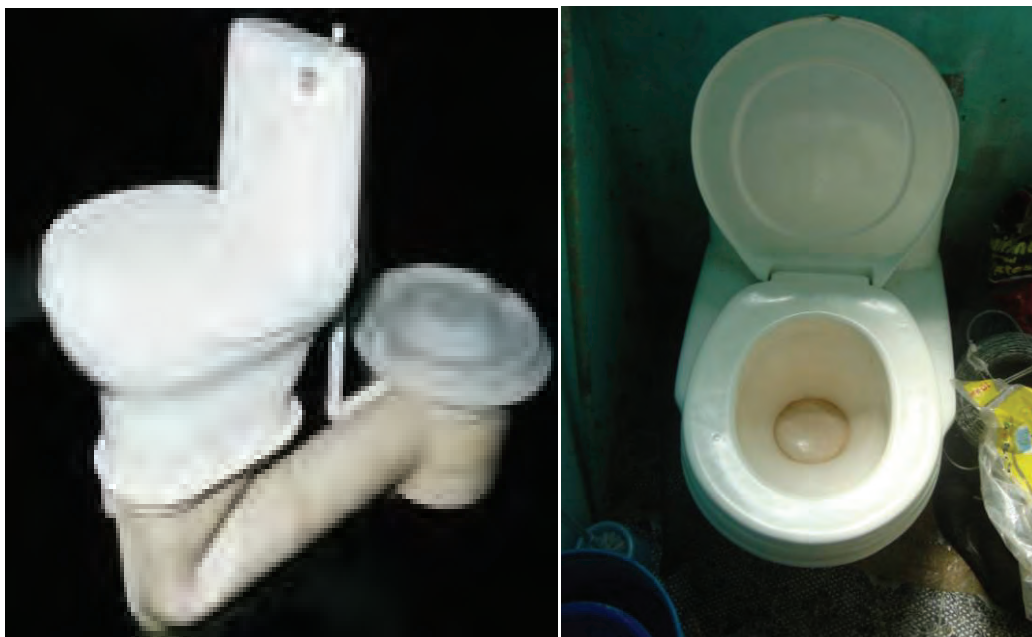
Figure 2.15 Hungerford Schroeder toilet

The HS system has a 13 litre cistern which dispenses 1 litre of water around the edge of the pan when flushed. In the original HS design, the one litre of water plus excreta sitting on the tipping tray in the bottom of the pan is then tipped into the liquefying tank below the toilet, displacing 1 litre of the tank's contents through a pipe into a small drum which contains a strainer to catch foreign matter, from which it is displaced into a soak pit. The designer believed that after being liquefied in the liquefier the sludge could be completely digested in the soak pit, resulting in no sludge build up.

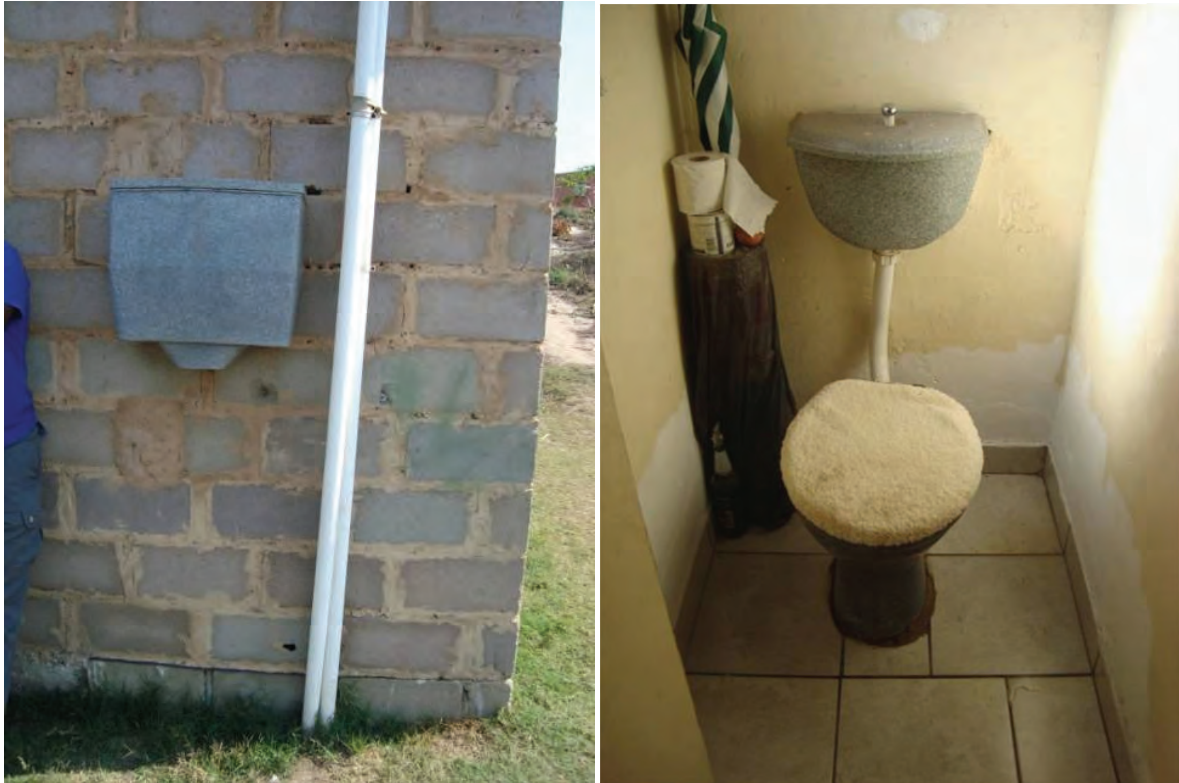
Figure 2.17 DSA reserve tank, cistern and pedestal

A 36 litre reserve water tank is installed on the outside wall of the toilet which can then be filled from the closest water source. This supplies the cistern inside which holds 9 litres, allowing 45 flushes before the system must be refilled. A pull knob dispenses 1 litre of water from the cistern around the pan. Contents are washed down a 110 mm long radius bend pipe out of the house into a 30 litre liquefier tank. A 50 mm pipe vents the toilet from just above the water seal on the toilet side of the liquefier tank. The role of the liquefier is to break down excreta and toilet paper into a homogenous liquid and promote the start of digestion. Each new flush displaces 1 litre from the bottom of the tank through the 110 mm pipe to the soak pit. The 1100 mm wide by 1900 mm long by 500 mm deep soak pit is designed to allow the sludge to interact with aerobic bacteria in the aerated layers of the soil with the intention that waste will be consumed in a short space of time resulting in no build-up of sludge (E. Bezuidenhout., pers. comm., 2010). The openings to the liquefier are to be sealed with silicone and the liquefier lid should be covered with soil. A smaller round cover is fitted within the concrete soak pit cover to give householders access to the pit if needed.

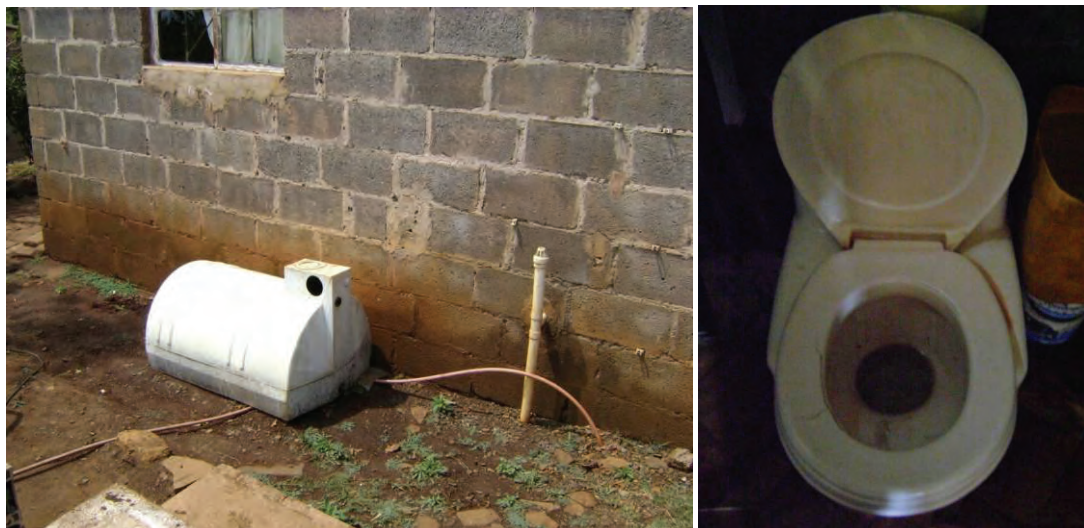
Figure 3.1 Water tank that has been removed (left) and pan with tipping tray missing (right)

Problems which caused the greatest distress were often with the tipping tray. Some of these had broken off or stopped working, with the result that there was no seal between the user and the pit. As a result, offensive smells, and sometimes worms, were found to come up from the pit into the pan. Cisterns had frequently begun to leak or flushers stopped working, with the result that the user had to pour water either into the cistern or pan to flush. Several families had removed their cisterns due to problems with insects. Thirteen percent of those without a working flush reported that they need to flush 2 or 3 times; while those whose cistern didn't work typically used a 5 litre bucket of water to flush, with a few reporting that they had used 2 or more buckets of water to flush. Blocked pipes and full or overflowing soak pits

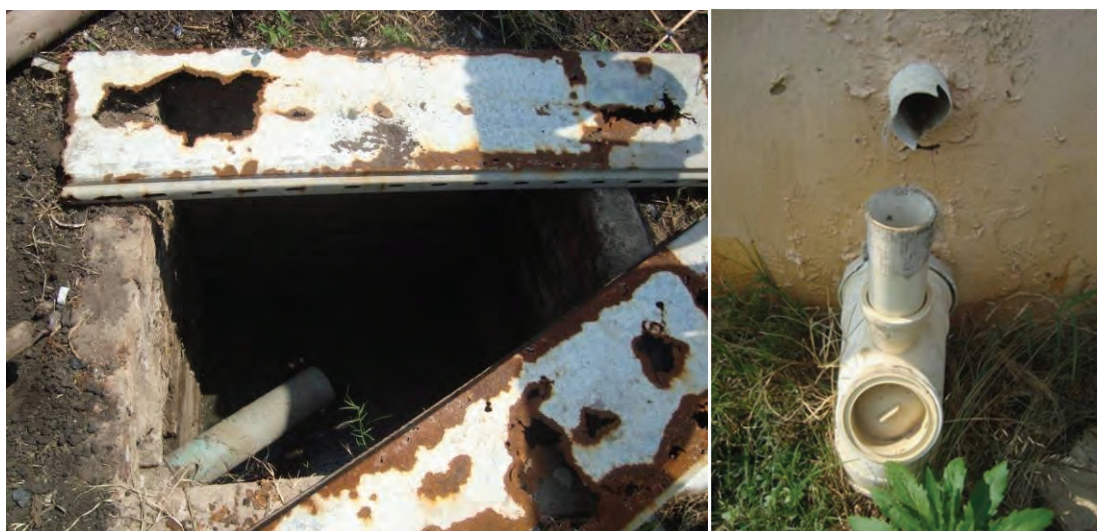
Figure 3.2 Exposed soakaway and broken pipes

Users noted similar problems with tipping trays breaking off or not working, worms coming up the system, and flushers not working or the amount of flush water being inadequate.

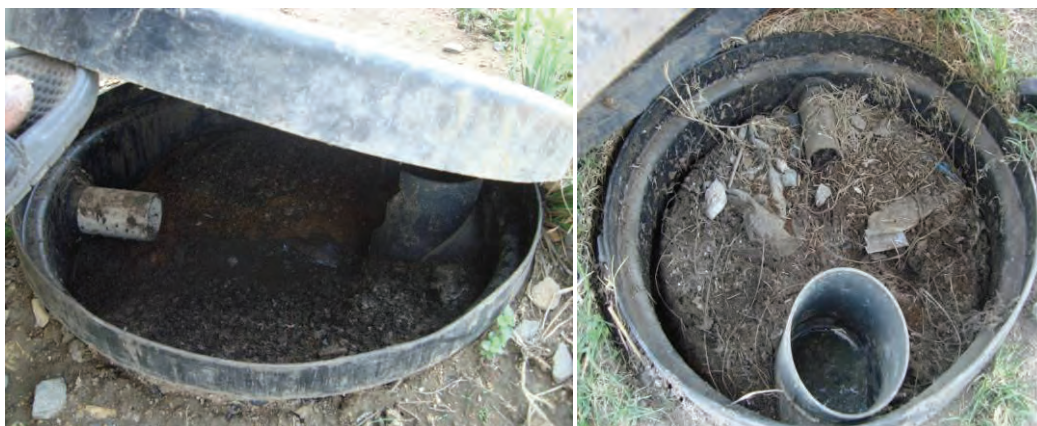
Figure 3.3 DSA liquefier tanks in Ifafa Grebe that were not properly sealed and covered with earth during installation

Some of the problems with systems reported by users related to improper installation at the beginning of the project by contractors. While 58% of respondents indicated that their liquefiers are not working, none of the systems had actually stopped functioning, indicating that excreta was still able to move from the pedestal to the pit, even if the system was not functioning optimally. Some of the liquefiers had never been sealed and buried properly by contractors during installation; in these cases evaporation would have been much greater than intended. Although the sludge was dry and crusted at the top in the liquefier, the system continued to function, indicating that wetter conditions must be maintained underneath. A third of reserve tanks were reported not working but no particular design flaw was apparent or reported. Because they are mounted on the outside of the house perhaps they are more vulnerable to the elements or to children tampering with them/placing objects in them or being vandalized. As 50% indicated that they use greywater for flushing, it is possible that as components in the greywater degrade over several days they cause build up in the tank which eventually results in blockages. If the 35 litre reserve tank is not functional, users can flush by filling the cistern directly or by pouring water into the pan with a bucket.

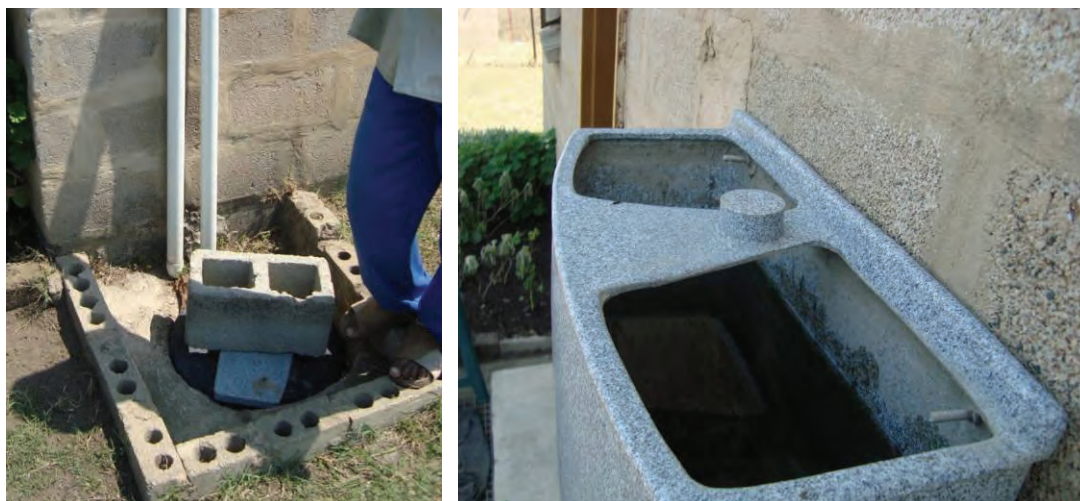
Figure 3.4 Householder has used the lid from a reserve tank (left) to seal a liquefier tank which has not been properly sealed and covered (right).

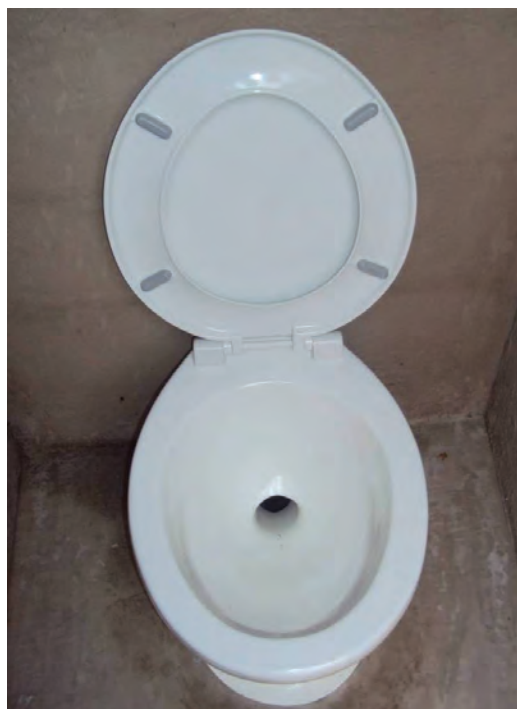
Figure 4.1 The pour flush pedestal prototype. The pan funnels steeply to a 70 mm diameter outlet, which is angled at 45° to the horizontal.

A pedestal was designed and a prototype manufactured from fibreglass. Externally, the pedestal looks similar to a standard flush pedestal. Internally, the pedestal does not have the bowl associated with full flush toilets, but is more funnel shaped. The front of the funnel slopes at 55° to 45°, while the back is near vertical. The funnel converges on a 70 mm diameter pipe which is angled 48° from the horizontal. This connects to a water trap made from 63 mm PVC pipe fittings. The key differences between this design and Sulabh's pedestal, apart from being designed for sitting rather than squatting, is the greater angle of the front slope of the pan (25 to 28° for the Asian pan and 55° to 45° for this pan), and the angle of the pipe exiting the pan (with the Asian units the pipe leaves vertically, whereas with this unit it leaves at approximately 45°). The changes in these slopes are driven partly by the change from a squat pan to a seat, and partly by the desire to facilitate the clearing of blockages from the S bend.

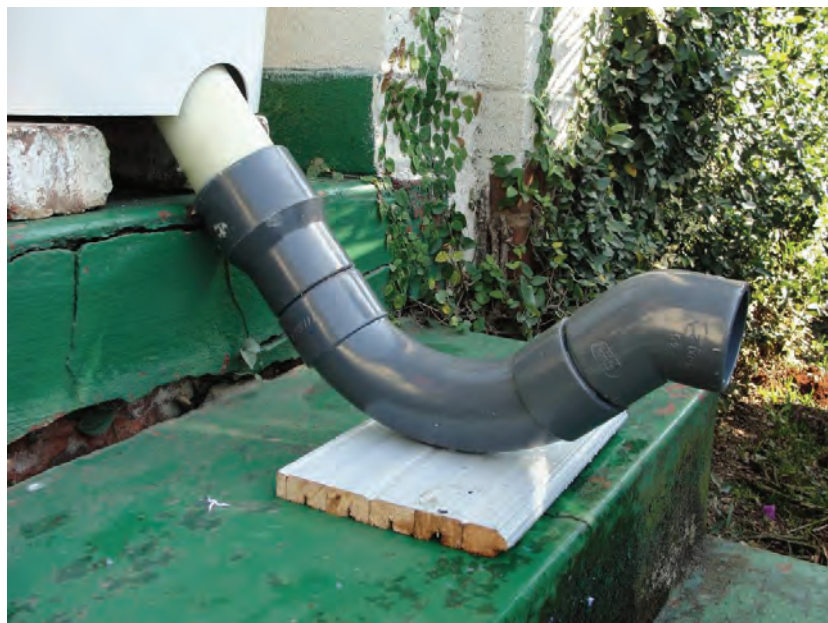
Figure 4.2 The water seal is made up using three standard 65 mm diameter PVC pipe fittings – a reducer, a long radius 90° bend, and a 45° bend

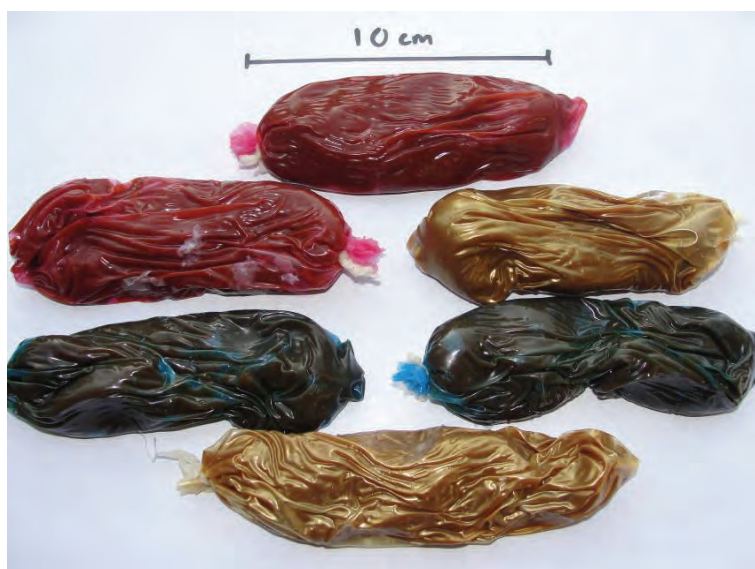
Figure 4.3 The test samples made up according to the method prescribed by the MaP test protocol. Each sample contains 50 grams of soy paste, and is contained in a latex sheath.

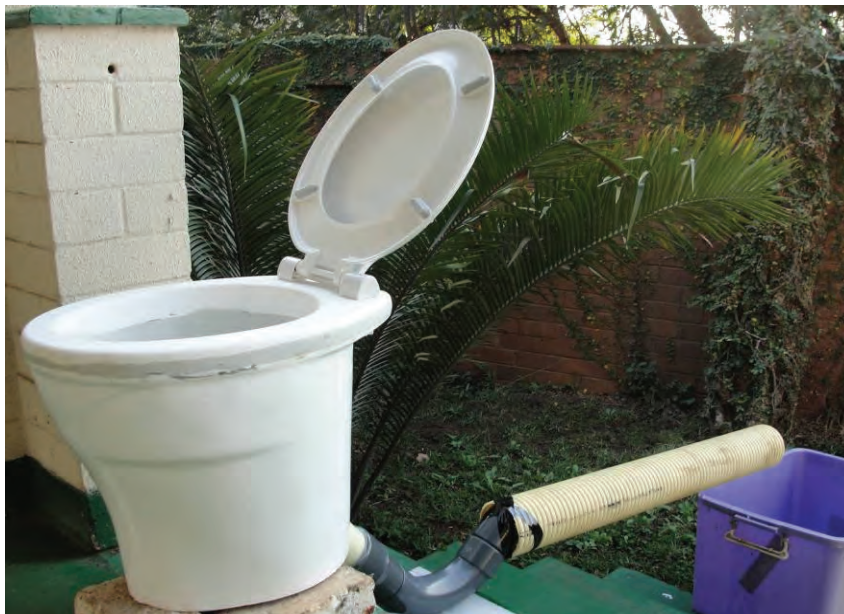
Figure 4.4 The test set-up. For each flush test up to six 50 g replica faecal samples were placed in the pan with a prescribed amount of toilet paper (20 squares of single ply).

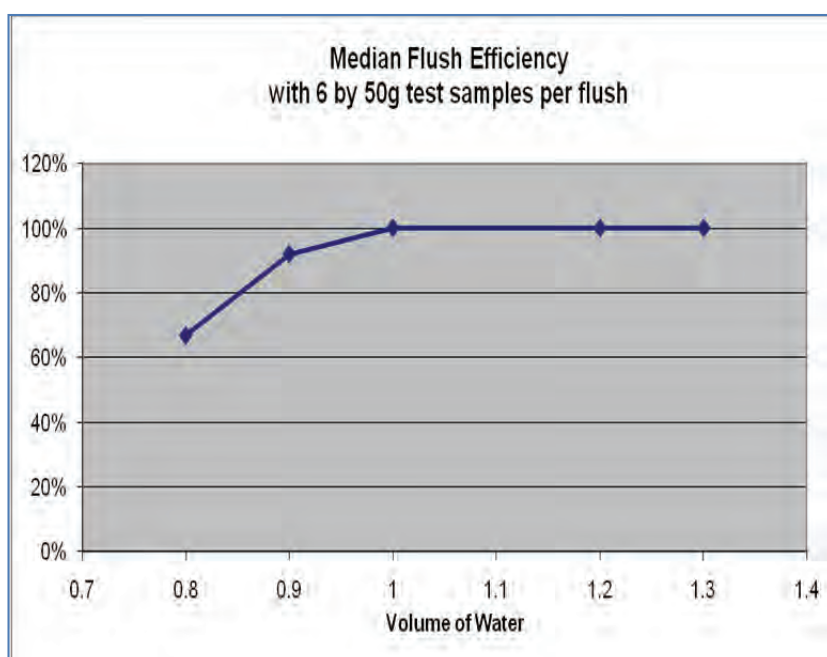
Figure 4.5 Results for the 6 by 50 g flush tests. A 1.0 litre flush was found to be sufficient to clear the pan.

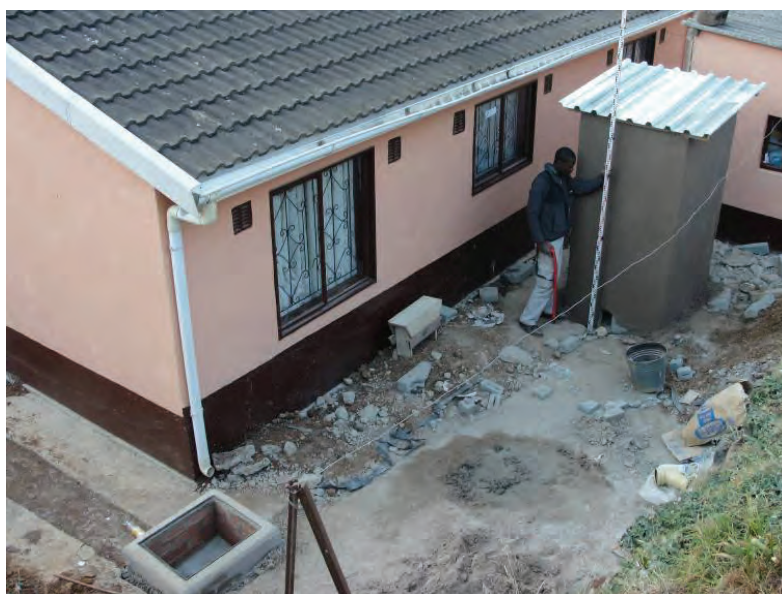
At Household 1 a VIP toilet, which was still in fair condition, was used by the family of four adults. The homeowner elected to have an outdoor structure built for the pour flush toilet rather than installing it indoors. A location was identified behind the house near the back door for the pour flush. Because the house is situated on a deep cut where the permeability of the soil is low, it was necessary to identify a site in front of the house (down slope) for the construction of the twin soak pits. This required a 16 metre long sewer with a manhole at the 90° bend around the corner of the house, and a splitter box to enable the flow to be switched between the two soak pits. Partly due to the topography of the site (and partly due to the inexperience of the construction crew) this sewer was laid at flat grades (1% for the first section, 2% for the second section, and 3% for the final section).⁴

Figure 4.6 (left) Structure built behind house; first manhole in left corner

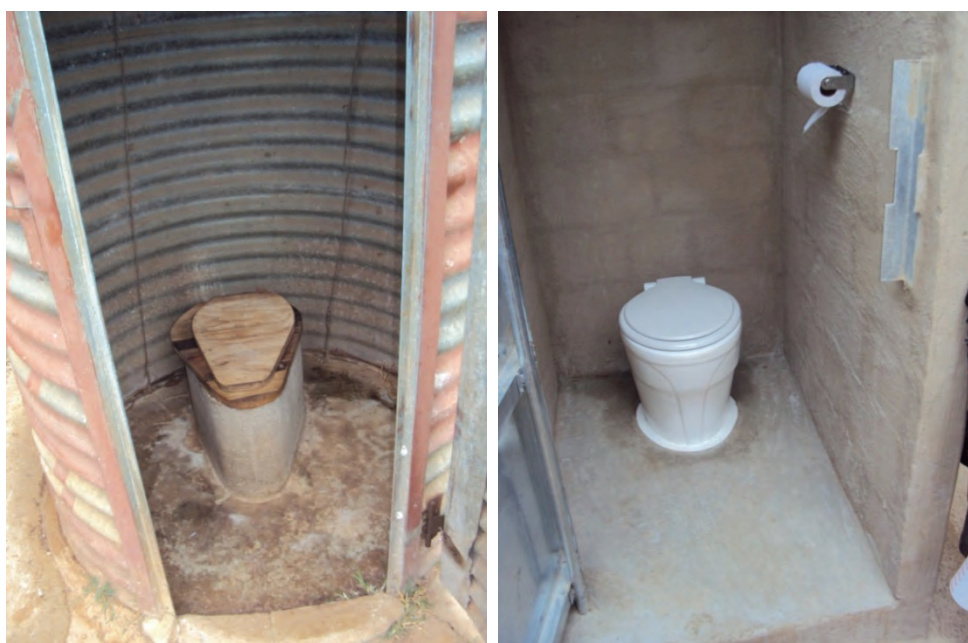
Figure 4.7 (below) Existing VIP (left) and new pour flush in structure (right) at Household 1

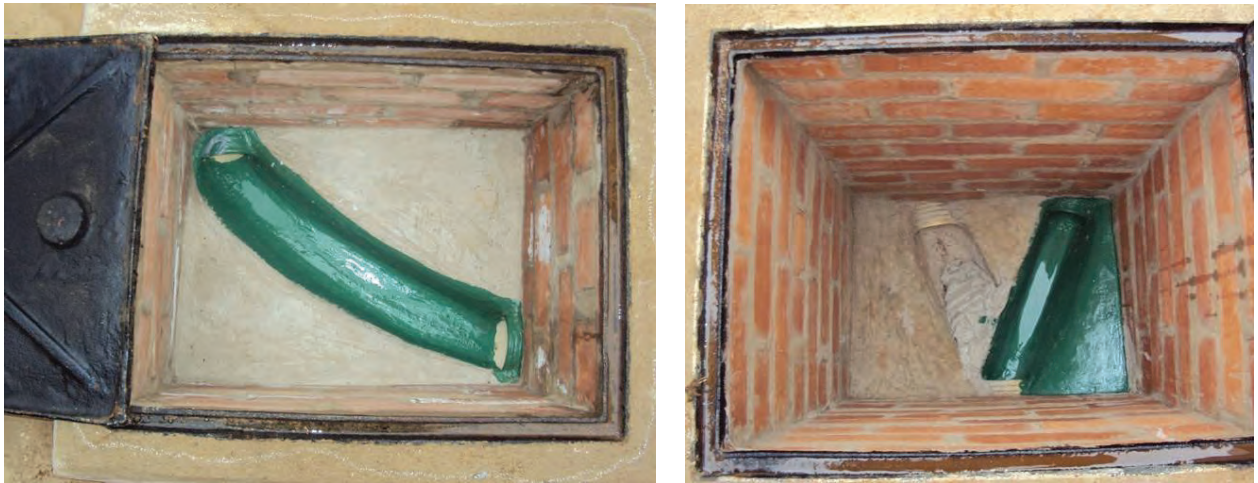
Figure 4.8 First and second junction boxes of sewer at Household 1. The second is a splitter box, where the flow is routed to either one of two leach pits using a section of PVC pipe as the switch.

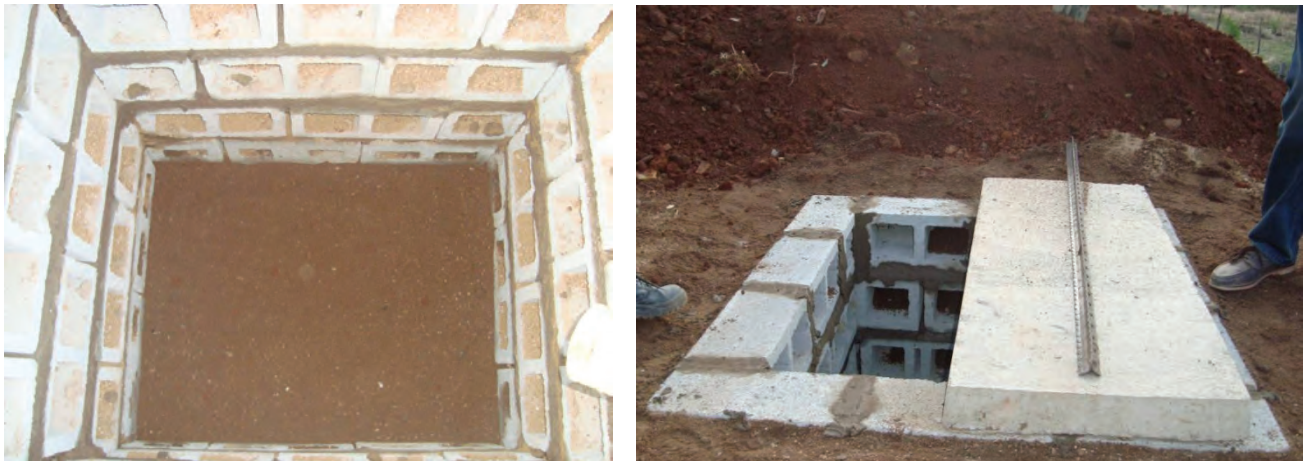
Figure 4.9 Interior of a soak pit (left). Each pit is covered by two 1.2 m by 1.4 m precast concrete slabs (right)

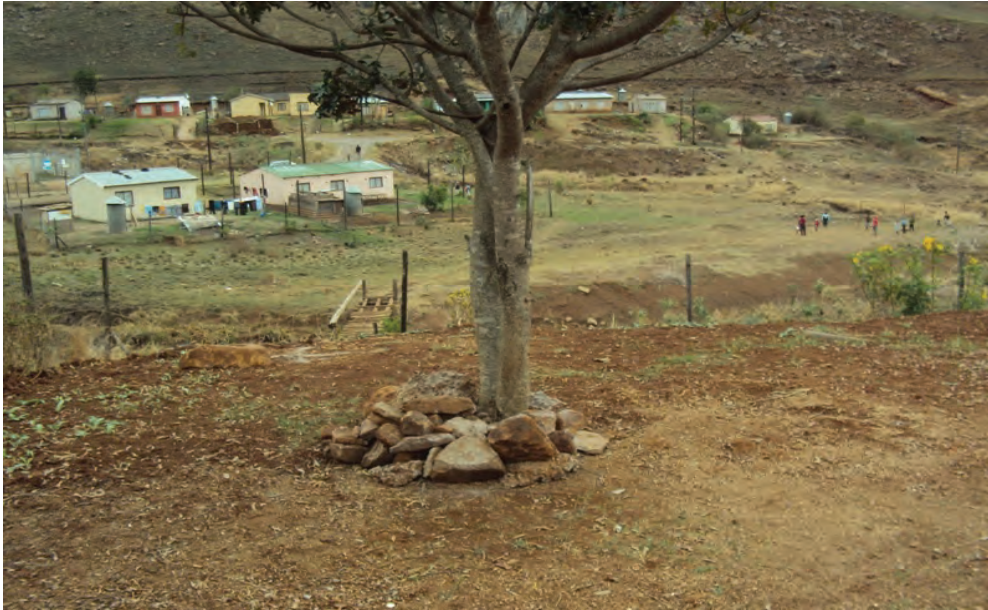
Figure 4.10 The completed soak pits (either side of the tree) are covered with topsoil. (At a later date inspection ports were added to aid with the checking of sludge depth)

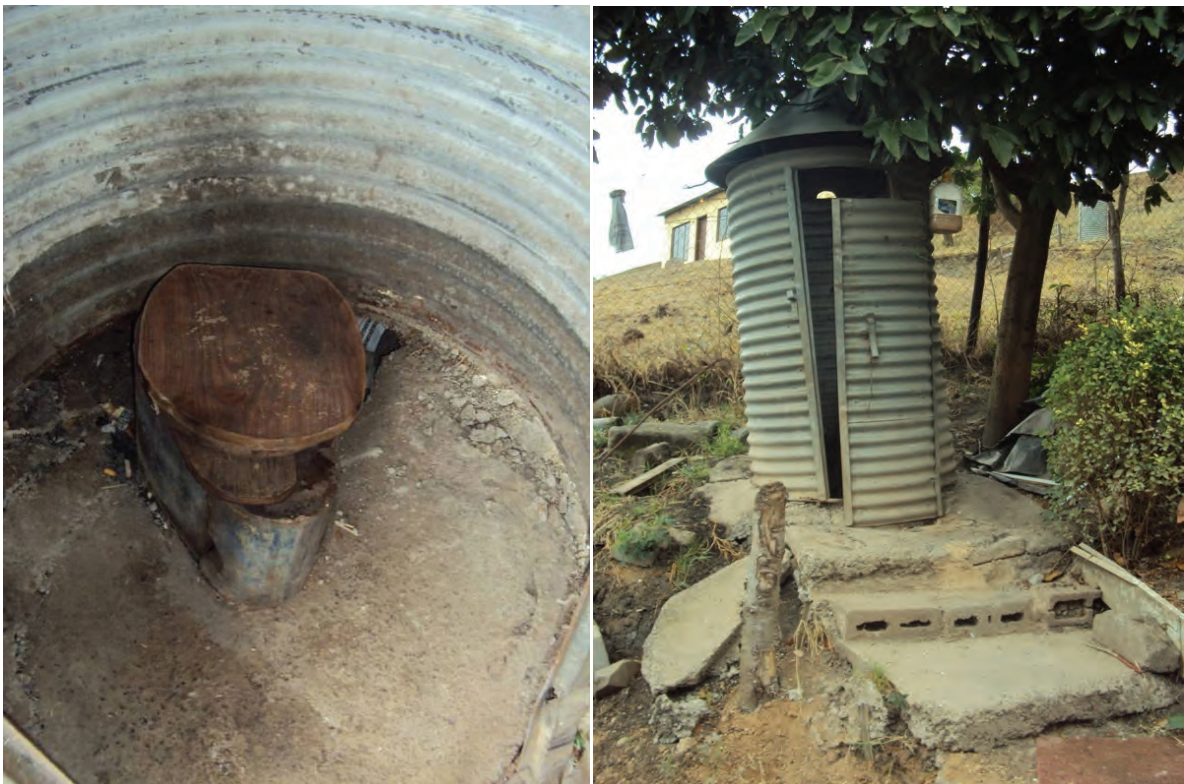
At Household 2, an indoor flush toilet connected to a septic tank served the main house while tenants living in an outbuilding still used the VIP toilet, which was in poor condition. The family had moved the VIP toilet twice since it was built because the pit was full.

Figure 4.11 Existing VIP toilet at Household 2.

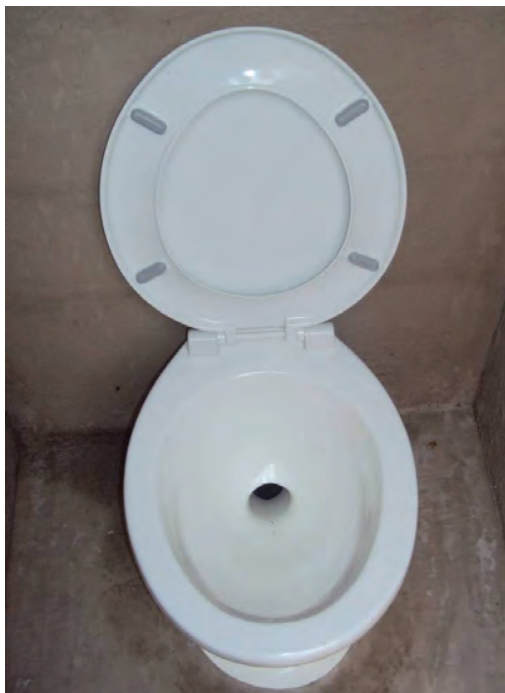
The family identified a room in the outbuilding which could house the test toilet. The pour flush toilet was to be used primarily by the four adult tenants, and it was connected to the existing septic tank.

Figure 4.12
Pour flush toilet
installed in an
out building at
Household 2

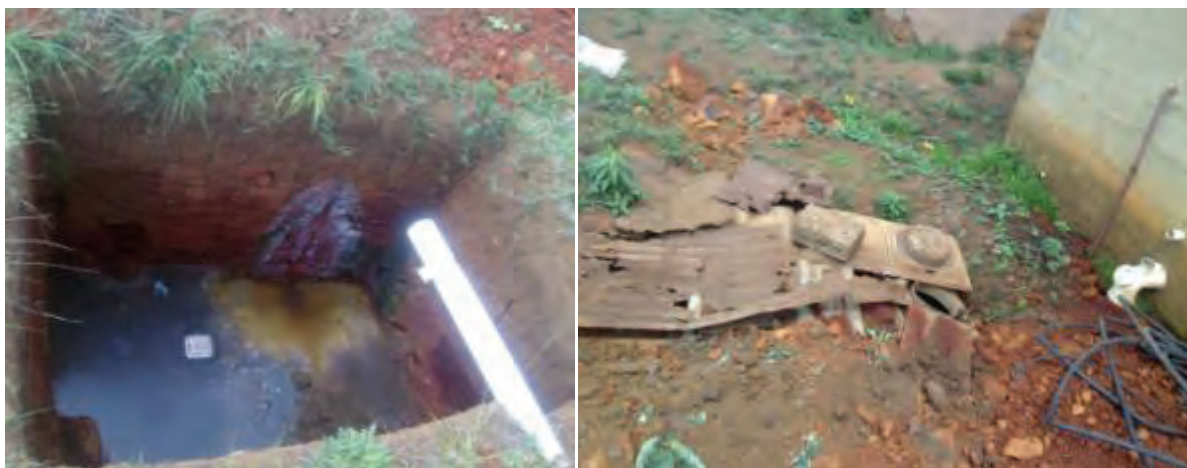
Figure 4.13 Uncovered or poorly covered soak pits in Siyathuthuka

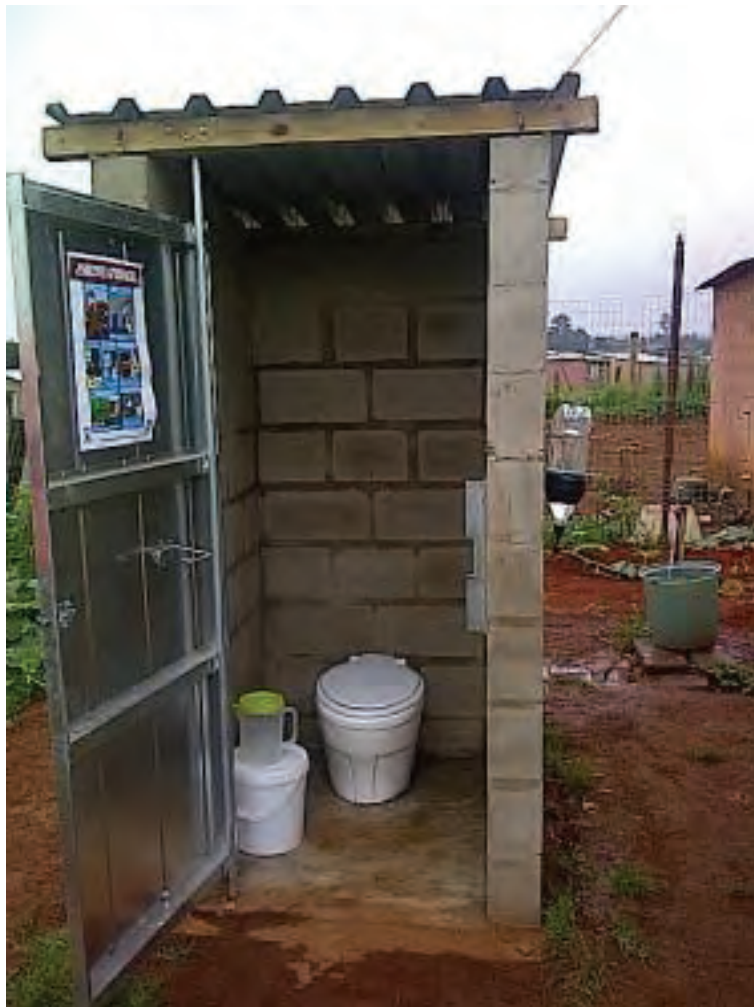
Figure 4.14 Outdoor structure with pour flush pedestal. A handwashing facility is mounted on the right hand side of the structure. The bucket and jug for flushing are stored in the loo and a poster explaining how to use and care for the system is mounted on the inside of the door

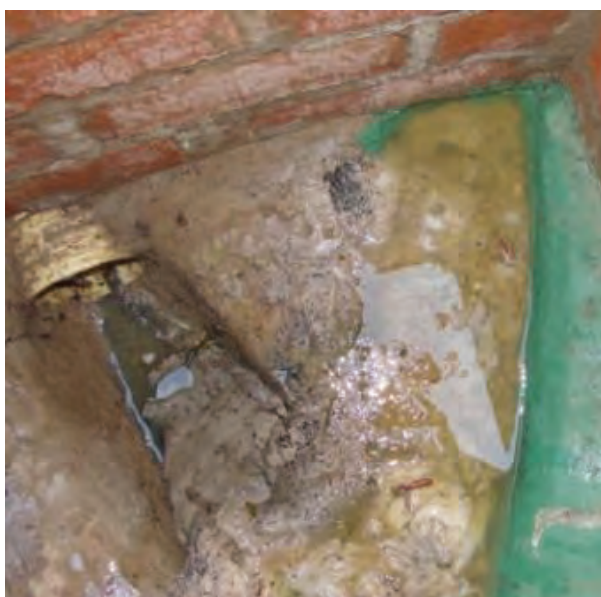
Figure 4.15 Blocked sewer leading to soak pit (left). The cause was a plastic packet which can be seen hanging from the pipe exiting into the soak pit (right).

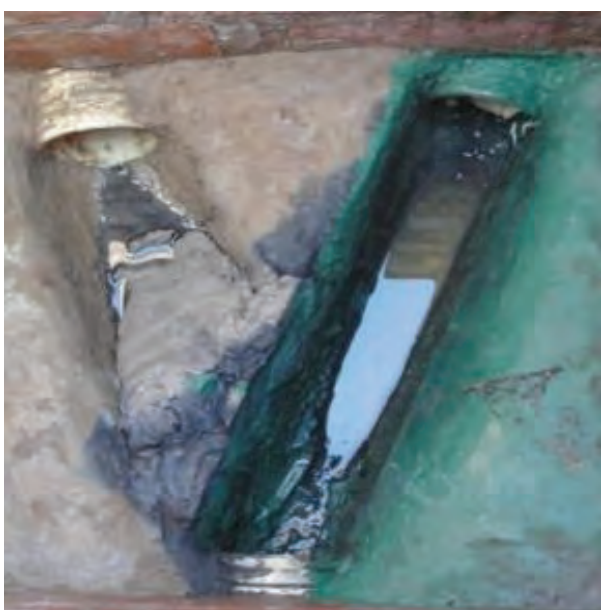
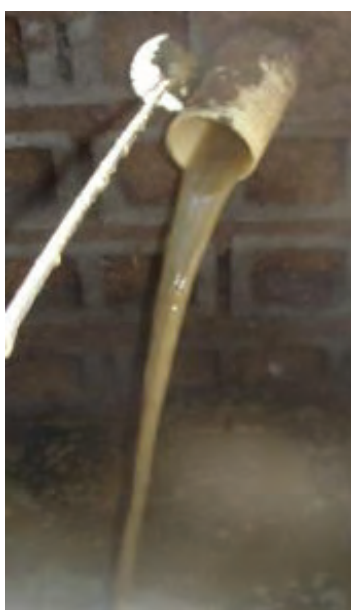
Figure 4.16 Sewer cleared after plastic packet is removed

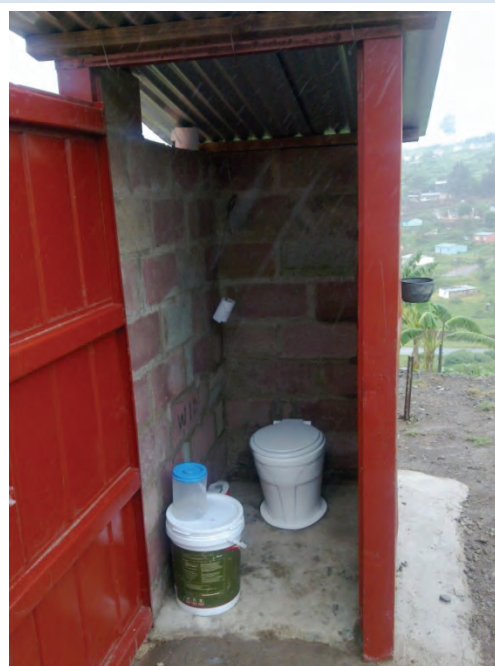
Construction: A soak pit was constructed and a pour flush toilet was installed in an outdoor structure built by the home owner.

Figure 4.17 Household 3: Pour flush toilet installed in outdoor structure.

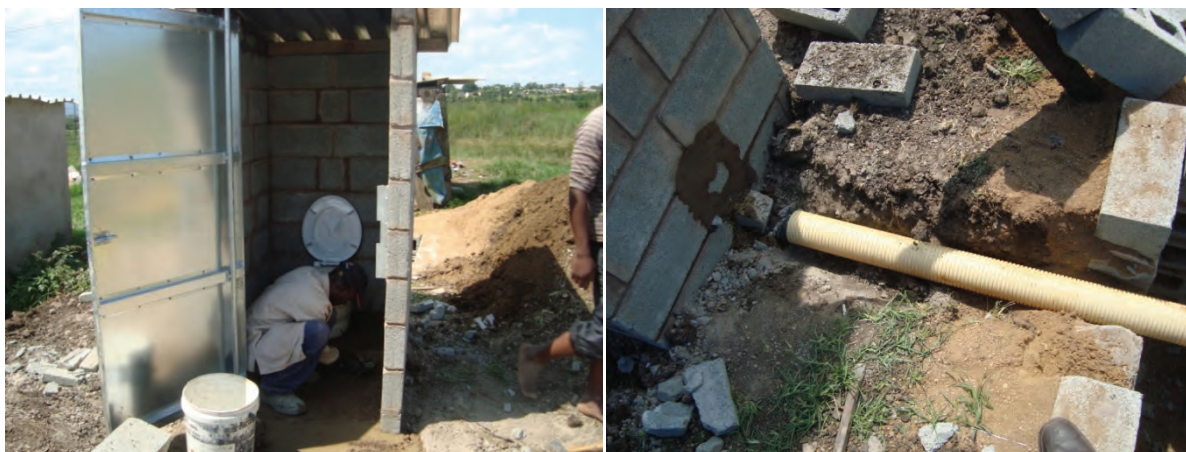
Household: 4**Area: France****Commissioned: 18 January 2011****Sanitation history:** Home built latrine. Afraid of floor breaking and someone falling into the pit.**Construction:** A top structure and soak pit were built and a pour flush toilet installed.**Operation:** No problems.

Figure 4.18 Household 4: A structure was built for Household 4 to house the pourflush toilet.

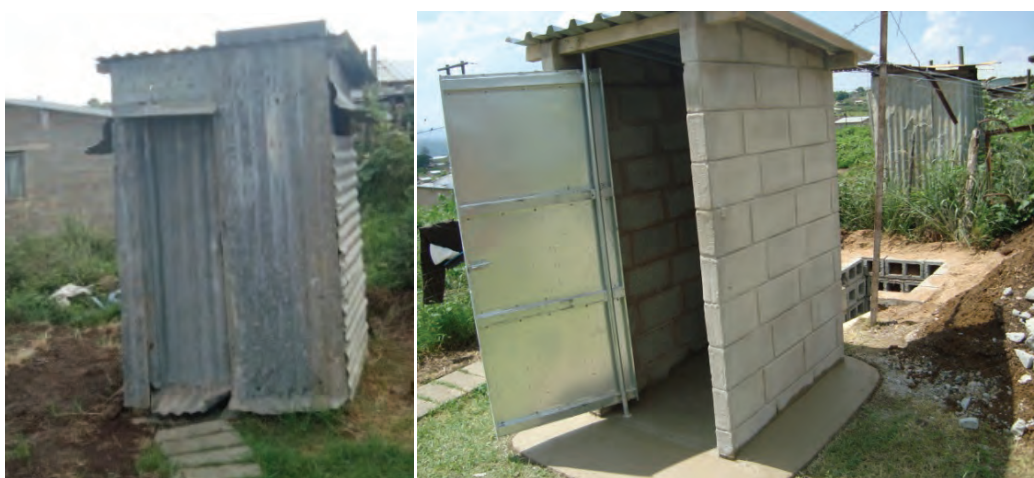
Household: 5**Area: France****Commissioned: 18 January 2011****Sanitation history:** Home built latrine. The house had been built with an indoor HS system which the family did not find acceptable. The family used a home built latrine they had constructed themselves. They did not want another indoor toilet.**Construction:** A top structure and soak pit were built and a pour flush toilet installed.**Operation:** No problems. The pit tended to collect rain water.

Figure 4.19 Household 5: Existing home built latrine (left) and pour flush under construction (right)

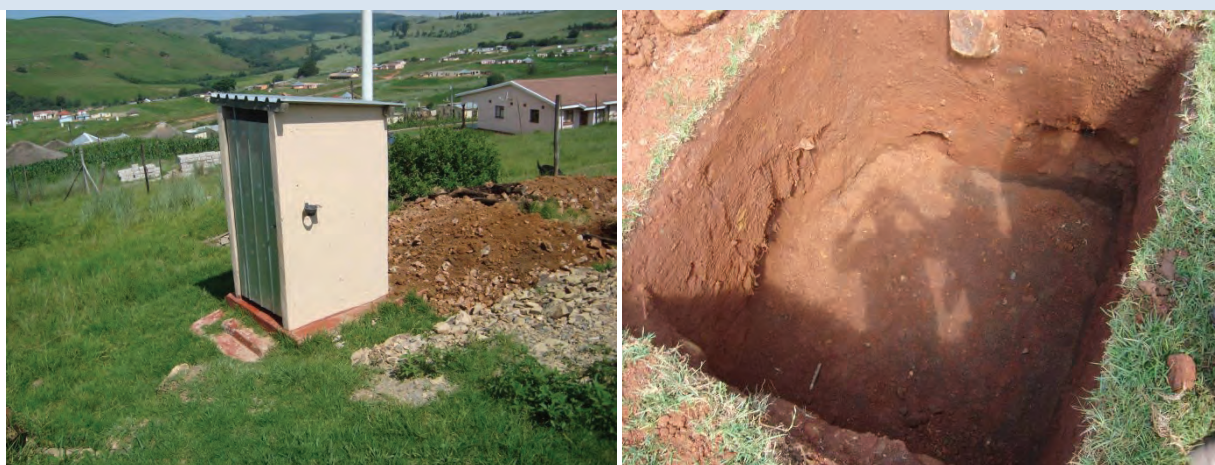
Construction: A top structure and soak pit were built and a pour flush toilet installed with a 25 m sewer to the soak pit.

Figure 4.20 Household 6: Existing municipal VIP (left) and pour flush pit under construction (right)

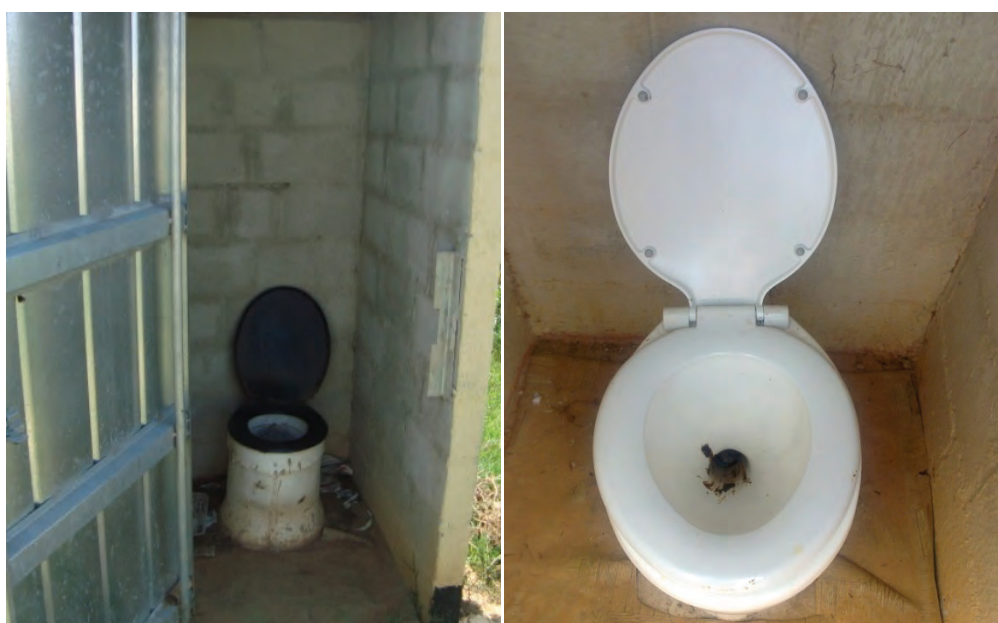
Construction: The construction team filled in the existing VIP pit, then removed the VIP pedestal and replaced it with a pour flush pedestal, cementing it in place. A soak pit was constructed behind the VIP pit with the pipe for the pour flush passing through the VIP pit to the pour flush pit.

Figure 4.21 Household 7: Previous VIP toilet (left) converted to pourflush (right).

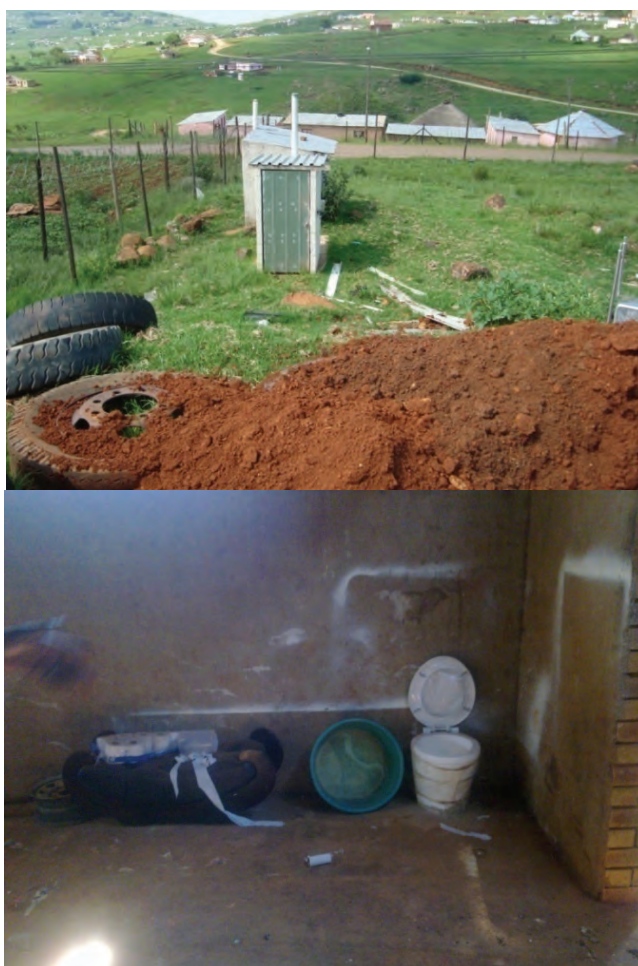
Construction: The construction team installed a pour flush toilet in the corner of a large garage attached to the family's shop. The construction team did not build walls around the toilet as the owner is planning to build a larger bathroom around it. The team constructed a soak pit on the other side of the driveway.

Figure 4.22 Household 8: Two existing VIPs and digging of soakpit (left). VIP installed in garage where animals are also kept; owner intends to enclose part of the garage as a bathroom (right).

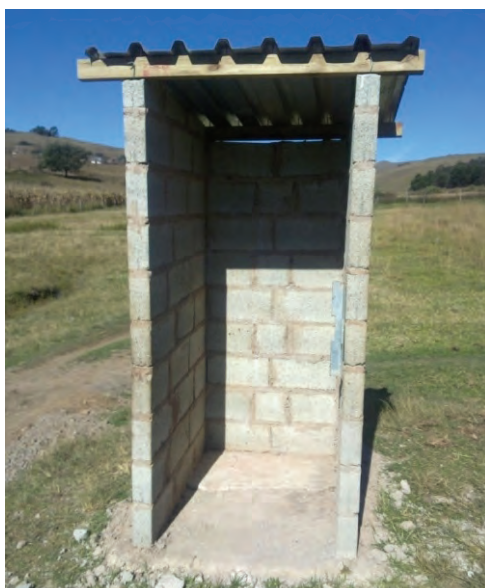
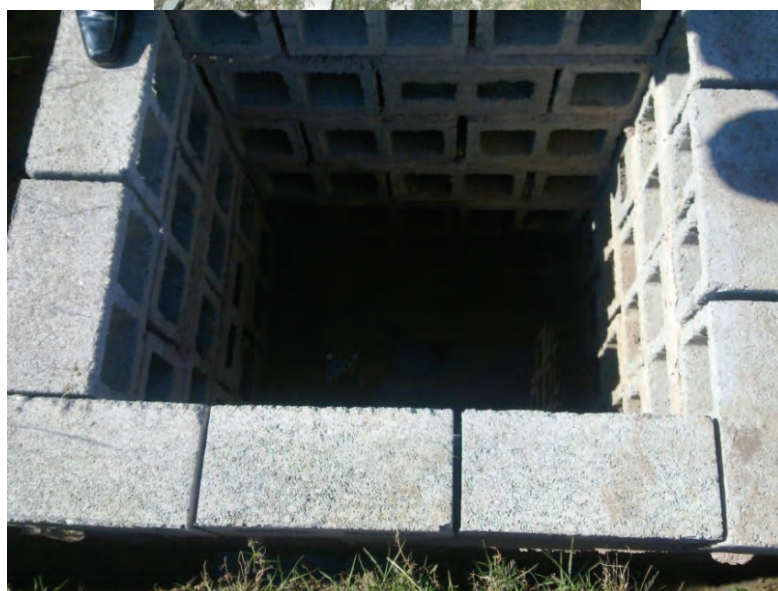
Operation: As the church was still under construction, the toilet had not yet been formally commissioned for use. Educational materials will be provided when the church is ready to introduce users to the pour flush technology. After construction the bottom of the pit filled with water before the system was commissioned.

Figure 4.23 Top structure (left) built for church with soak pit collecting some water (right)
