PILOTING AND TESTING THE POUR FLUSH LATRINE TECHNOLOGY FOR ITS APPLICABILITY IN SOUTH AFRICA

Report to the
Water Research Commission

WRC Report No. 1887/1/12
ISBN 978-1-4312- 0289-8

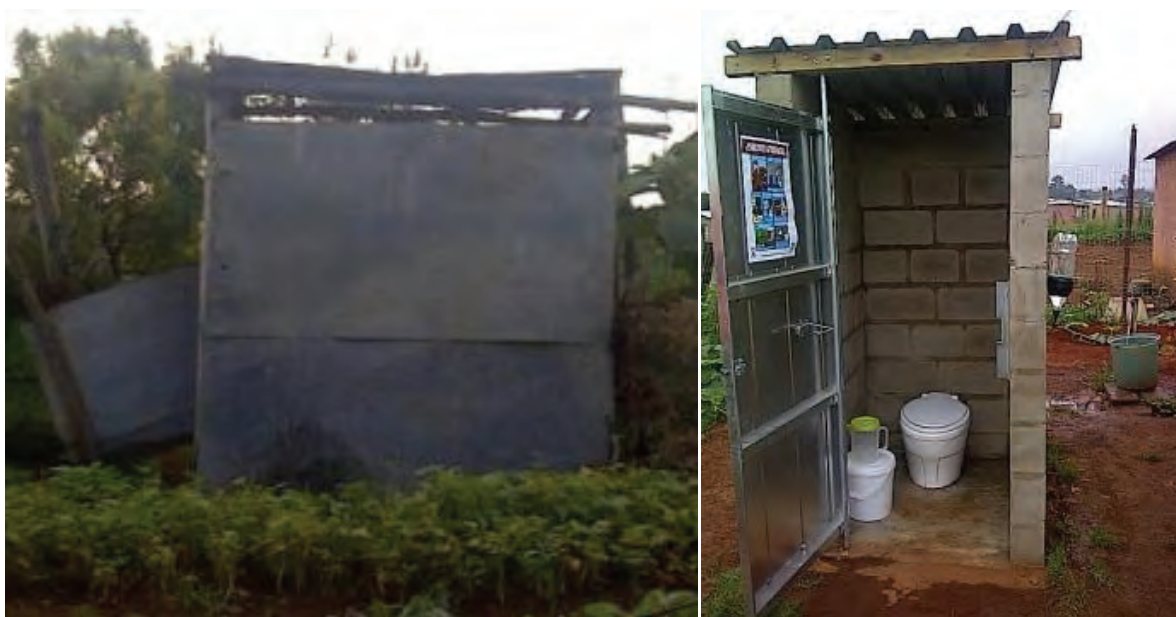
Household: 10**Area: Siyathuthuka****Commissioned: 6 December 2011****Sanitation history:** None provided by municipality; homebuilt latrine.**Construction:** The construction team built an outdoor structure with a pour flush system and soak pit.**Operation:** No problems. One householder said that his mother is quite large and prefers to use the old home built latrine because she finds the pour flush structure too small.

Figure 4.24 Household 10: Home built structure for a latrine at a home which was overlooked when HS systems were originally installed (left); new pour flush system (right)

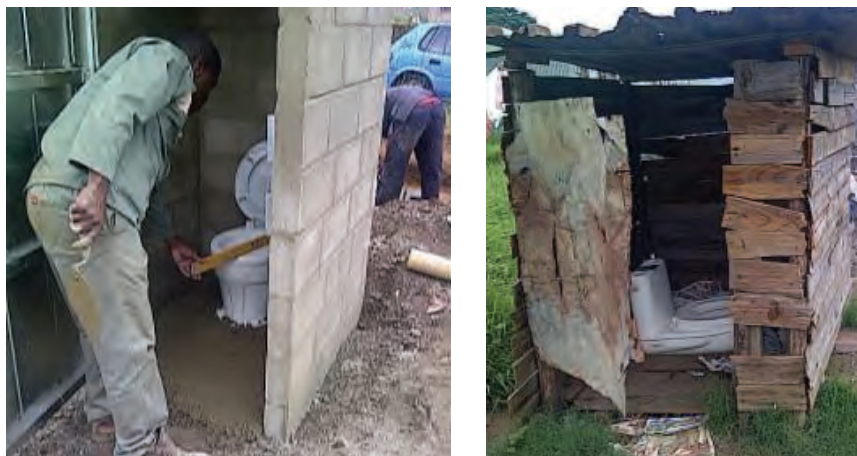
Household: 11**Area: France****Commissioned: 22 December 2011****Sanitation history:** The family had removed the original HS system from the house and built their own latrine, using the HS pedestal over the pit.**Construction details:** An outdoor structure and soak pit were constructed and a pour flush pedestal installed.**Operation:** No problems.

Figure 4.25 Household 11: Homebuilt latrine with HS pedestal (right). Pour flush system under construction (left).

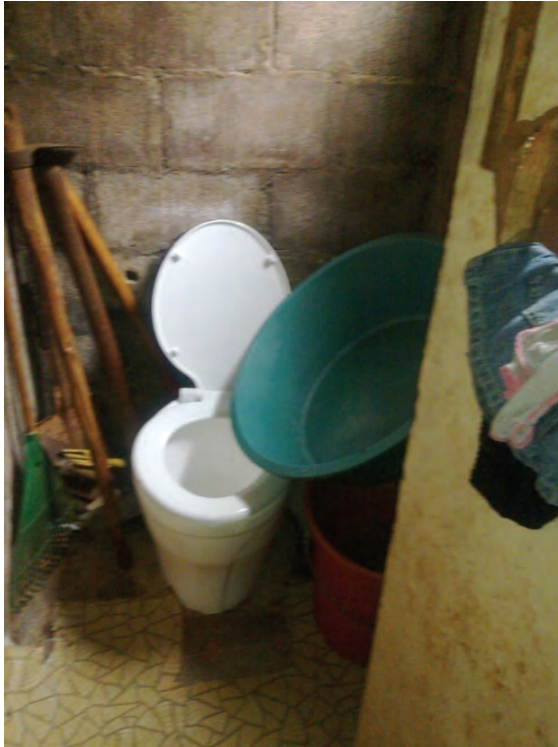
Household: 12	Area: France	Commissioned: 17 December 2010	
<p>Sanitation history: Indoor HS low flush system. Existing soak pit full.</p> <p>Construction: The construction team replaced the existing indoor HS system with a pour flush system. The existing soak pit was full. The team emptied this for continued use.</p> <p>Operation: Six visits were made to the site; no one was home on two of these visits. The householders reported no problems with the toilet but concerns about not being able to afford toilet paper and that newspaper might block the system. The research team encouraged her to try to use newspaper using the method of flushing small amounts of newspaper at a time and told her to call the research team immediately if she experienced any problems. The contents of the pit were measured on 1.5.12 (approximately 1 year in use). Details are provided in Section 4.5.11.</p>

Figure 4.26 Household 12: Pour flush toilet installed.

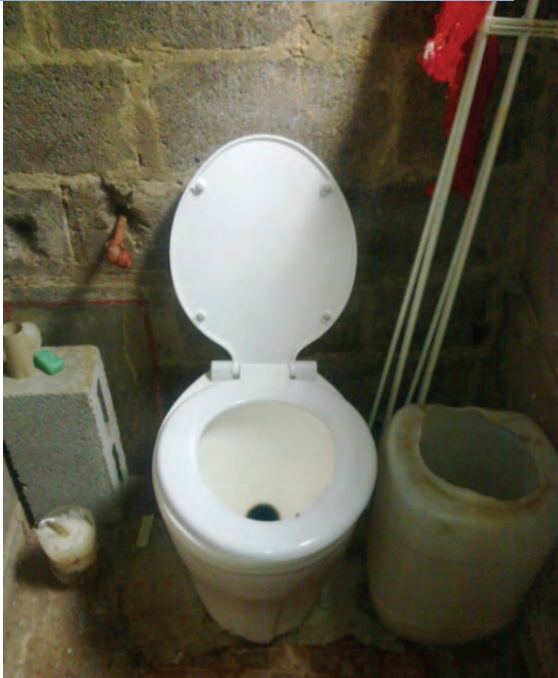
Household: 13	Area: France	Commissioned: 17 December 2010	
<p>Sanitation history: Indoor HS low flush system. Cistern and tipping tray broken; soak pit full.</p> <p>Construction: The construction team replaced the existing indoor HS system. The existing soak pit was full. The team emptied this for continued use.</p> <p>Operation: Eight visits were made to the site. In May, the seat and lid were found to have come off the toilet. It was found that some of the screws had not been tightened properly and the problem was resolved. An unpleasant smell was noted on one visit even though the toilet appeared very clean. The homeowner was asked to monitor water and toilet paper usage for a month; however, data that was collected appeared unreliable.</p>

Figure 4.27 Household 13: New pour flush toilet

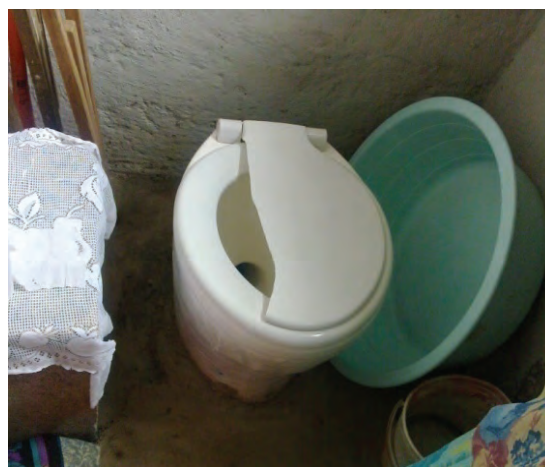
Figure 4.28 Household 14: Householder stood on lid during first week of use and broke it.

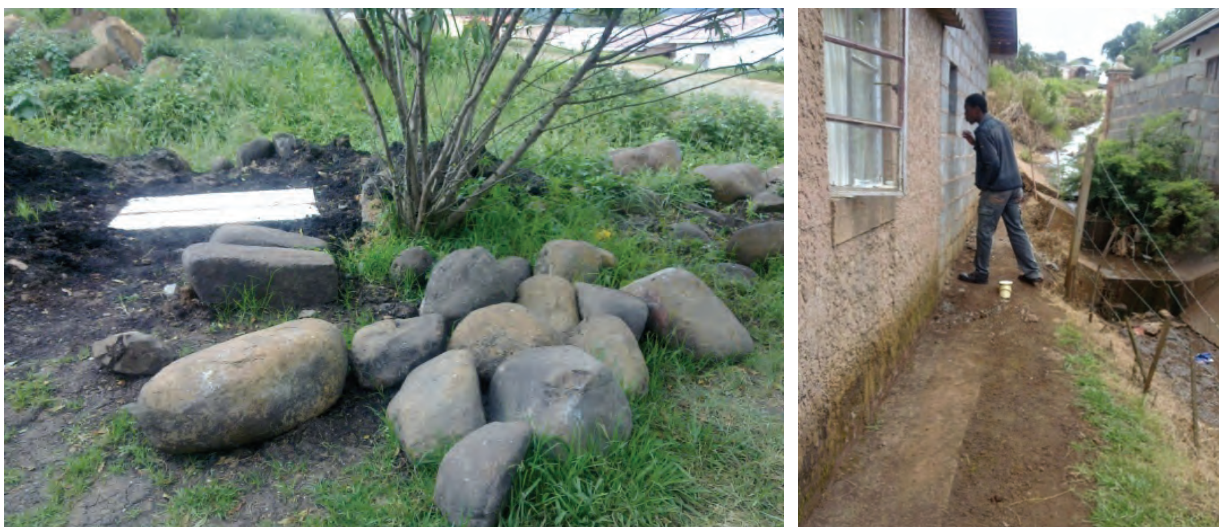
Construction: The family was in the process of extending the house and chose a location for the pour flush toilet which was in the new section that was still being built. A new soak pit was constructed with some difficulty because of the many large rocks which had to be removed.

Figure 4.29 Household 15: Large rocks removed for construction of soak pit (left); soak pit installed in new extension of the house (right)

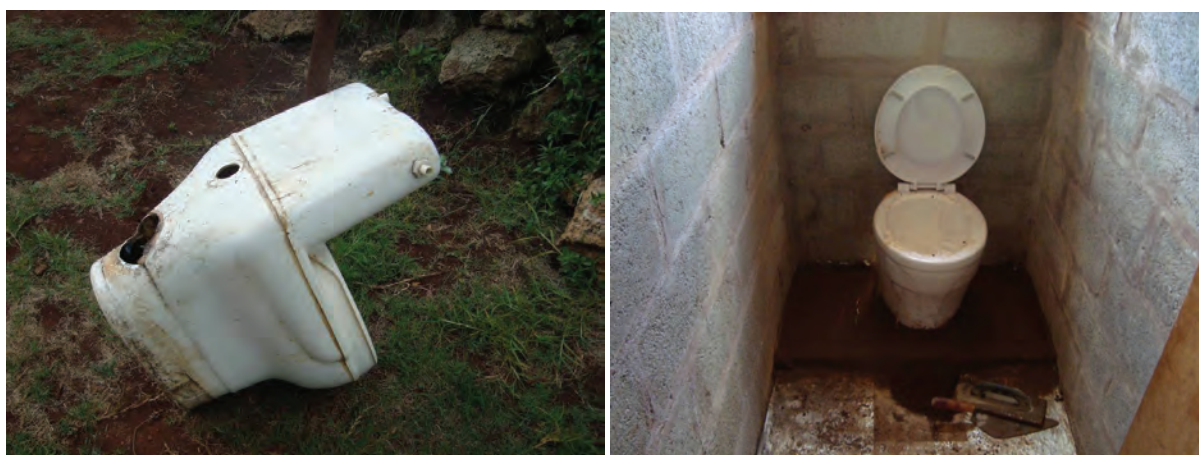
Construction: The construction team replaced the indoor HS system with a pour flush toilet and constructed a new soak pit.

Figure 4.30 Household 16: Old HS pedestal removed (left); new pour flush system during installation (right)

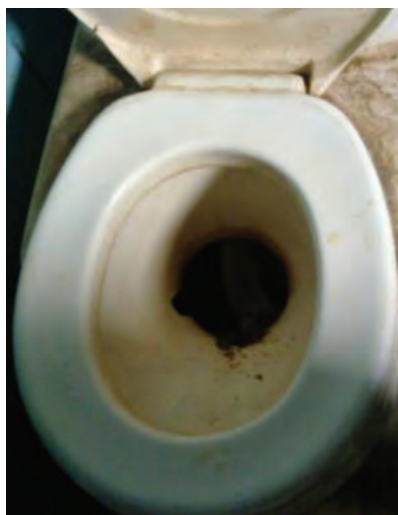
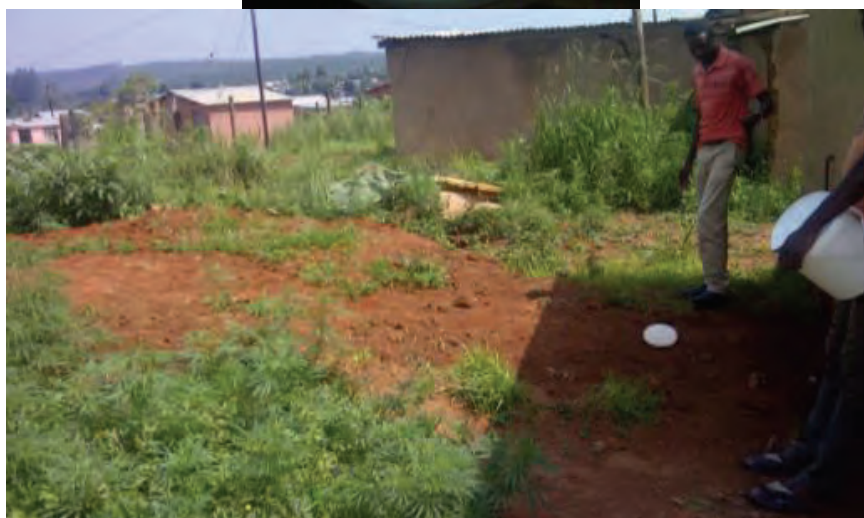
Figure 4.31 Household 17: HS system with missing tipping tray which had not been flushed because the water supply was cut off (right). Rodding eye (white) indicates sewer laid through old pit to new pit (left).

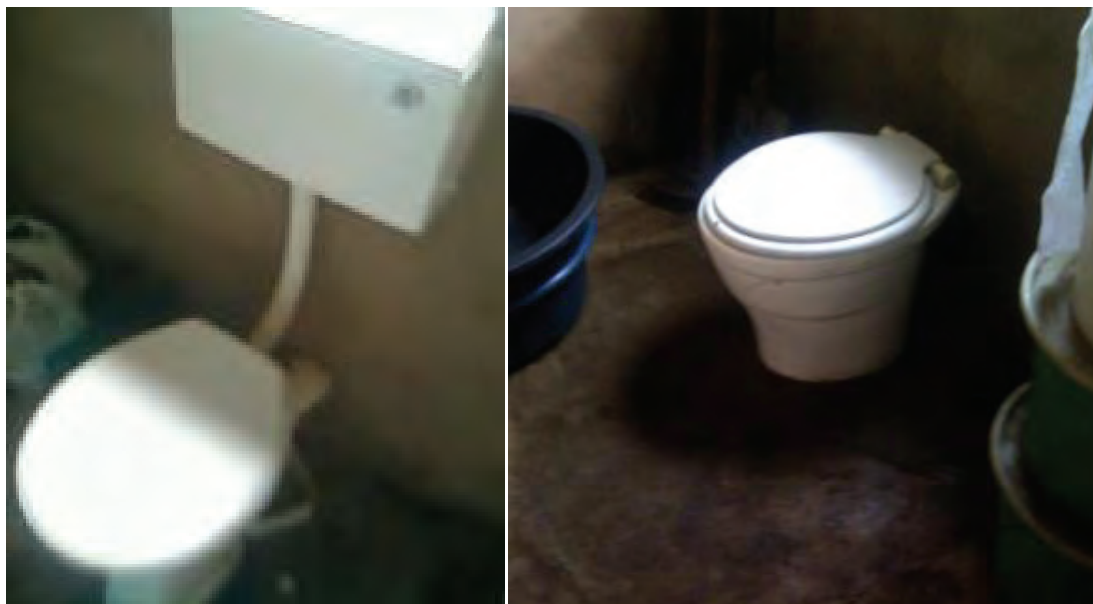
Construction: The construction team replaced the full flush system which was unable to function properly with the available water supply. The cistern had to be filled manually for each flush. The homebuilt soak pit was filled with earth and an 18 m sewer was laid through the two previous soak pits to a new soak pit.

Figure 4.32 Household 18: Full flush pedestal (left) replaced with pour flush system (right)

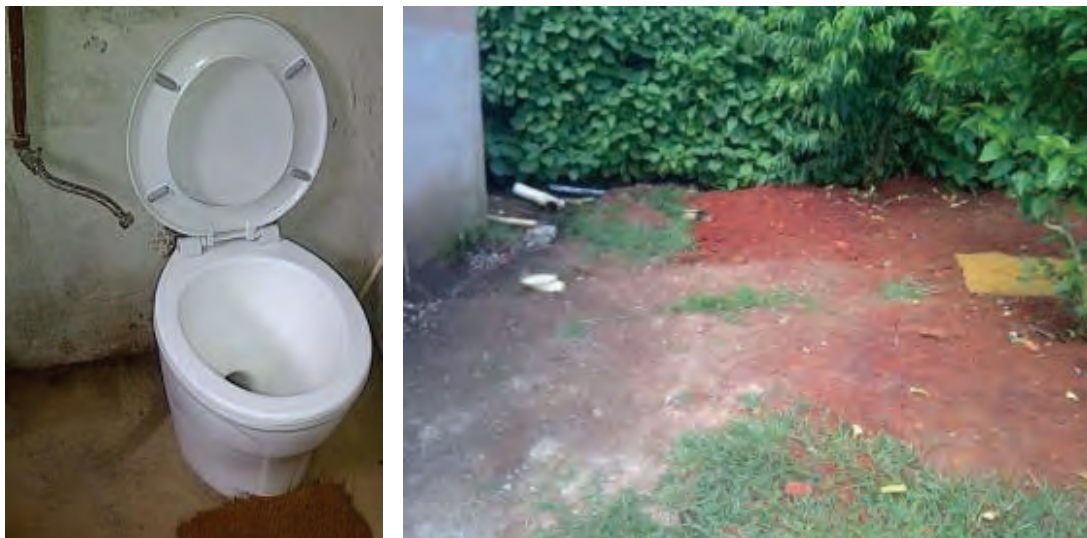
Household: 19	Area: Siyathuthuka	Commissioned: 6 December 2011
Sanitation history: Indoor HS low flush toilet with broken tipping tray and full pit. The toilet could only be flushed by rodding contents through the pedestal.		
Construction: PID replaced the existing indoor HS system. The homebuilt soak pit was filled with earth and a sewer was laid through it to a new soak pit.		
Operation: No problems noted or reported.

Figure 4.33 Household 19: New pour flush pedestal installed in the house (left) and soak pit constructed and covered with earth behind the house (right).

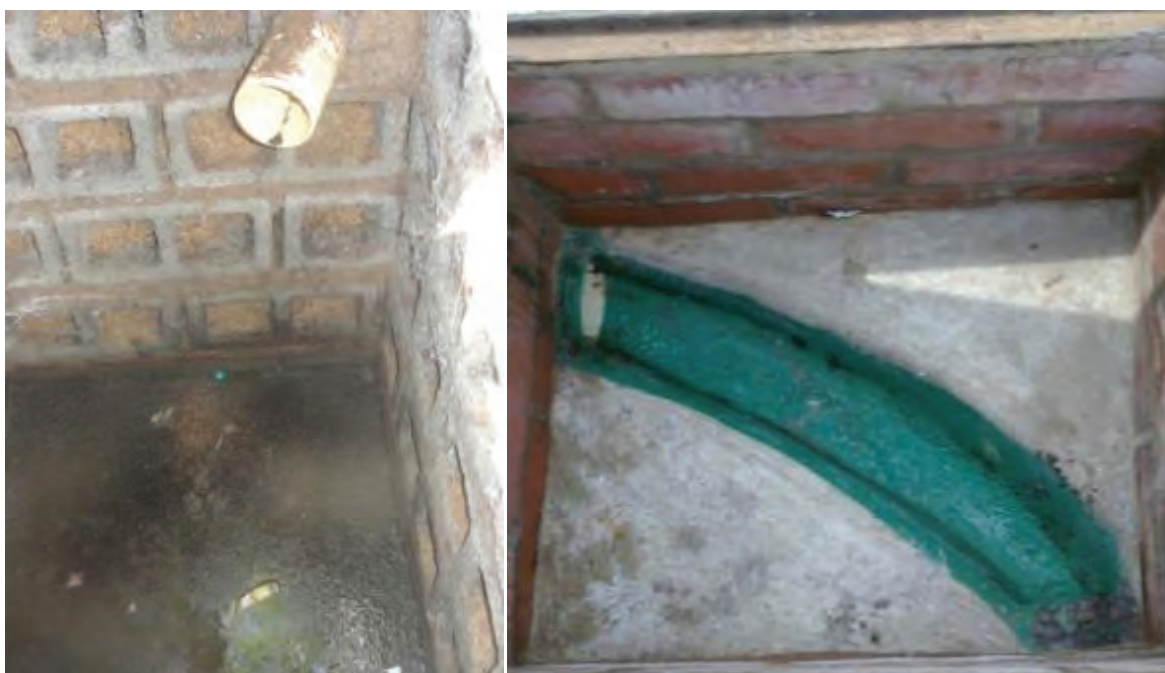
Figure 4.35 Soak pit (left) and first junction box (right) after 13 months of use

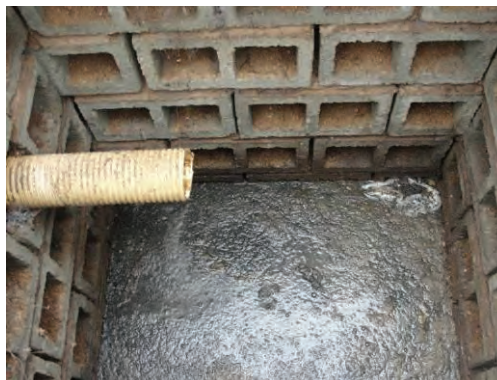
Household 14

300	330
390	
290	330

The measurements have been summarised in Table 3.1 below. The median number of users is 4 and the median sludge accumulation rate is 33.5 litres per person per year. This is similar to the rate observed by Norris in his 2000 study of sludge accumulation in septic tanks⁵. It is notable that at one of the homes (No. 4) the accumulation rates are substantially greater than at the other five. In the case of this family (accumulation rate 57 litres per person per annum) they report that they use four litres to flush. It is possible that the pit is partly flooded and that the sludge depth has been incorrectly measured. Measurements at this site should be checked.

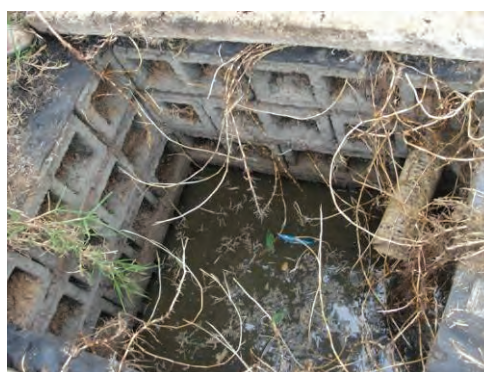
Household 15

180	170
190	
170	190

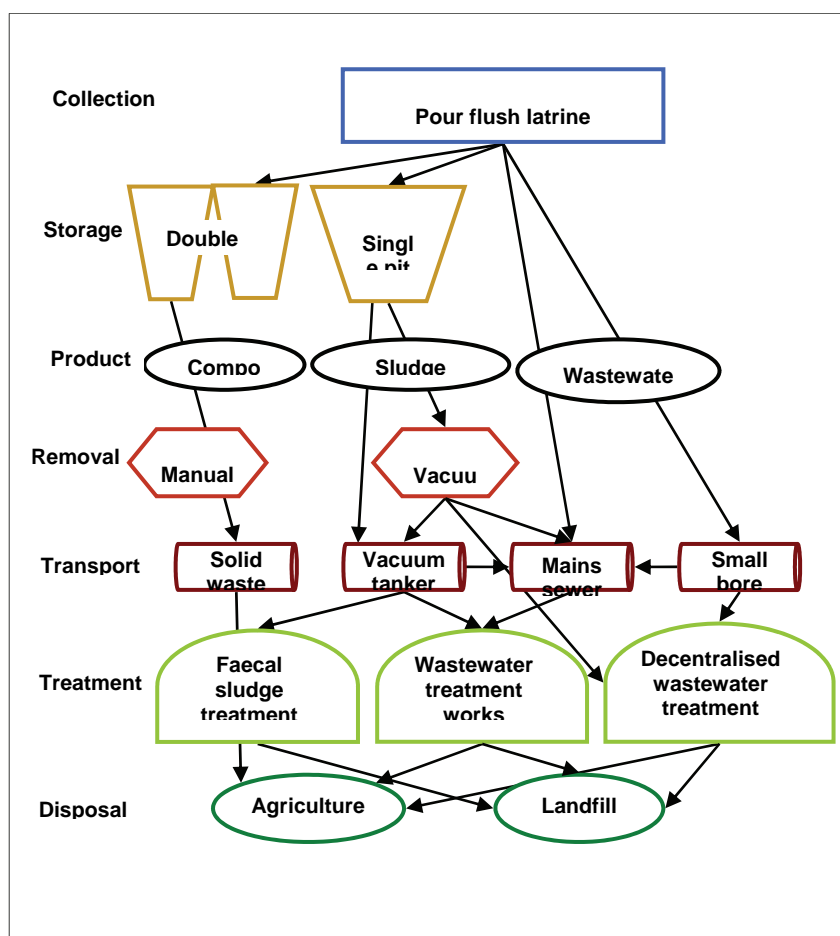
Figure 5.1 Schematic diagram of sludge treatment options for pour flush systems

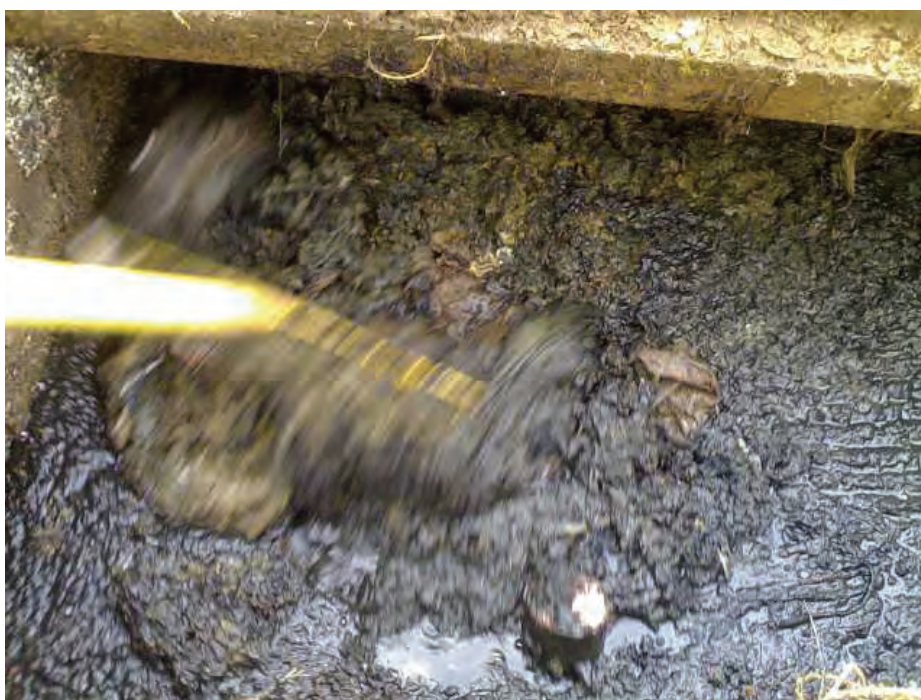
Removing rubbish from a pit with a rake prior to emptying

Although less rubbish was found in the HS soak pits than is typically found in VIP pits, some was still present and removal of rubbish prior to emptying the pit increased the amount of time required. If rubbish was not removed prior to emptying, blockages resulted in as much as 1.5 hours more time being spent emptying the pit. Sludge was dryer in some pits than others. Working with drier sludge could increase the emptying time by 15 minutes or more. It was found that adding 40 to 80 litres of water to the soak pit liquified the sludge enough to be removed.

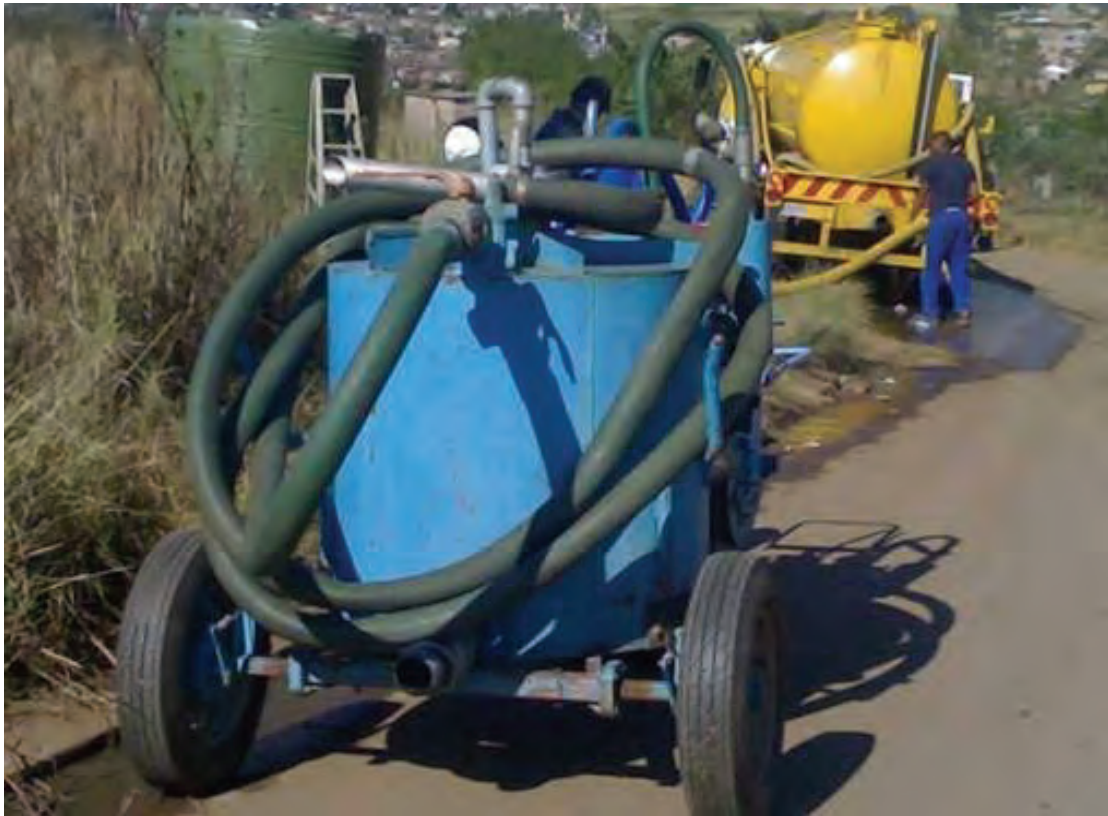
The Vacutug (blue) transferred sludge from the pits of low flush systems in Slangspruit to a 5 m³ holding tank (green) which was later emptied by a municipal vacuum tanker (yellow).

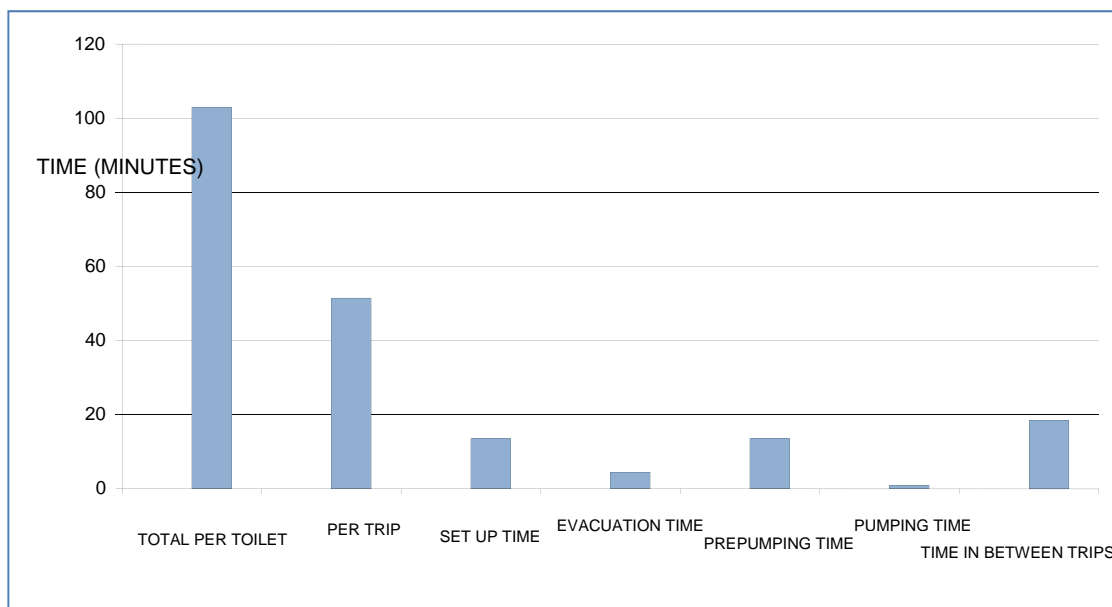
Analysis of time taken to empty 1 cubic metre low flush soak pits at Slangspruit using Vacutug

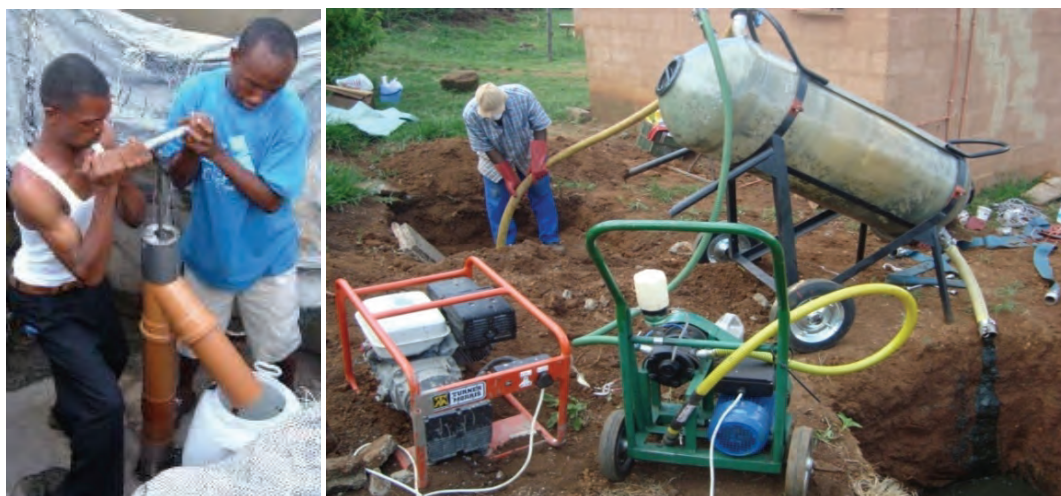
The Gulper (left) a hand operated vacuum pump (Sugden, 2008) and the E Vac (right) and electrically powered vacuum pump developed by Partners in Development

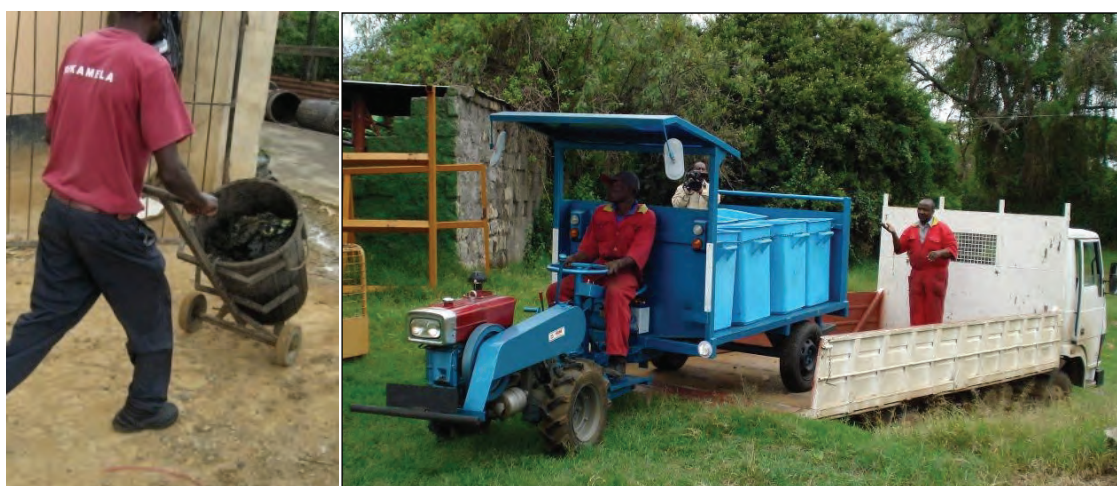
Drumbarrow used by eThekweni (left) and Chinese two-wheeled tractor with trailer transporting bins to truck for road transport (right, UN HABITAT 2009)

If access to the site is difficult, it may be necessary to remove sludge in bins or with a small vehicle to the nearest access point for the transport vehicle.

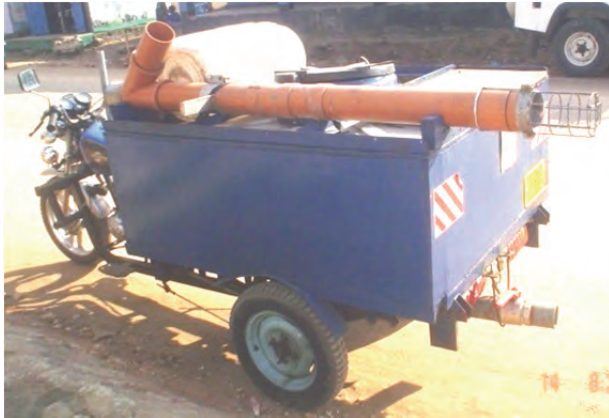
Steven Sugden has developed a faecal waste management system called the trike, which combines manual extraction, manual carting and mechanized hauling.

The trike in use in Dar es Salaam (Steven Sugden).
