SFD Promotion Initiative

Domiz 1 Syrian Refugee Camp Kurdistan Region of Iraq

Final Report

This Comprehensive SFD Report was prepared
by GIZ.

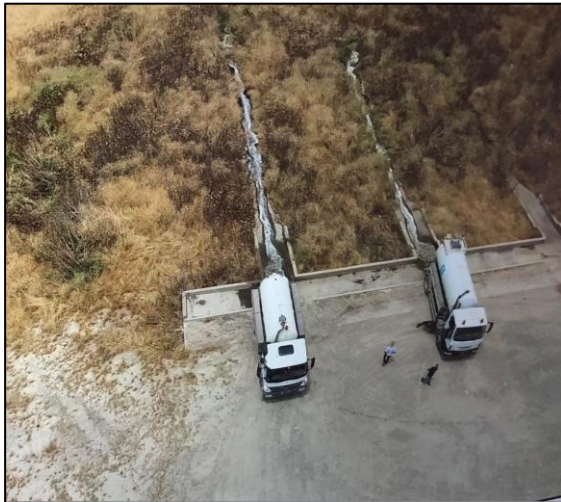
Figure 6: Desludged Material being Dumped into the Environment near Domiz 1 camp (Source: RedR Australia, 2019)

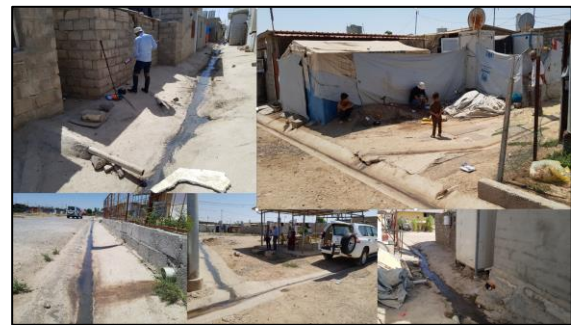
Figure 8: Grey water collection system of channels within Domiz 1 (Source: Author, 2018)

Grey water is directed from within to the households into the street drainage for collection through V-shaped channels, which also collect surface run off and then deliver this through increasingly larger channels into the natural drainage, which is part of the Mosul Dam catchment area. In most situations in KRI, including the host community, black water is considered to be toilet water only and grey water is all the other water outlets, including kitchen, washing, showers and laundry.

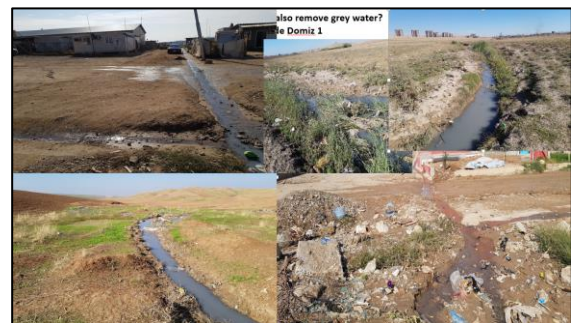
Figure 9: Grey water collection channels into the natural environment outside of Domiz 1 (Source: Author, 2018)

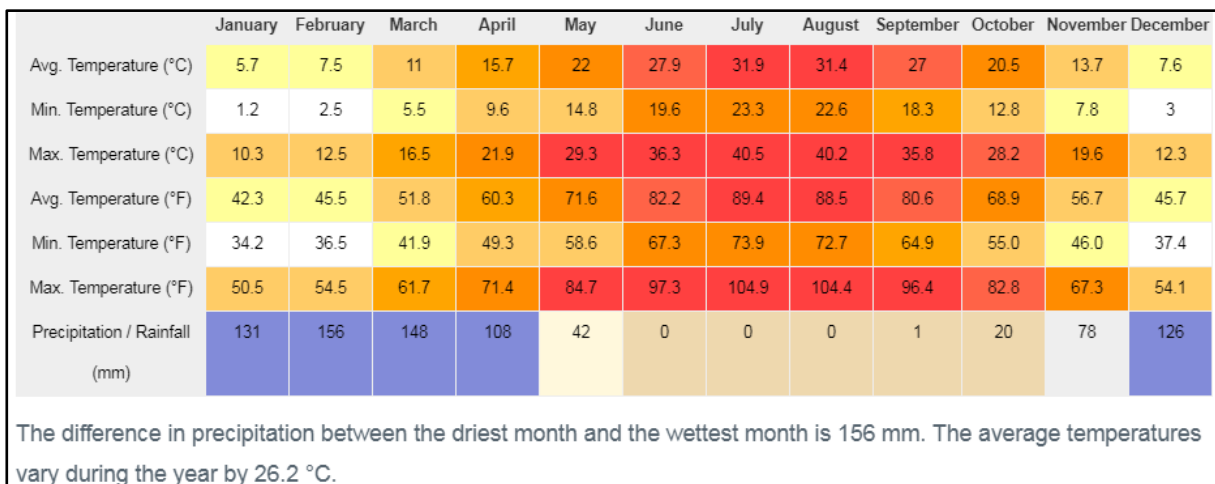
Figure 11 – Duhok Weather by Month (Source: Weatheronline.com, 2019)

The climate in the area experiences some significant variations from summer to winter in terms of temperature and rainfall, as indicated in figure 10 below.

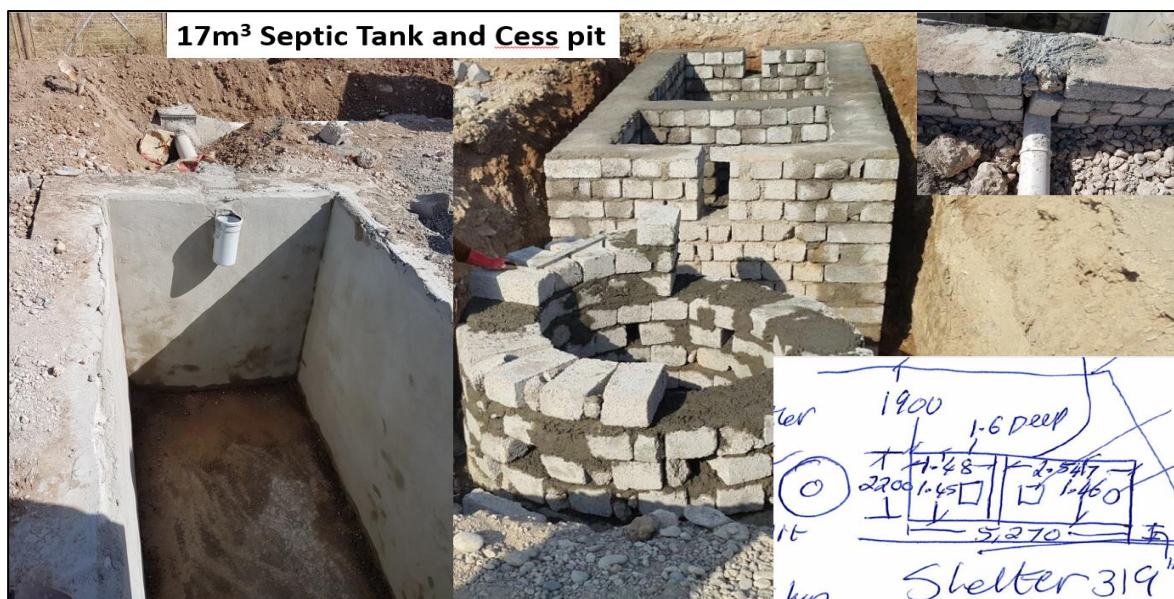
Figure 14: Blockwork septic tank and soak pit, New Zozan, Domiz 1. (Source: UNHCR Duhok, 2019)

1. Septic Tank and Soak Pit – At the time of writing there were 70 of these in Domiz 1 camp, mostly in New Farashin and New Zozan quarters. They comprise 15% of the total amount of containment systems (976). These are all 17m³ in size and are constructed from blockwork and plastered on the inside, thereby providing an internal seal. There is a partition wall in the tank that separates it into the primary and secondary chambers, with the ratio being 2:1. These tanks have a concrete base slab, as seen in figure 14. They have an outlet pipe installed slightly lower than the inlet and takes the “treated” liquid through to the soak pit where it can infiltrate through the walls of the pit into the surrounding ground. On many of the inspected tanks the outlet tee was either installed incorrectly or not installed at all, leading to solids and suspended particles passing through to the soak pit and the surrounding ground.

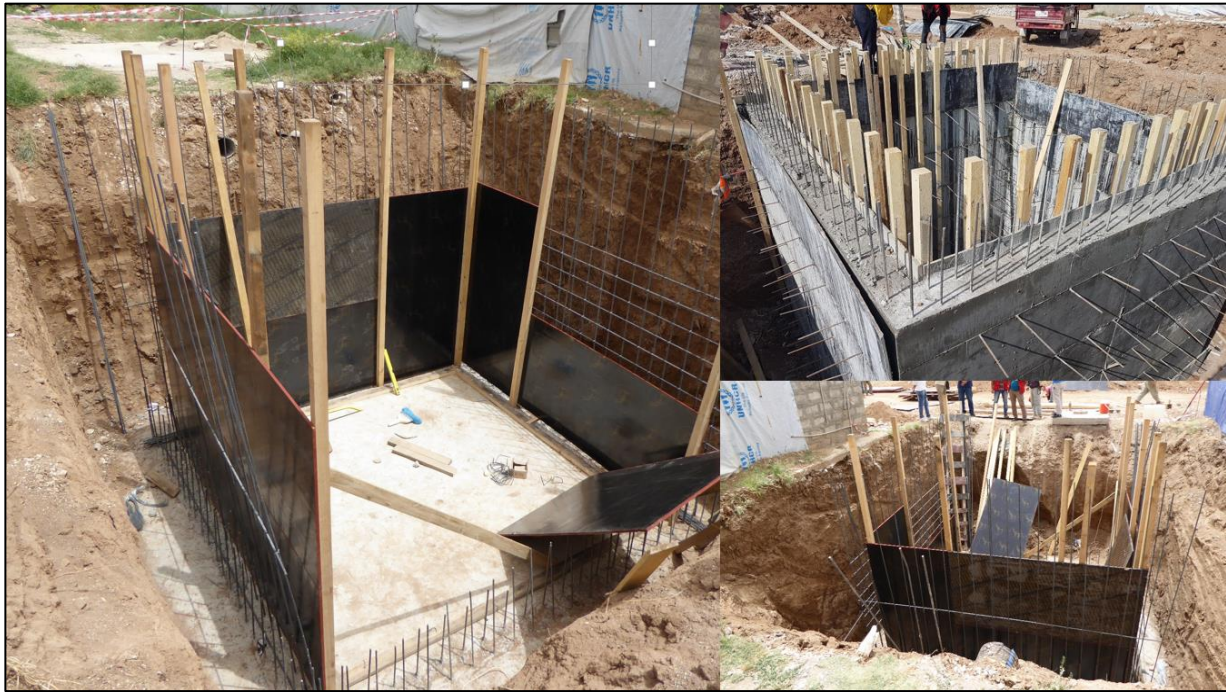
Figure 16: Concrete holding tank, considered fully sealed. (Source: UNHCR Duhok, 2019)

3. Holding tank – There are many tanks in Domiz 1 camp that are described as holding tanks, but for the purposes of this report, the only ones considered to be proper holding tanks are the ones constructed entirely from reinforced concrete, including the base. There are 96 of these in total, ranging in size from 20m³ to 45m³. The desludging assessment is missing information on some of these tanks relating to how many houses are connected, but it was

As mentioned, construction is by reinforced concrete, as indicated in figure 16 below.
