# Sanitation Study

Evaluation of Dry Sanitation Systems in Namibia 2011

Authors: Cosenza, Ameli\*\*; Haxsen, Sören\*\*; Sattler, Yara\*\*;  
Wucherpennig, Kai\*\*

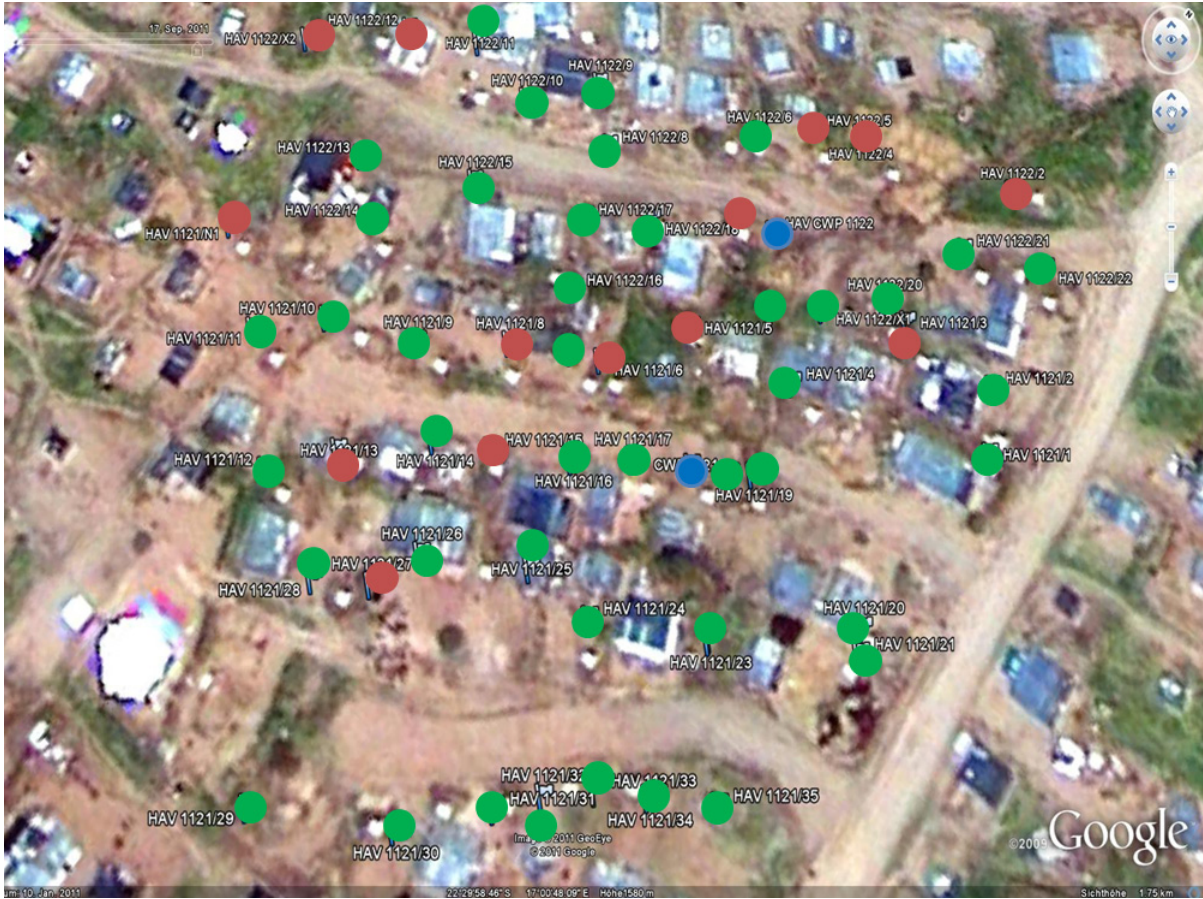
Picture 1: Otji-Toilets in Havana ext. 6

Out of these 58 existing Otji-Toilets, 44 facilities were observed and 43 beneficiaries were interviewed during the sanitation study. Picture 1 illustrates the project sight and gives an overview on the location of Otji-Toilets in Havana Extension 6.

Legend: Green dots: evaluated Otji-Toilets (three of those are not in use); red dots: evaluation not accomplished (reasons differ and are described above); blue dots: water points; the GPS data for one toilet was not collected

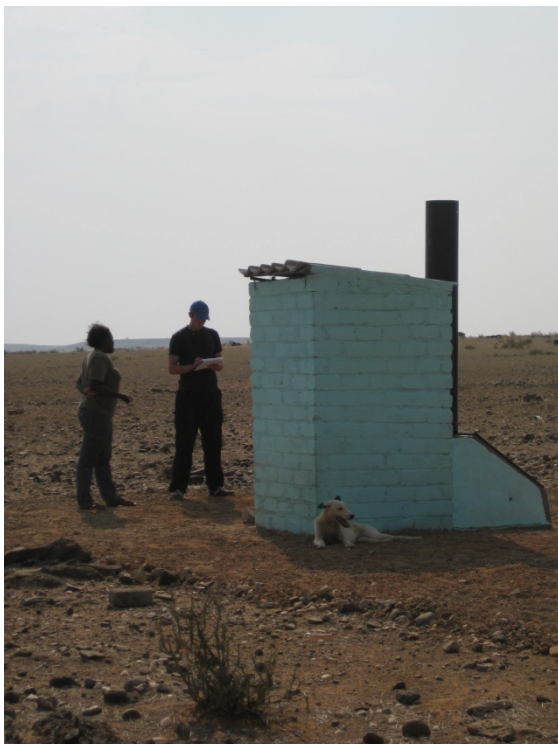
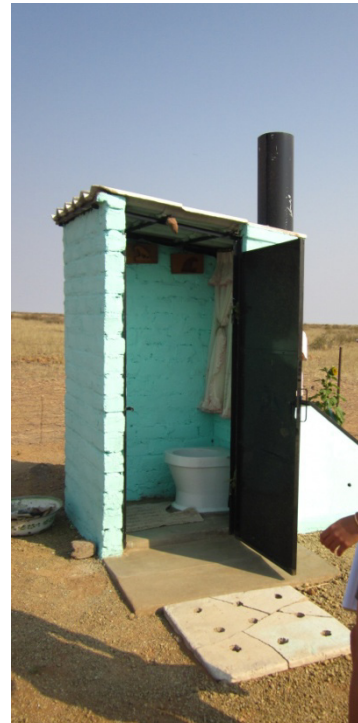
*Picture 3 & 4: Otji-Toilets on Odendaal Farms  
Source: Pictures taken by authors*

Due to the fact of the Otji-Toilets being rather new, the comparability to the other visited sites might be limited.

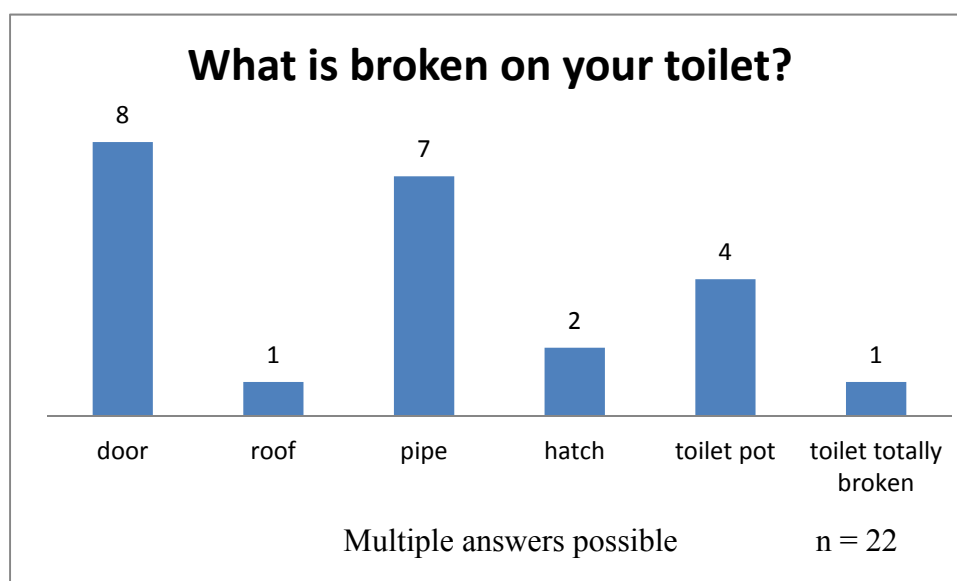
Figure 11: Damages on the toilet<sup>1</sup>  
Source: Compiled by the authors

A further important sub-item is the question whether the toilet is damaged in any manner. Out of all 49 inspected toilets, 22 had some damages and 27 toilets did not show any damages at all. From these 22 toilets, one toilet was so damaged that is could not be used anymore. The other 21 toilets showed damages, but they were still functional. The detailed list of the damages is to be gathered out of figure 11.

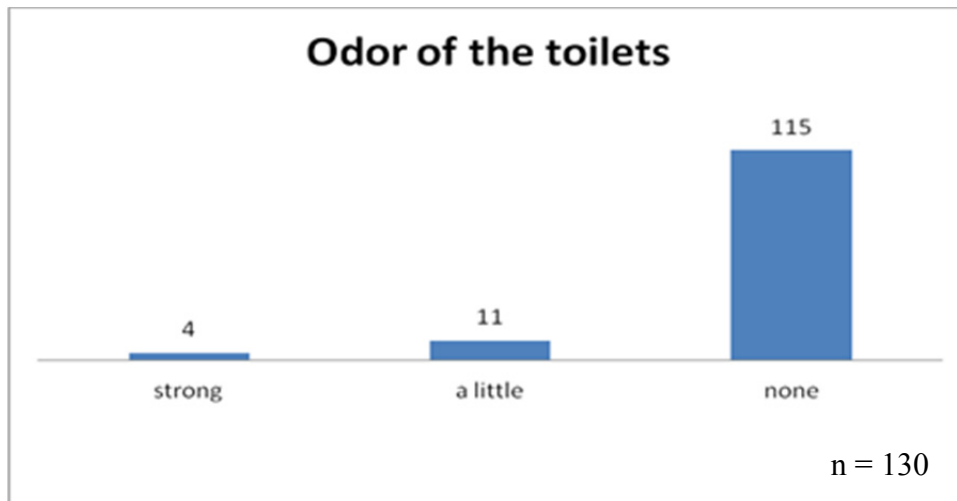
*Figure 16: Odor of the toilets<sup>1</sup>*  
*Source: Compiled by the authors*

A clear result can be identified concerning the odour of the toilets that was determined during the inspection. Only 4 toilets smelled strong, 11 toilets smelled a little and 115 toilets did not smell at all (please see figure 16). The remaining 38 observed toilets were not inspected regarding the odour.

From the observation of the students, 115 toilets did not smell at all. Only eleven toilets smelled a little and four toilets smelled strongly (please see figure 16). In contrast to that, 48 of the interviewees said that their toilet smells, additional 29 said the toilet smells sometimes, 50 interviewees stated that the toilet did not smell at all and nine interviewees said the toilet only smells when the bins are full. The sample size all in all is 146 but ten interviewees did not answer to this question, meaning there are 136 answers available.

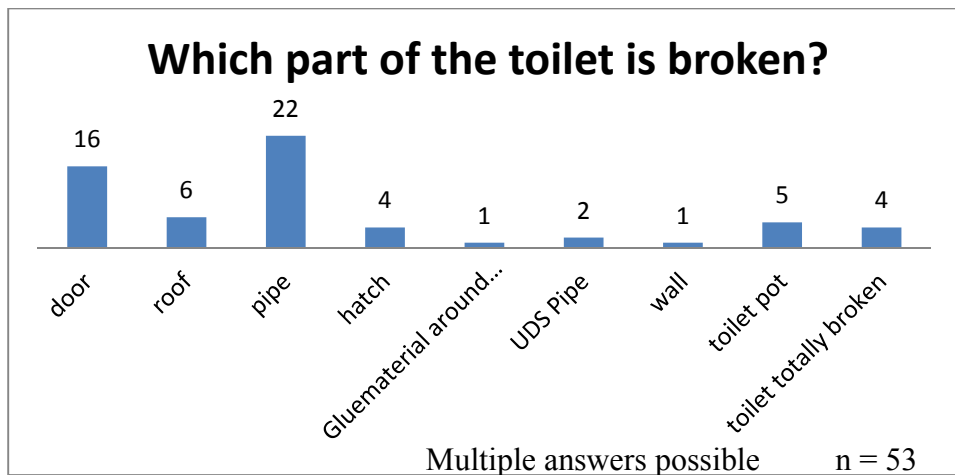
Figure 19: Which part of the toilet is broken?<sup>1</sup>  
Source: Compiled by the authors

The answers to the question whether the toilet had ever been damaged provide an interesting result. Of a total of 144 answering interviewees, 53 persons said that their toilet is damaged; 91 toilets were not damaged and three toilets lack data. After evaluating the results, the pipe that promotes the ventilation and the drying of the faeces seems to be to the weakest point of toilets. Besides the pipe, the door was also damaged in some cases; but overall and in spite of

these minor damages, the toilets were still usable and made a good impression. A detailed listing of the damaged parts can be gathered out of figure 19.
