Cape Town's problematic vacuum sewer: A reflection on the technical, social and institutional blockages that constrain municipal management

ABSTRACT

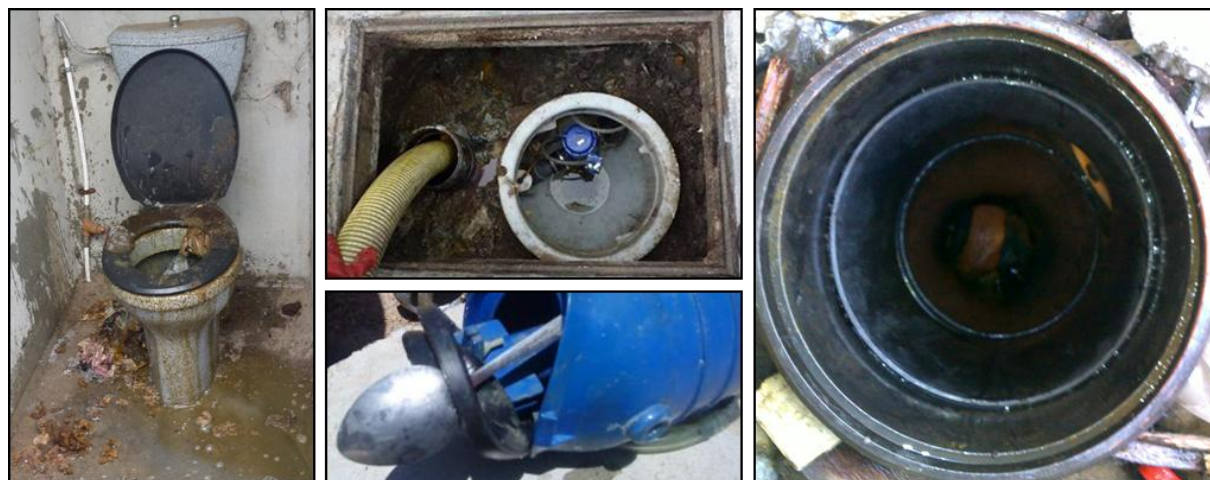
Since installation, however, Kosovo's vacuum sewer system has continuously been hampered by poor management from both the end users (Kosovo's residents) and the service providers (CoCT) (Ashipala, 2011). The disposal of items such as cutlery and bricks into the vacuum system by the residents quickly resulted in some interface valve diaphragms being pierced by sharp objects whilst some sumps were filled up with gross solids. These problems were exacerbated when some of sensor controllers malfunctioned due to fats and dirt clogging the pilot tubes, or rendered completely useless from water-logging after the chambers over-filled

as a consequence of the failure of the valves to open. This has resulted in sewage regularly flooding the concrete ring, inundating the collection chambers and spilling out onto the ground around the toilet blocks (Figure 1). Meanwhile, the vacuum pumps have been overworked due to air leakages.

Figure 1. Clockwise from left to right: Typical conditions of a vacuum system toilet; raw sewage being pumped out of a clogged sump and flooded concrete ring; a brick in a sump; and a spoon piercing an interface valve diaphragm.

taken some 25 months after the system was commissioned, was to arrange a five-day skills training course for the WSISU technical staff and the pump operators to learn how to manage the system. Simultaneously, consulting engineers have provided new O&M manuals detailing short- and long-term maintenance requirements.
