data sheets for ecosan projects

Waterless sanitation in UNESCO-IHE building

Delft, The Netherlands

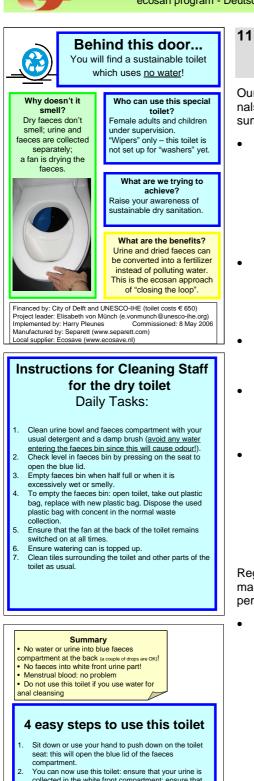
Figure 5. Explanatory posters at the toilet for users and cleaning staff
