SFD Lite Report

Kabarto 2 IDP Camp Kurdistan Region of Iraq

This SFD Lite Report was prepared by GOPA Infra

Date of production/ last update: 16/09/2021

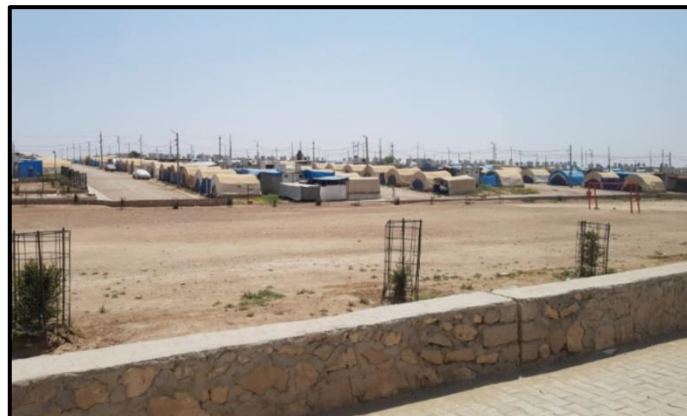
Figure 4 - Kabarto 2 Block (Source: Author, 2018)

An example of the layout of the blocks is provided in figure 4, where you can see that each tent is established on its own plot and these can then develop over time as the family expands the shelter to take up more space on the plot and make it more comfortable, as the likelihood of returning to their place of origin becomes less likely in the near future.

The space in the middle ground of figure 4 is the clear area left on the low point of ground, where the wadi runs through here in a box culvert. The area is not developed for accommodation in case of flooding from the wadi.

In each of the blocks, tents are established on plots that are usually 12m x 7m = 84m². The space allocated for each household is thus smaller than the average of 200m² in the host community, but much bigger than the recommended minimum of 30m² per household for camp settings, from the emergency shelter handbook, according to Ali Mobasher of UNHCR. The tent size provided on the plot is generally 4.6m² per person, compared to the minimum recommended of 3.5m² per person, as explained by UNHCR.

In figure 4, the stormwater channels that have been constructed around the plots can be seen on either side of the internal roads. These have been constructed from concrete to prevent erosion and to ensure that runoff from roads is channelled around the tent plots, thereby minimising the opportunity for flooding from rainwater.

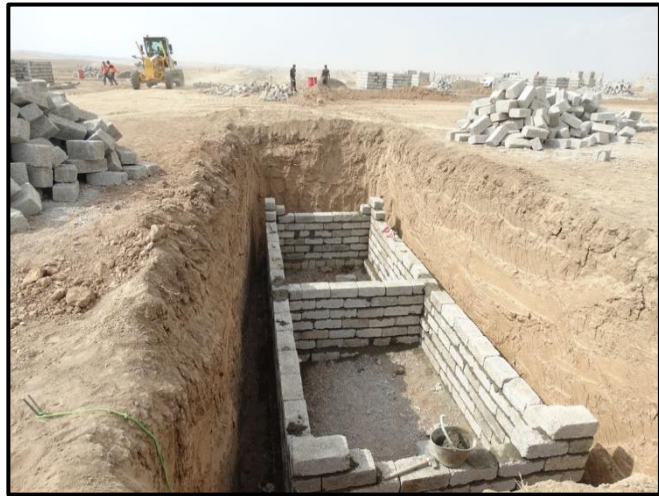
Figure 7 - Kabarto 2 Blackwater Containment, 1 of the total of 150. (Source: Duhok Governorate, 2021)

The containment system consists of a blockwork wall, constructed directly on the ground, without any base slab or foundation. A concrete slab is poured over the top of the “tank”, to provide a cover and support its own weight. The intention of the containment system is to let as much liquid as possible infiltrate into the ground, through the permeable walls and the open bottom. The system requires regular desludging, as with twenty households connected to it, there is more liquid being added than what usually can infiltrate into the ground, particularly where grey and blackwater are mixed. It reduces the amount of desludging that must happen, thereby minimising the cost, but that does mean that untreated liquid is permeating into the ground from every containment system in the camp (150 in total), which creates a potential risk for groundwater. As described in the SFD manual, the material that is removed from the containment system is called faecal sludge (FS).

In the SFD manual, this type of containment is referred to as “Lined pit with semi-permeable walls and open bottom”.

The engineer from KURDS NGO stated that some of these containment systems are prone to getting stormwater inflow during wet weather and that this increases the amount of desludging needed, otherwise the pits will overflow. In winter the ground is also more saturated from the rain and so there is less permeability for the contents of the pit, also resulting in increased desludging requirements. Other than emptying these systems, no other planned maintenance is currently carried out.

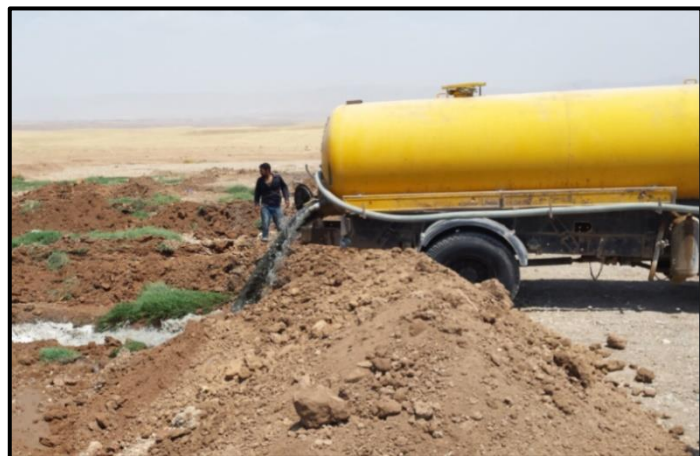
Author, 2018)

This is carried out by 10,000l vacuum trucks, provided by the municipality and the trucks can also be provided by private contractors, where needed for extra capacity or to cover breakdown of the municipality trucks according to KURDS NGO. Their staff monitor the various pits within the camp and direct the desludging service to the various locations when it is required to prevent overflow. KURDS NGO carry out camp surveys at least annually and gauge people’s satisfaction with the various

These vacuum trucks are widely used in the area and they come with a flexible suction hose that is inserted into the containment pit in order to vacuum the FS out. As noted in the Sanitation Assessment & Concept Options Report, 04 June 2019, there is difficulty in completely emptying these types of pits, owing to the narrow opening in the roof slab and the flexible hose, which often results in solids being left in the corners of the pit, away from the opening in the roof slab, reducing the working volume and thus increasing the frequency of desludging.
